Appendix A: Project Planning Matrices

Table A-1 . Wilsonville Problem Area Matrix

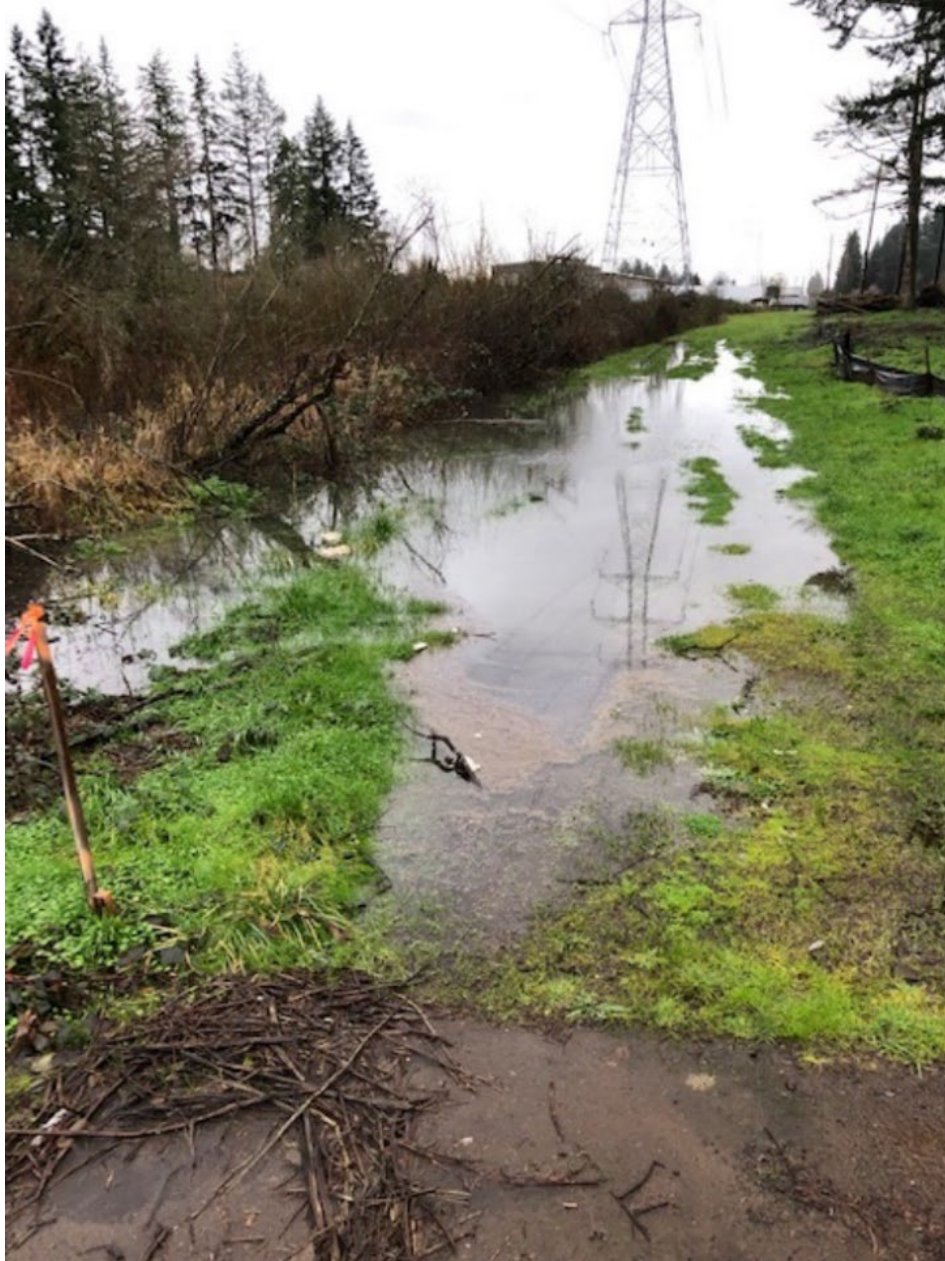
Figure 1. Validation observations (south of Day Road)

Public Works staff provided several photographs from January 6 (time unknown) to document the reported ponded water south of Day Road as shown in Figure 1.

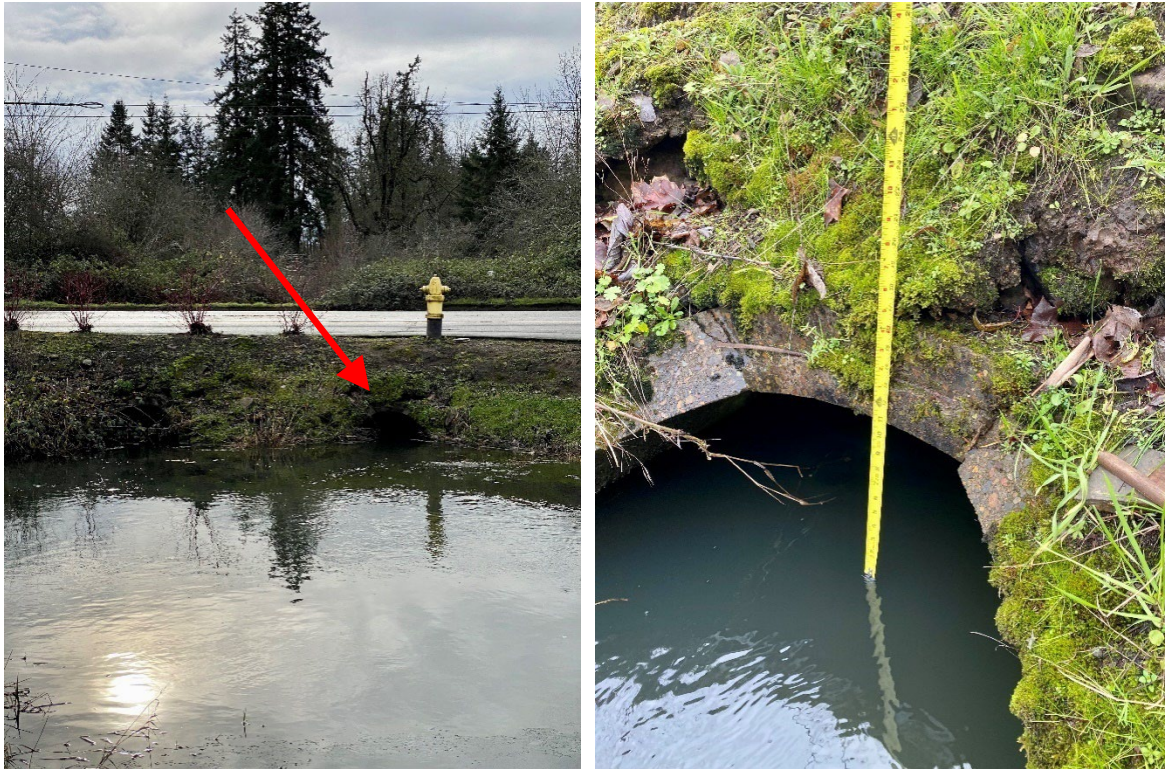
Figure 2. Validation measurement location (48-in. culvert underneath Ridder Road)

To correlate observed standing water conditions with measured data, BC staff collected a water depth measurement downstream of the observed flooding per Figure 2 (left) on January 7, 2022 at 11 a.m.. This measurement was collected at one of the 48-inch culverts underneath Ridder Road. While this measurement was collected after the peak of the storm event, water levels within the culvert remained high, as the culvert was approximately 67 percent full as shown in Figure 2 (right) below.

Left: Location of culvert. Right: Depth of water in culvert.

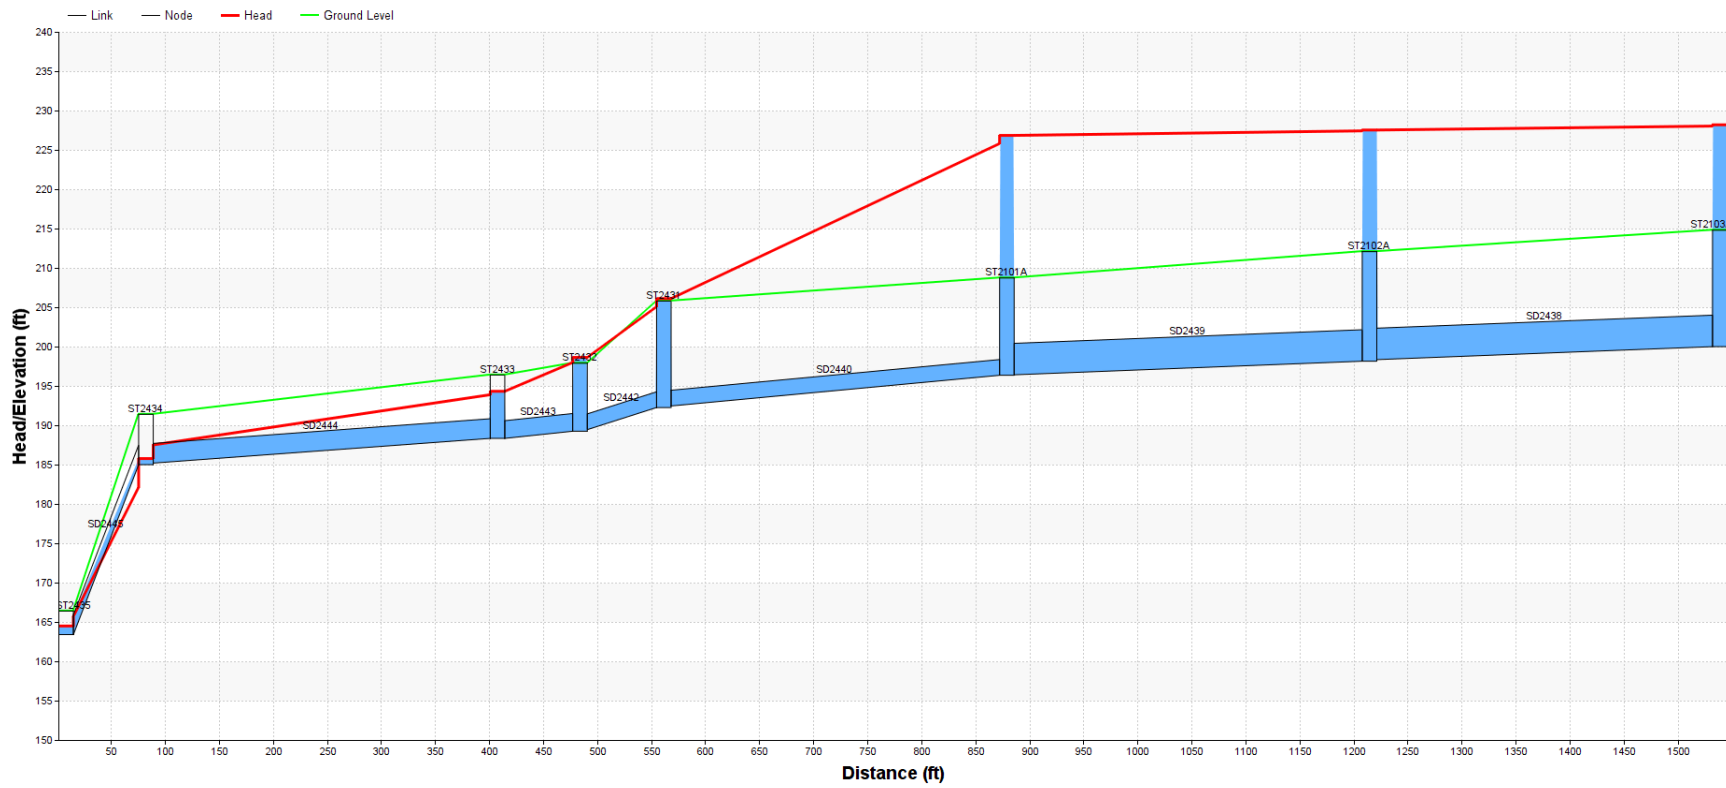
Figure 8. Peters Road-hydraulic grade line 25-yr design storm

This location has several deficiencies within the waterway such as undersized culverts, heavy buildup of vegetation/debris, and segments with negative grade. Historically, this location has been particularly difficult to address due to space constraints, limited available grade, and the original drainage design allowing for the adjacent parking lots to flood to provide detention. This SMP update will build upon previous preliminary design concepts to develop a refined option for implementation.

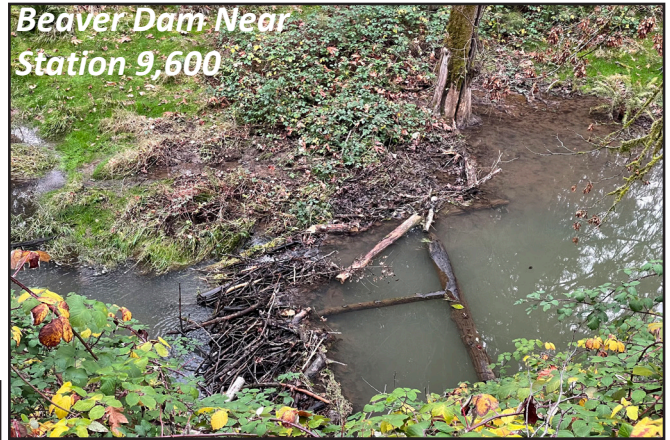
*Beaver Dam Near
Station 9,600*

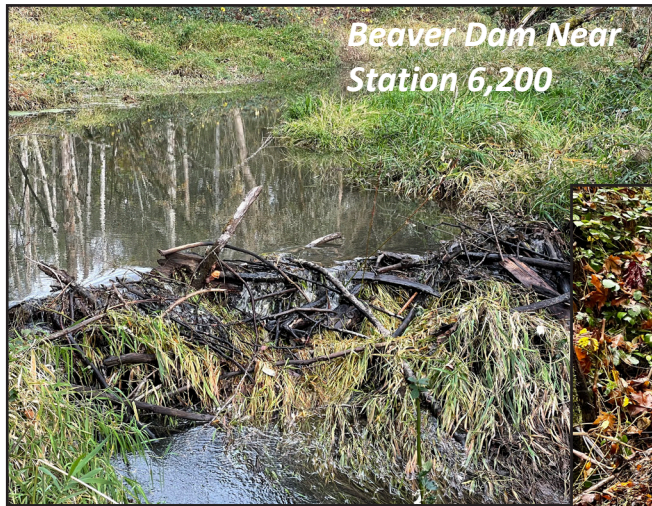
*Beaver Dam Near
Station 6,200*

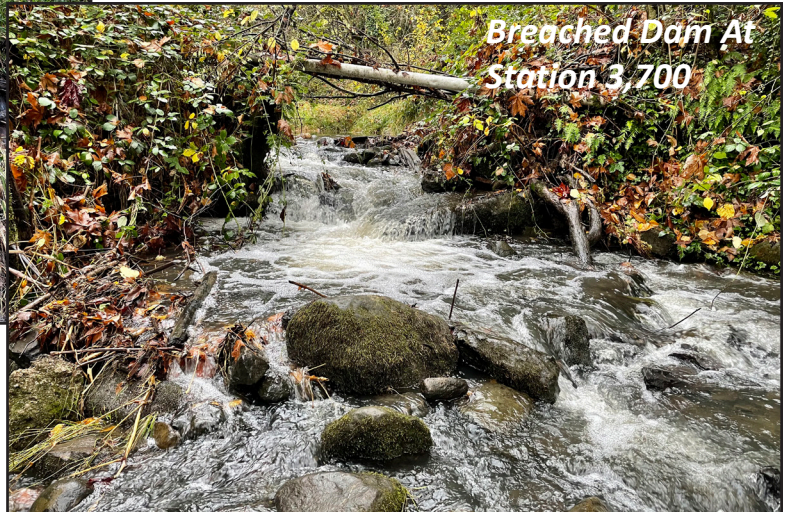
*Breachd Dam At
Station 3,700*

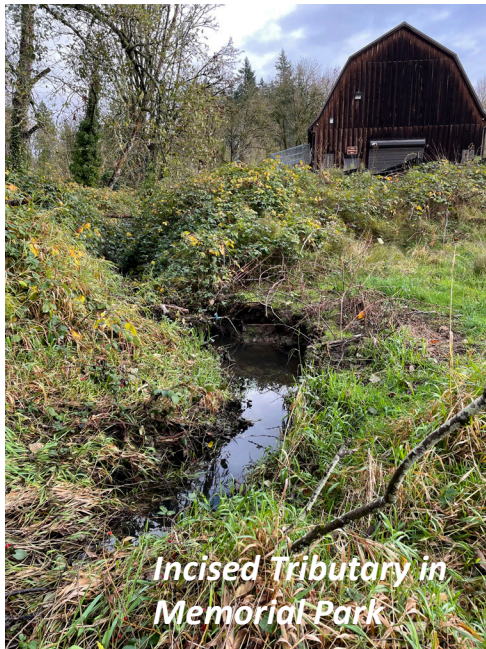
*Incised Tributary in
Memorial Park*

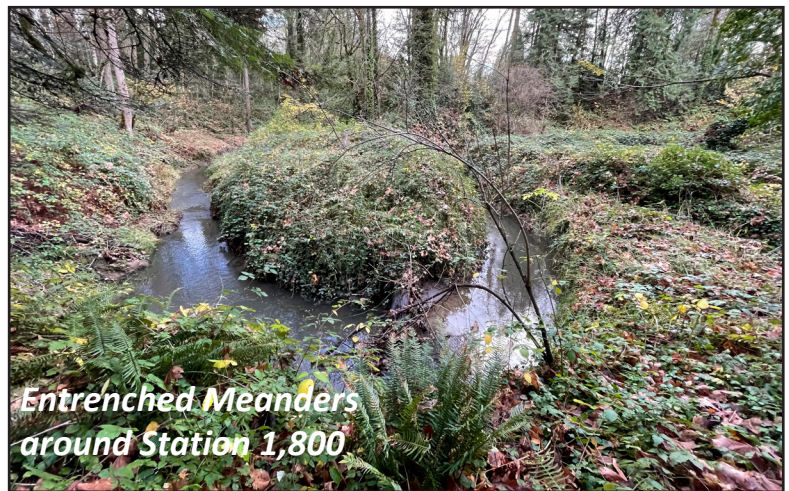
*Entrenched Meanders
around Station 1,800*

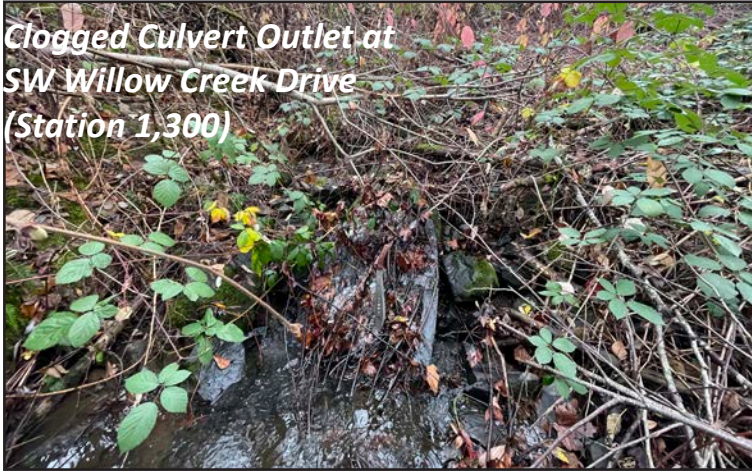
*Close Up of Clogged Culvert
at Station 1,300*

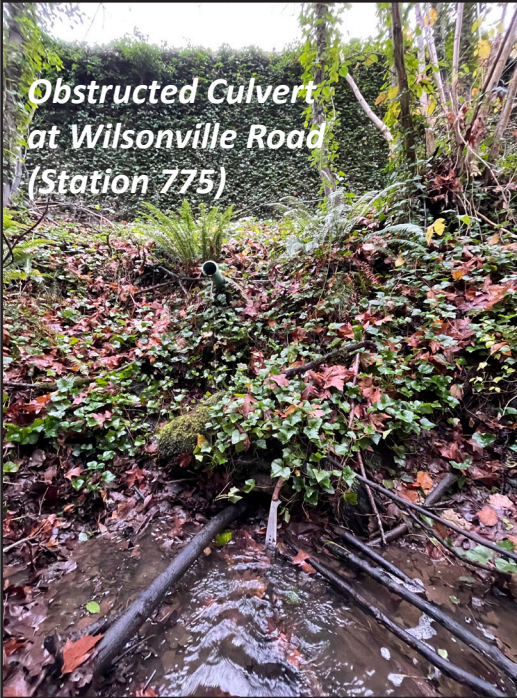
18		Meridian Creek in Landover Park - Reach 1 (US of Wilsonville Rd.)	Meridian Creek	Stream Assessment	Sediment-clogged culvert (30-inch) at the Meridian Creek Crossing at Wilsonville Road. Culvert is mostly obstructed and appears to cause ponding during storm runoff.	MAINT	E&S	Y	Y	N	Y	N	<ul style="list-style-type: none"> Consider location of ponding and whether infrastructure is being impacted. If ponding is isolated to park and not overtopping any roadways or impacting private property, then maybe this isn't a problem that needs to be fixed. It's effectively a detention pond. Per Wksp 3-15, planning project need to monitor location and confirm worsening. 	Y-City-2	N	Y-P-5	N
19		Meridian Creek in Landover Park - Reach 2 (DS of Willow Creek Dr.)	Meridian Creek	Stream Assessment	Culvert outlet at upstream end of reach is clogged and backs up water underneath Willow Creek Dr. PVC SW outfall along reach is undermined (STA 1,100) and 6-foot section has washed out and moved downstream.	MAINT	E&S	Y	Y	N	Y	N	<ul style="list-style-type: none"> Need in-water work permits to replace culvert. Traffic impacts to Willow Creek Drive during culvert replacement. Per Wksp 3-15, planning project need to monitor location and confirm worsening. 	Y-City-2	N	Y-P-5	N

*Close Up of Obstructed
Culvert at Wilsonville Rd*

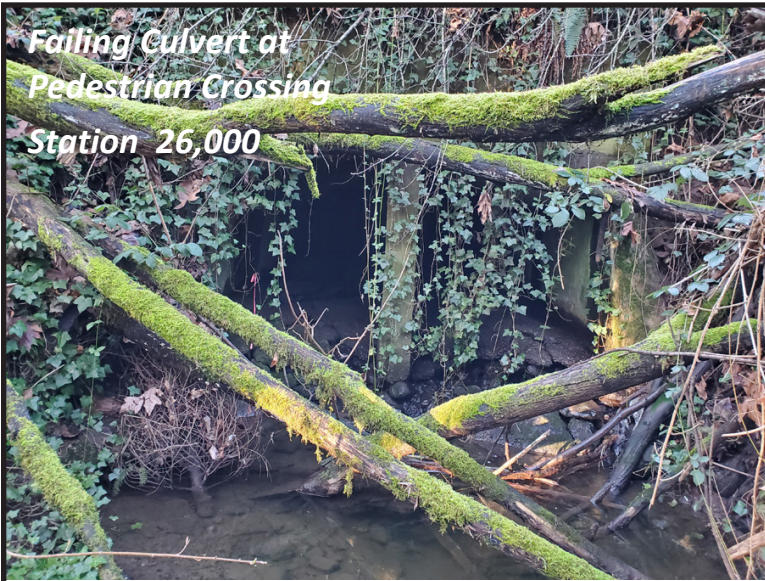
20		Arrowhead Creek at Pedestrian Bridge (Reach 4)	Coffee Lake Creek	Stream Assessment	Culvert at upstream end of reach (at pedestrian crossing) is failing and should be considered for replacement.	R/R		Y	Y	N	Y	N	<ul style="list-style-type: none"> Need in-water work permits to replace culvert. See Project Opportunity #14. 	Y-CLC-2	N	N	N
21*		Memorial Park (Swale Retrofit, Pipe Upsizing, and Mitigation)	Boeckman Creek	Retrofit Analysis H/H Model	Swale at Memorial Dr. is not draining properly. Potential concept is to extend swale all the way along the road or relocate to the base of hill. Modeling evaluation indicates that the pipe system after convergence point at Memorial Drive has a constriction resulting in backwater and upstream system flooding (preliminary flooding location #5).	MAINT	CAP	Y	Y	Y	N	Y	<ul style="list-style-type: none"> Opportunity to expand water quality treatment through retrofit of existing facility. Location is also affiliated with Boeckman Road mitigation alternative location (raising of pedestrian trail to detain flow from entering Boeckman Creek). Relocation of swale allows for offline facility construction. 	Y-BC-5	--	N	N

4	19+50	26+00	Stable reach with hardpan grade control. Culvert at upstream extent of reach is in the process of failing	1.31%	plane bed meandering	hardpan bedrock gravel	incised but stable	shallow alluvium intermittent on hardpan bedrock	valley walls ~25-ft high with low energy	N	stable	1	2	2	2	Ivy removal and riparian restoration	Subreach consists of 50'-75' valley bottom confined by 25'-30' of 1:1 valley walls. Channel incised 2'-5' into valley bottom with some active inset foodplains. Creek flows on hardpan bedrock. Cottonwood/alder/fir canopy threatened by ivy which dominates groundcover.

*Falling Culvert at
Pedestrian Crossing
Station 26,000*

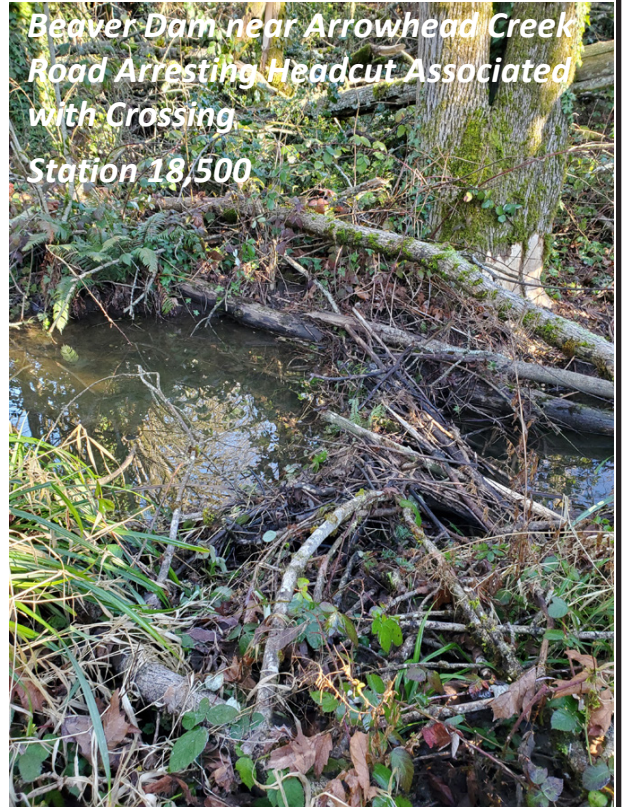
*Beaver Dam near Arrowhead Creek
Road Arresting Headcut Associated
with Crossing
Station 18,500*
