TECHNICAL MEMORANDUM

Subject: Facility Crack Survey and
Supplemental Exploration Results
Wilsonville WWTP Campus

Project: Wilsonville WWTP Master Plan

Project No. 00-231579-0

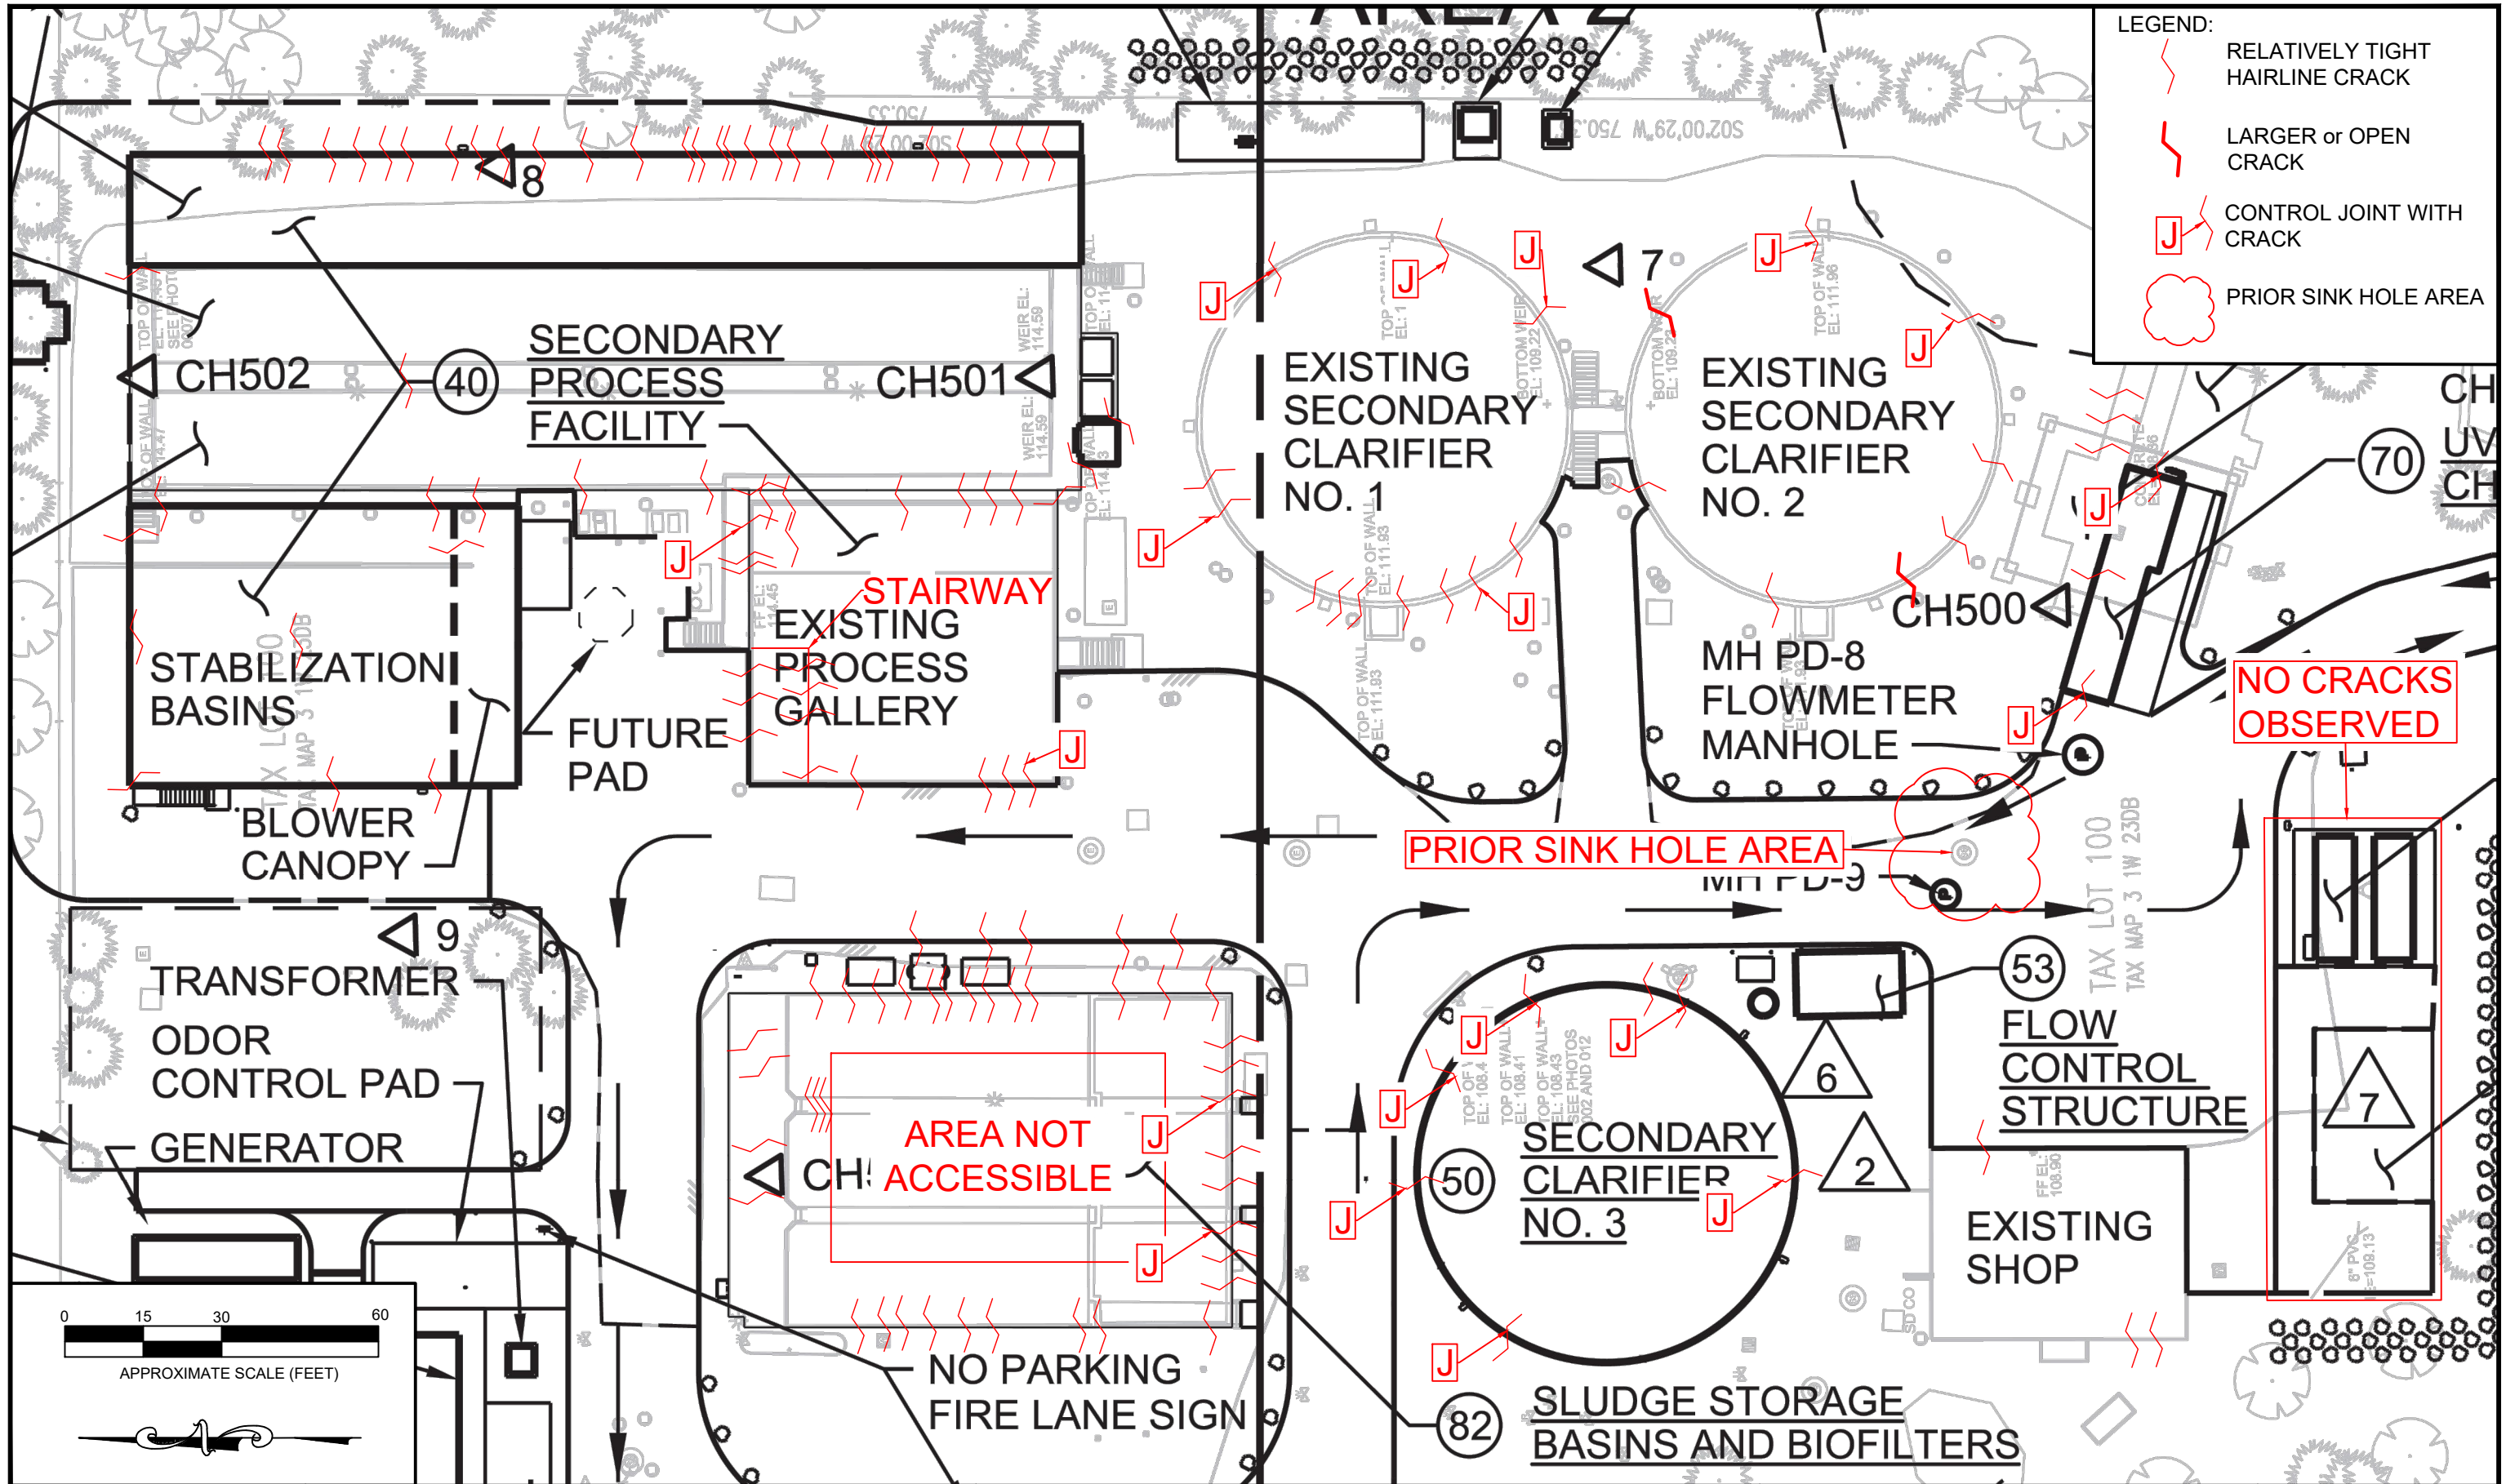
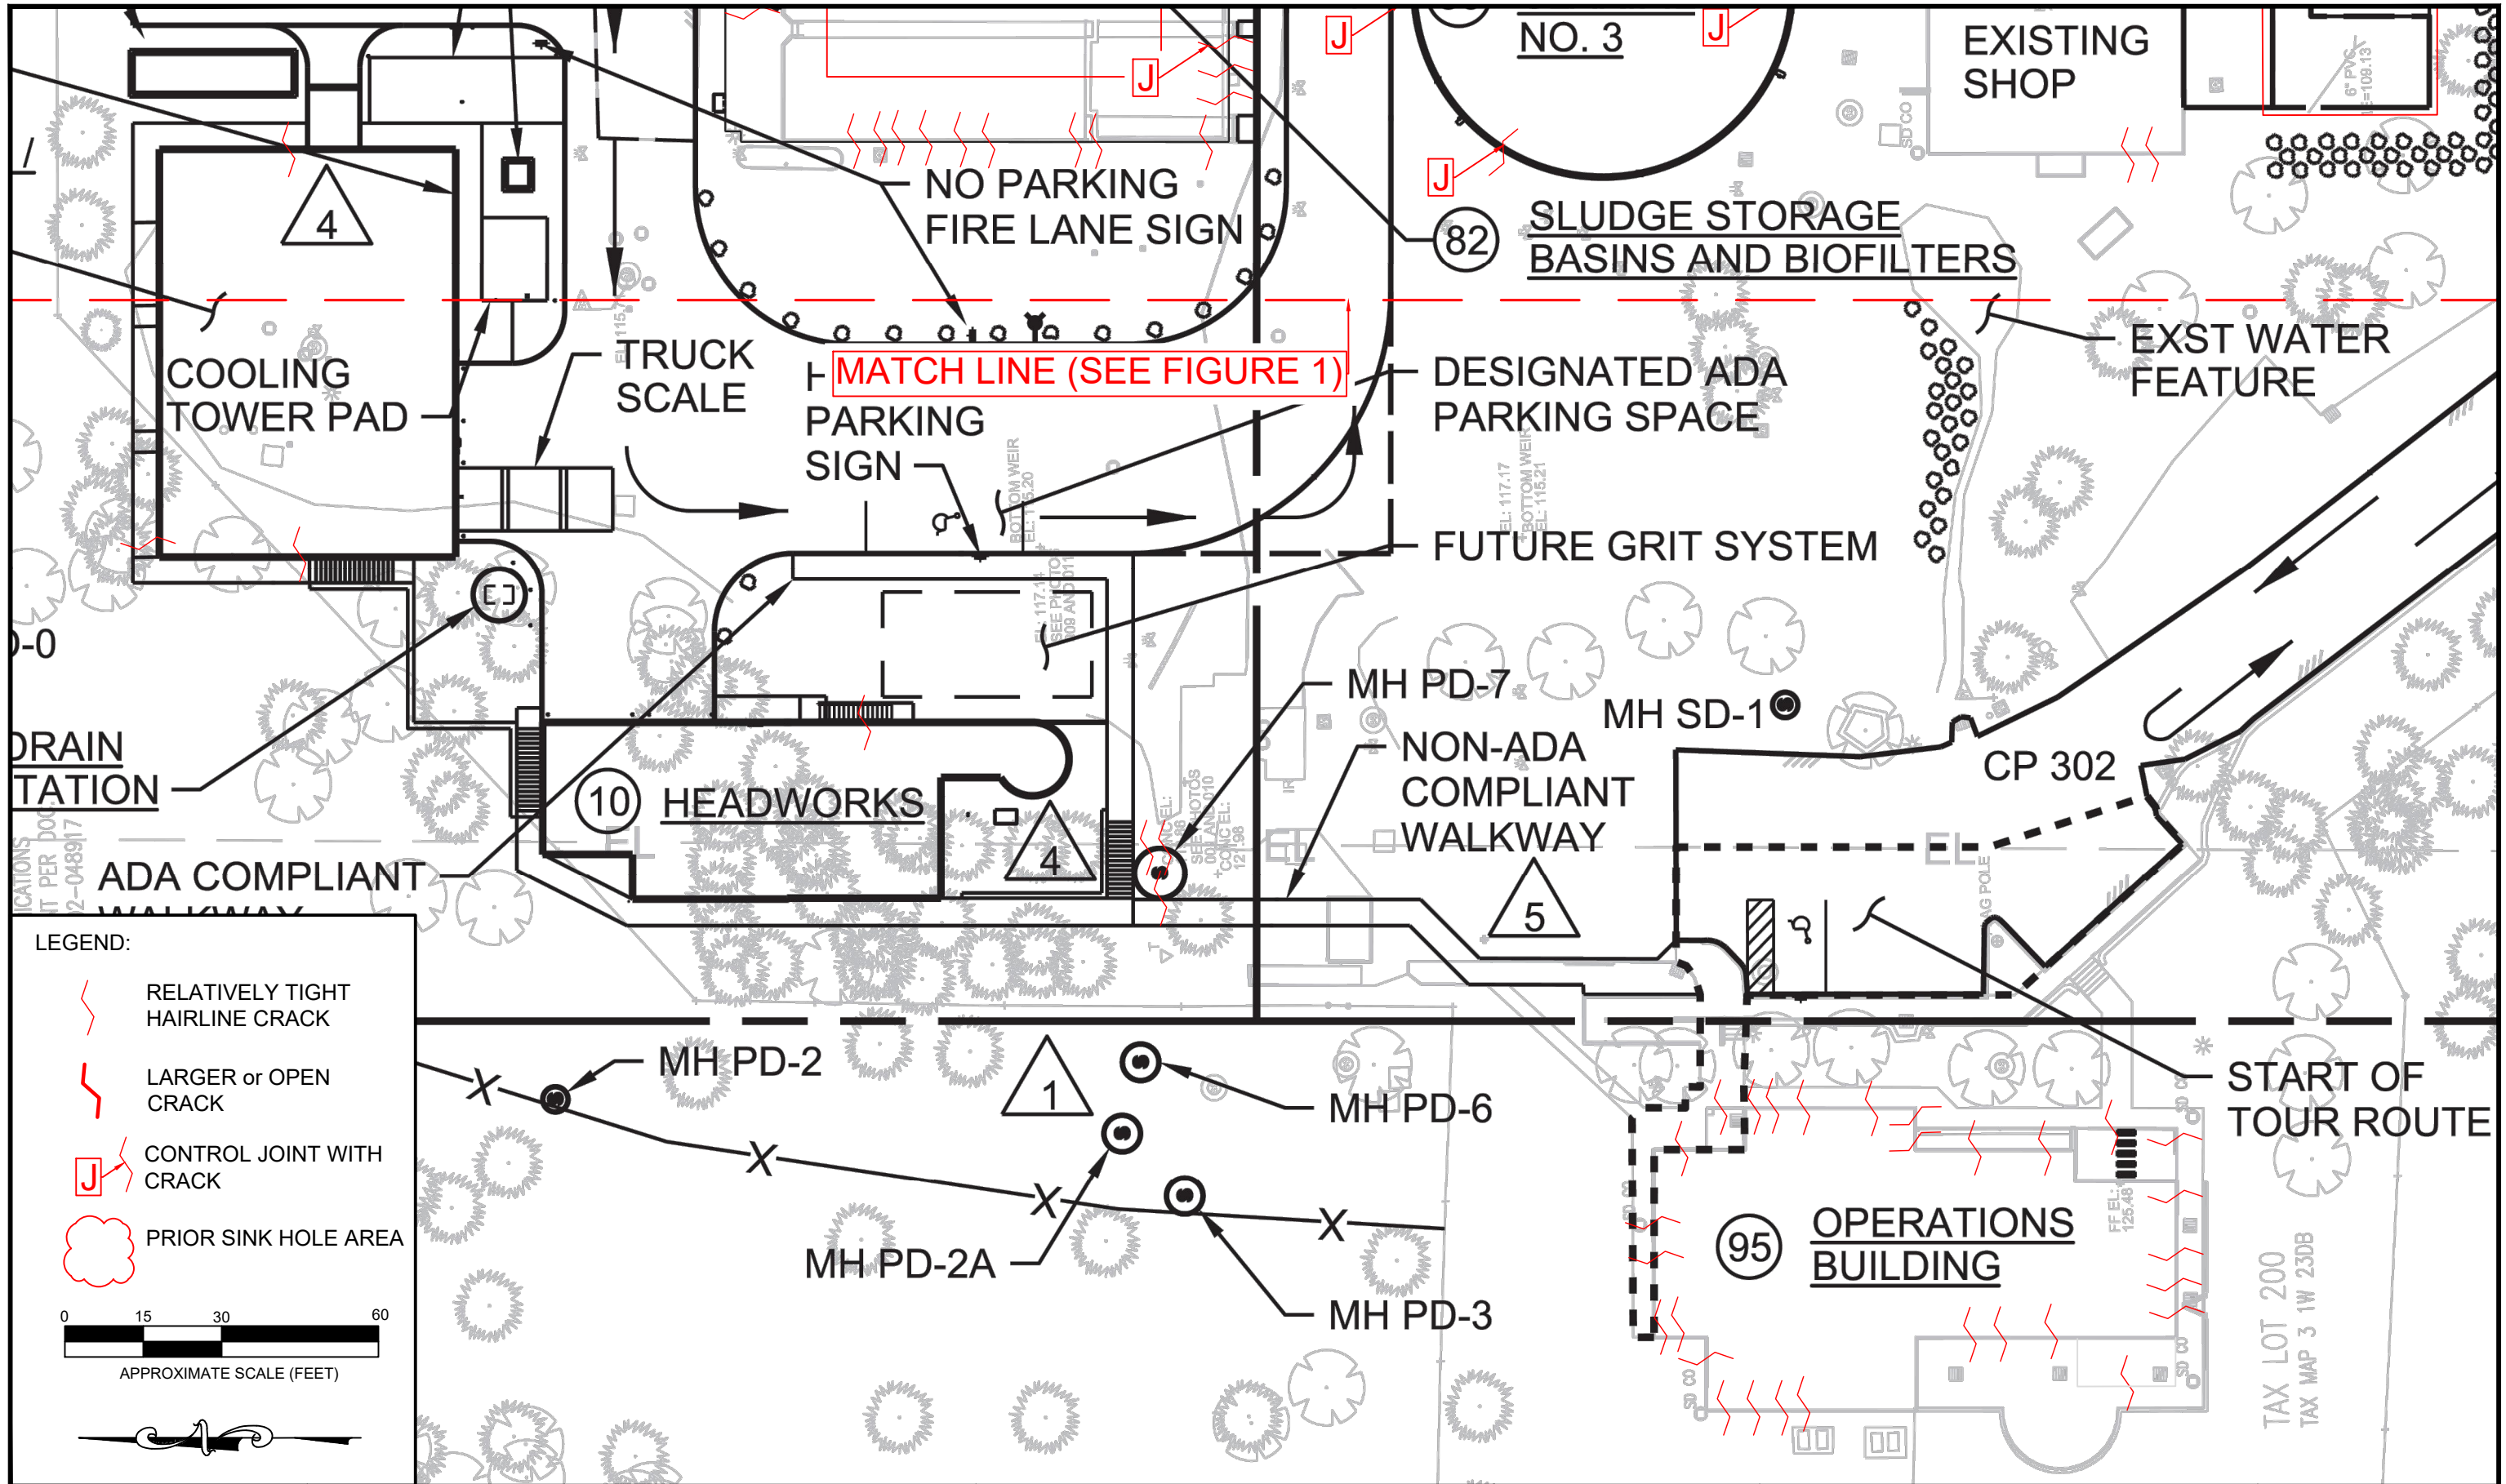
We performed a visual crack survey of the facilities that were accessible without specific fall protection equipment. The crack locations are approximate and utilized nearby features and geometry identifiable on the base drawings utilized to manually record the visual survey. The attached Figure 4, sheets 1 and 2 document this effort. The crack types were separated into typical hairline cracks, control joints with cracks/movement, and open or more pronounced cracks. Overall, many of the structures had very few cracks, a testament to the conservative design process that would be important for structures constructed over uncontrolled spoil fills.

Nonetheless, a few structures did indicate that some differential settlement stress had occurred or is occurring. The crack survey provides a baseline for evaluating or monitoring any future cracking progression and we recommend it be repeated every 5 to 10 years for signs of progression.
