September 13, 2021(Revision)

RE: Tree Protection Plan for the North Valley Complex Renovation Project

Appendix 5: Tree Protection Plan

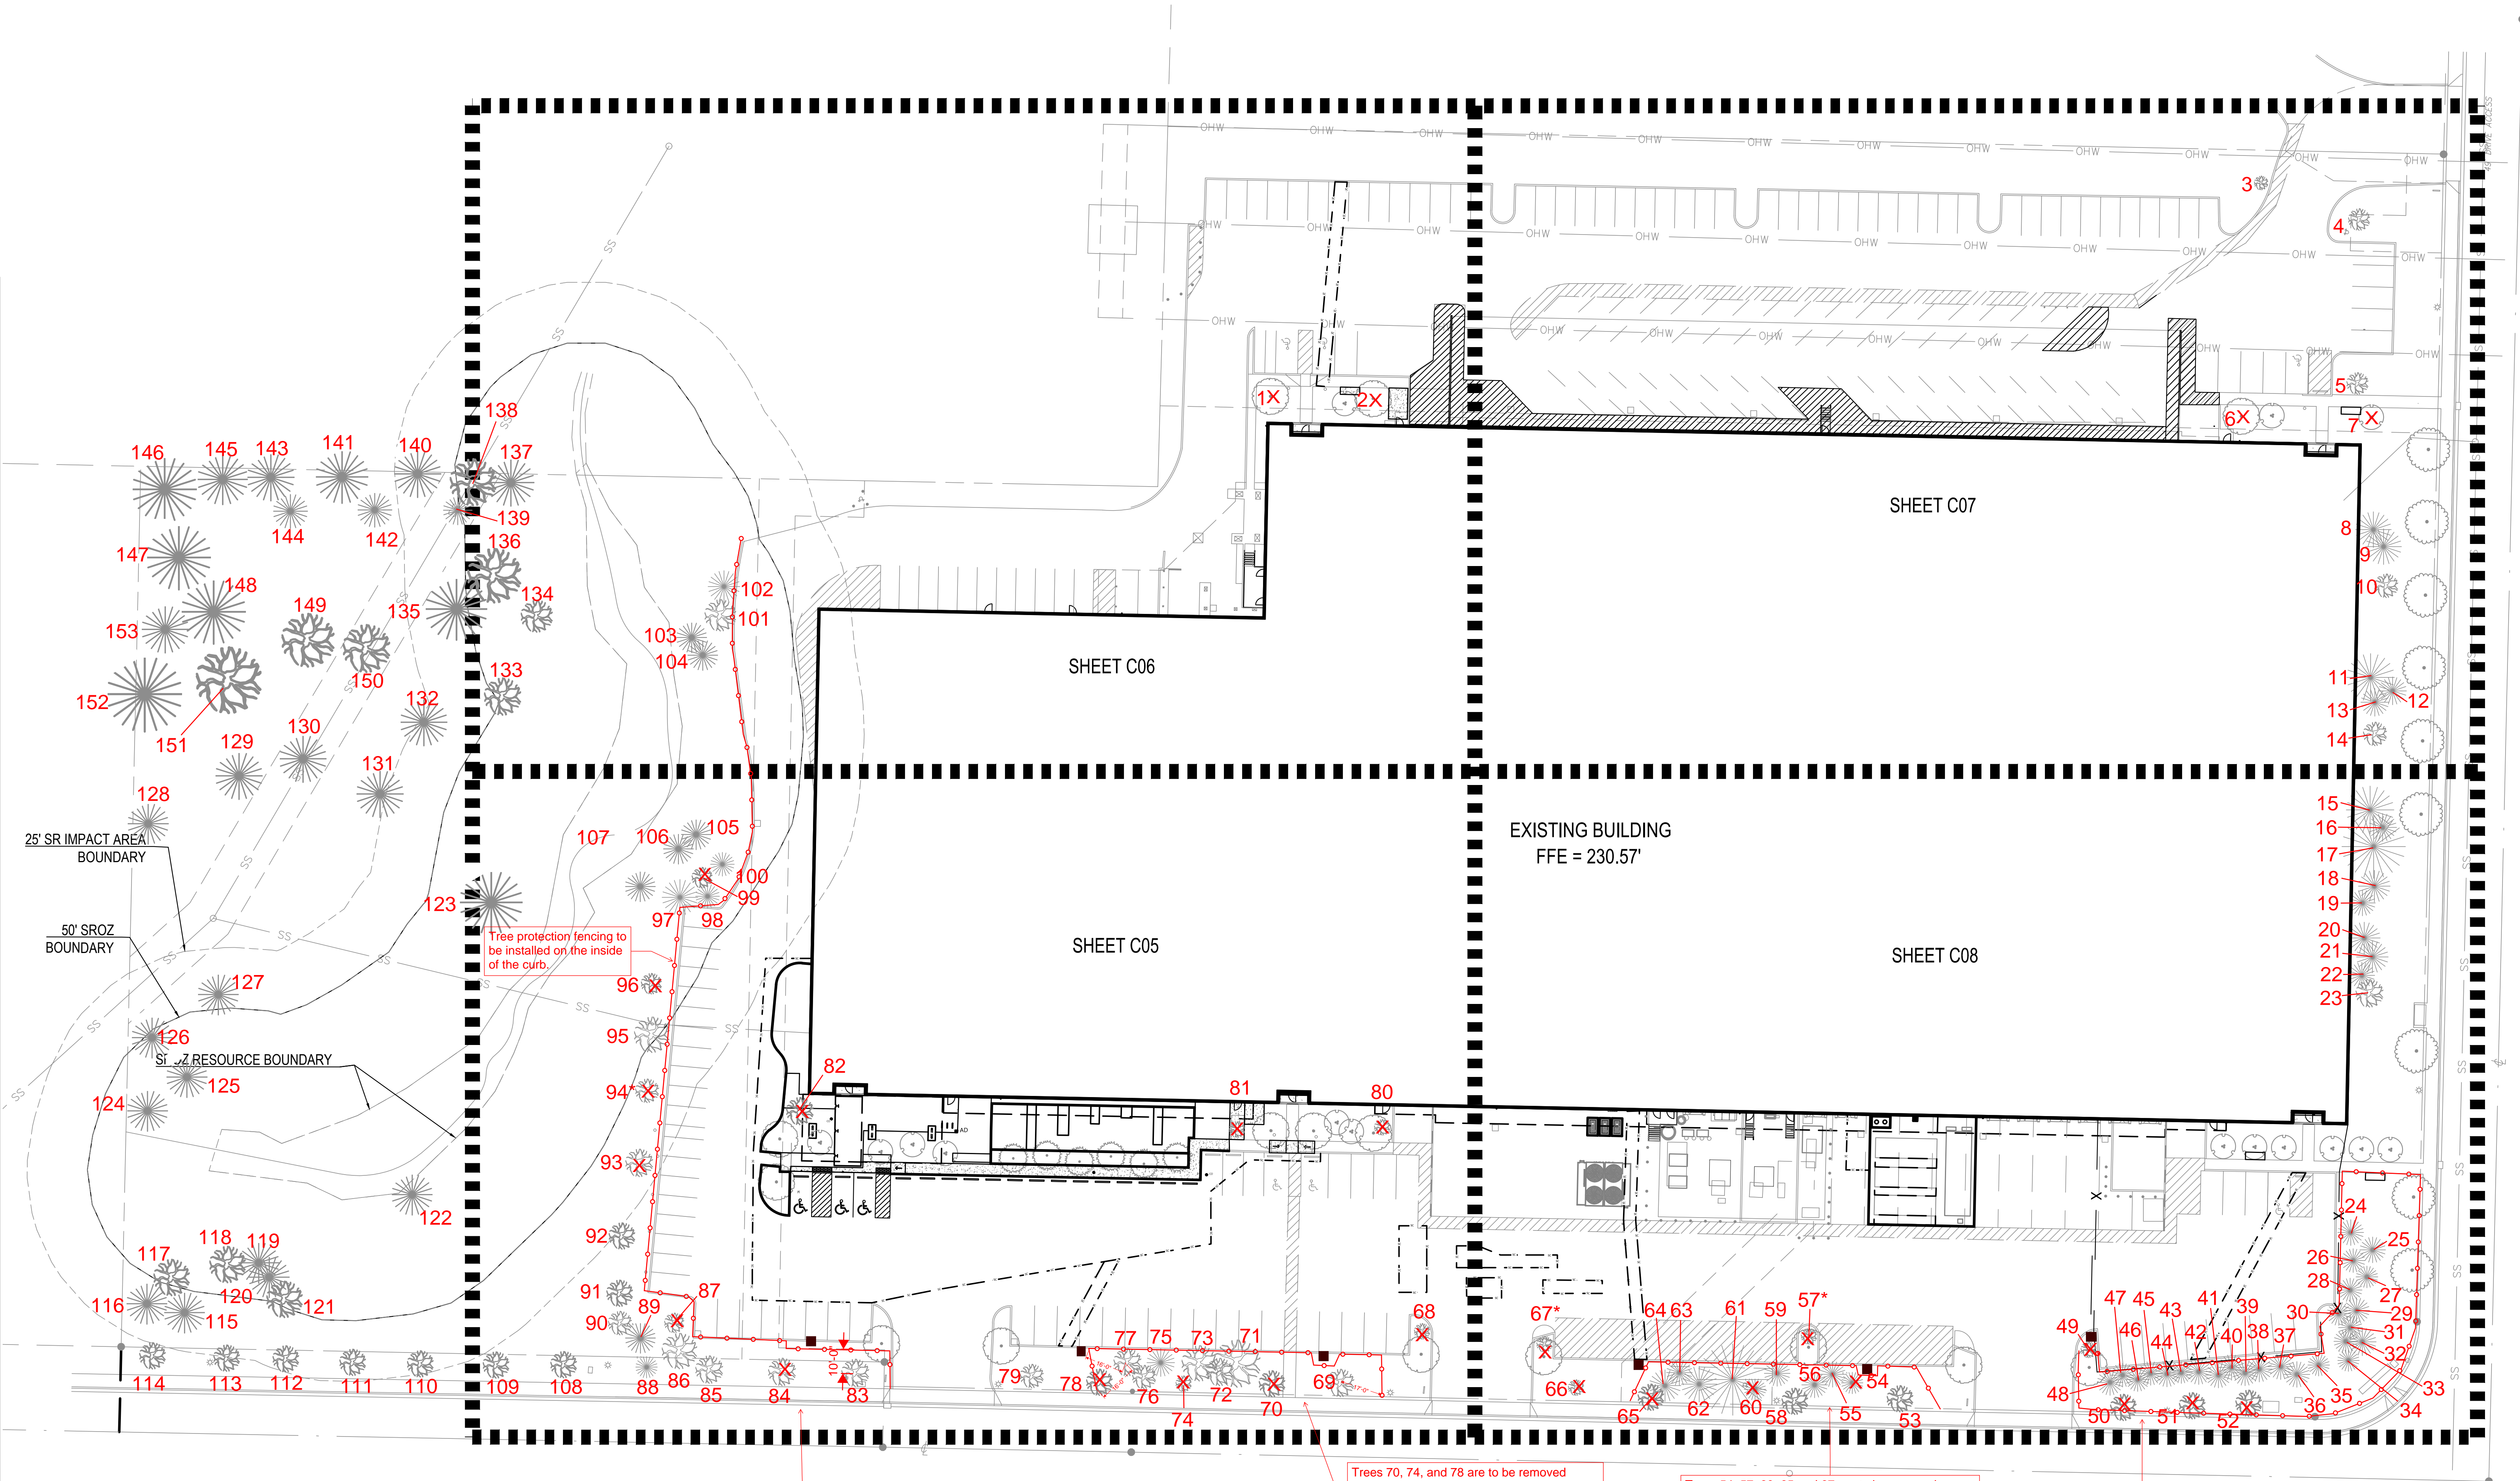
Trees 84, 87, 93, 94, 96, 99 are to be removed BEFORE installing tree protection fencing. Fencing is being installed to protect trees from accidental damage from construction equipment and vehicles.

Trees 70, 74, and 78 are to be removed BEFORE installing tree protection fencing. Fencing is being installed to protect trees from accidental damage from construction equipment and vehicles.

Trees 54, 57, 60, 65 and 67 are to be removed BEFORE installing tree protection fencing. Fencing is being installed to protect trees from accidental damage from construction equipment and vehicles.

Trees 49-52 are to be removed BEFORE installing tree protection fencing. Tree protection fencing locations TBD.
