APPENDIX E: ARBORIST REPORT

Frog Pond East and South Master Plan – Wilsonville, Oregon Tree Reconnaissance February 6, 2022

MHA21056

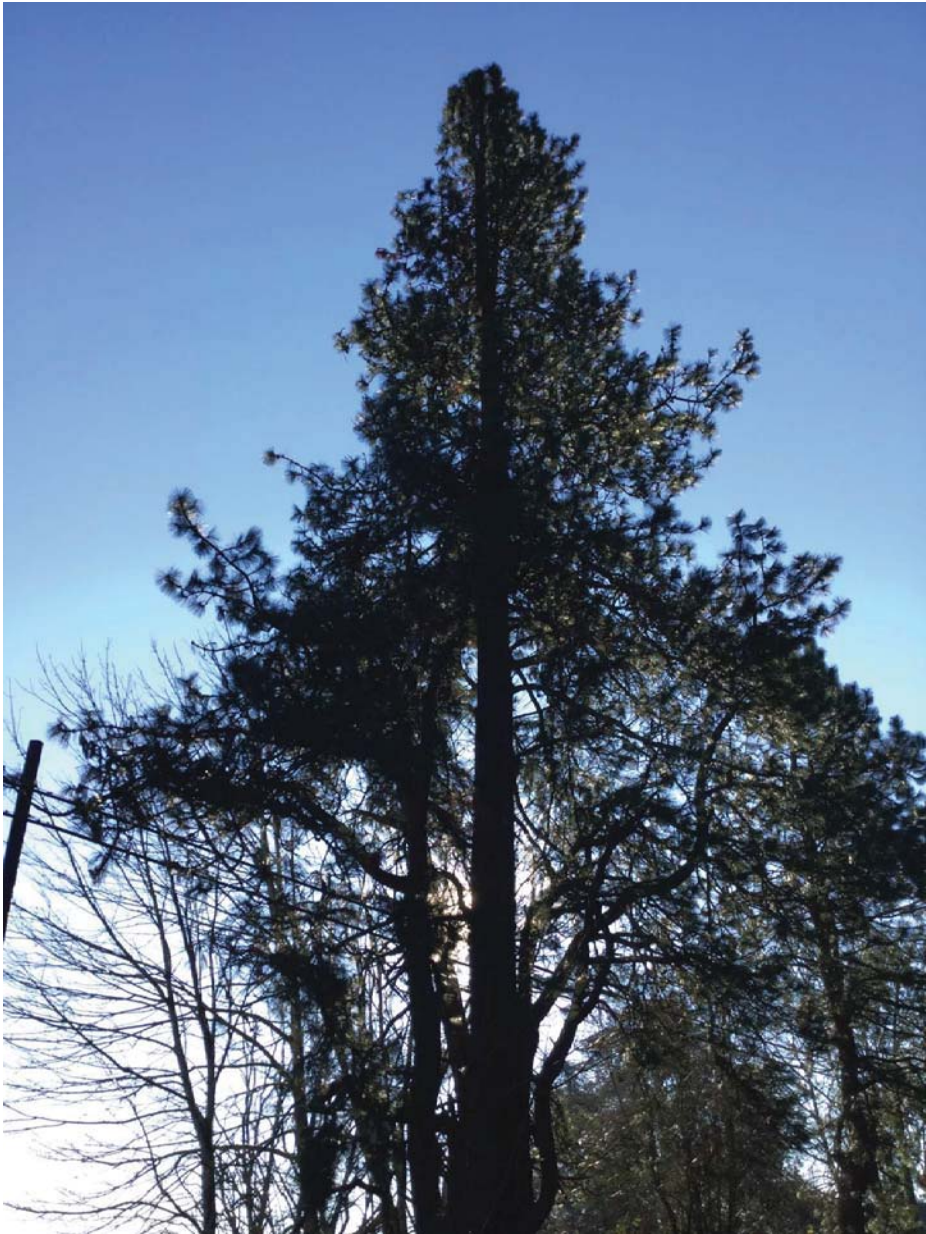
- **31E07 00700 (Map ID No. 1; Photo 1):** One 45" diameter ponderosa pine (*Pinus ponderosa*) located in the Stafford Road right-of-way adjacent to this parcel is in generally good condition, but with moderate structure including codominant stems and western gall rust infection caused by the fungus *Endocronartium harknessii*. This infection was not noted in the 2014 assessment and may have progressed substantially since that time. Infected branches are more susceptible to failure at the gall and the tree could become increasingly hazardous adjacent to the road. Overall, this tree may be challenging to retain with future street improvements and its long-term viability may be jeopardized by the infection.

Photo 1. A 45" diameter ponderosa pine with moderate structure and western gall rust infection. In the ROW adjacent to tax lot 31E07 00700 - Map ID 1.

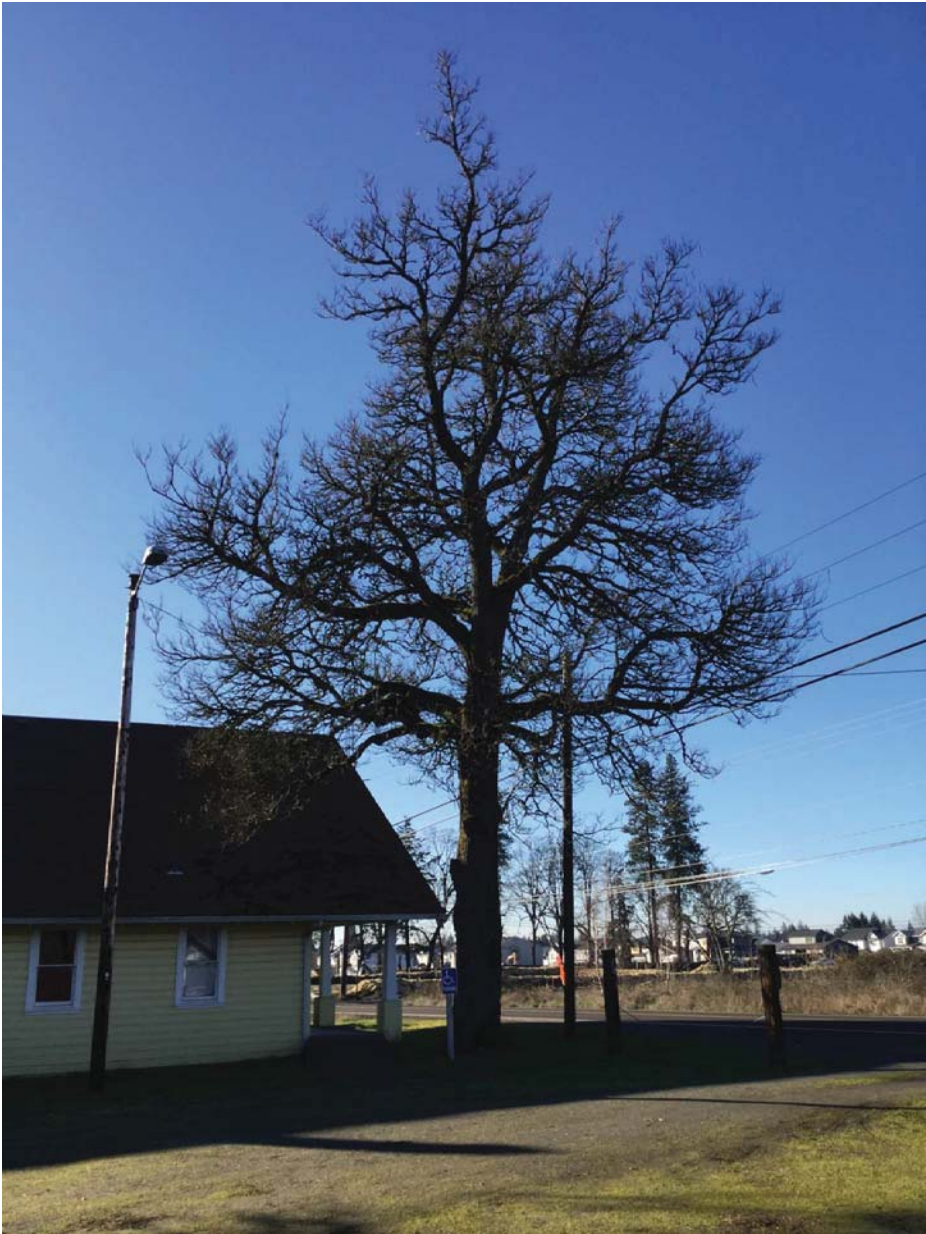
Photo 2. A 40" diameter mature catalpa tree in generally good condition outside of the grange hall at tax lot 31E07 00800 - Map ID No. 2.

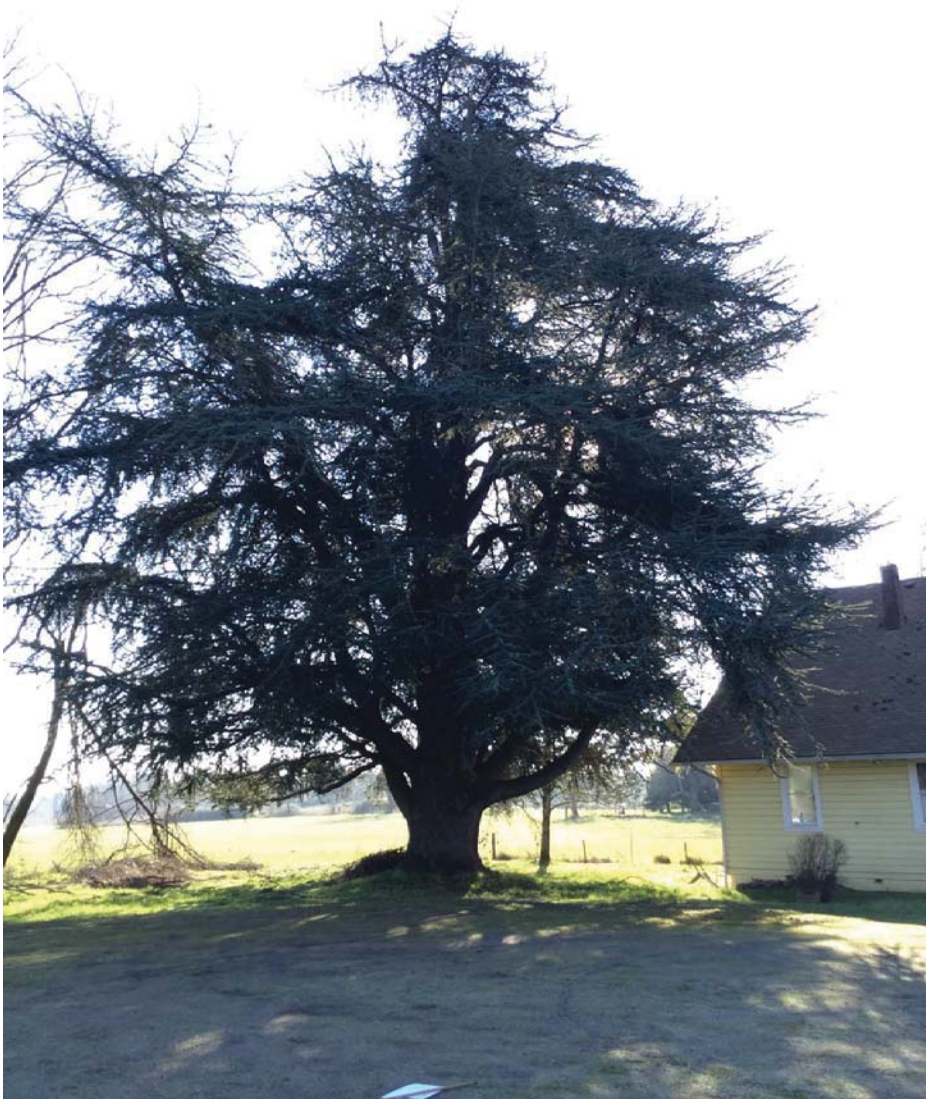
Photo 3. A 74" diameter open-grown Atlas cedar in generally good condition behind the grange hall at tax lot 31E07 00800 - Map ID No. 3.

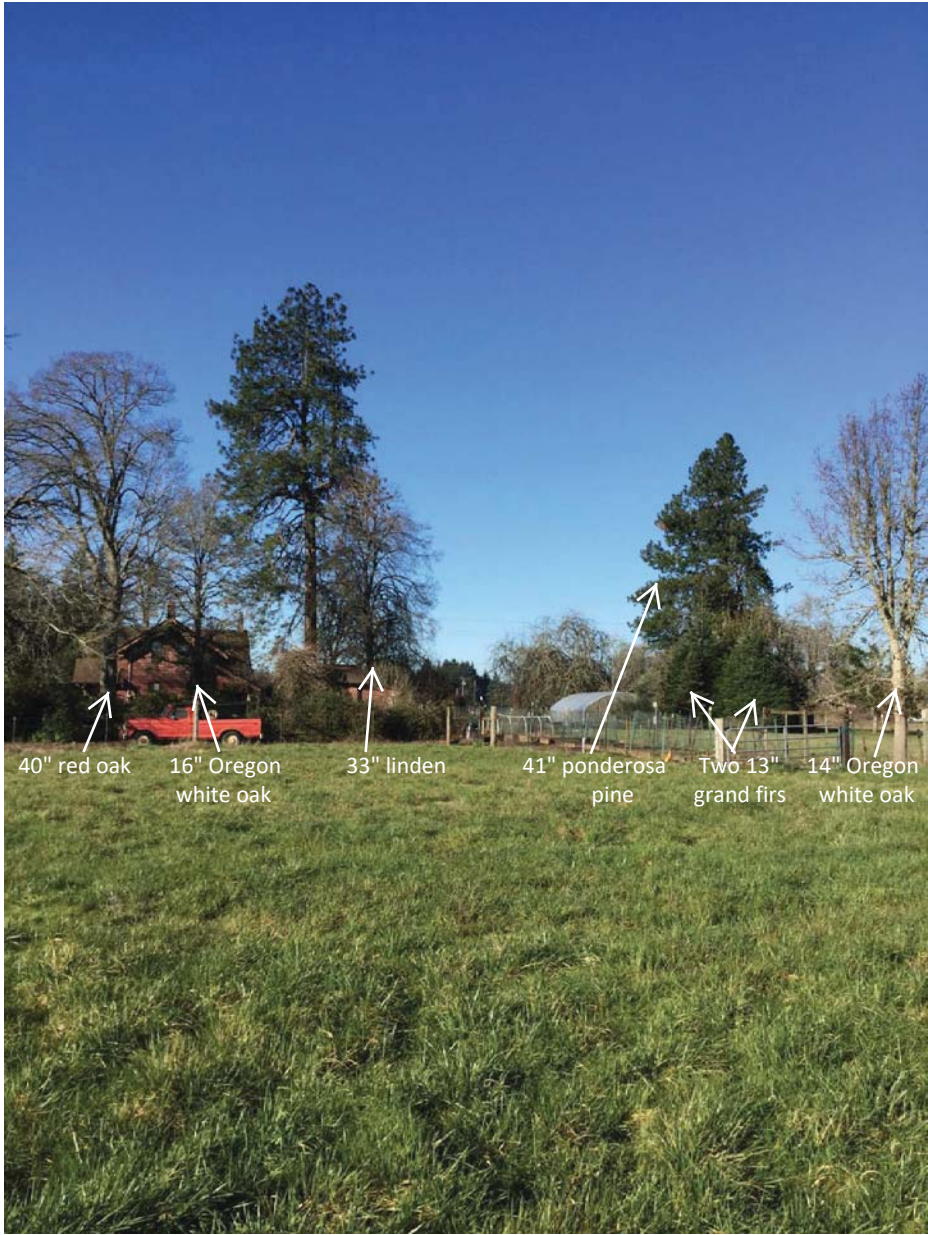
- **31E07 00601 (Map ID No. 4; Photo 4):** The 2014 assessment noted mixed species in variable condition on this parcel with some storm damaged trees and a few large trees in good condition. Many of these trees suffered significant damage during the February 2021 ice storm. Also, closer inspection of a 52" diameter ponderosa pine near the existing house revealed hazardous top structure. Still, there are numerous trees on this parcel, scattered around and near the existing house, that are suitable for long-term preservation, including: a 40" diameter open grown red oak (*Quercus* spp., exact variety unknown); one 33" diameter linden (*Tilia* spp.) with codominant stems, but generally good structure; one 41" diameter ponderosa pine in good condition; two Oregon white oaks measuring 14" and 16" diameter each (relatively small, but excellent condition and great long-term amenities); and, two 13" diameter grand firs (*Abies grandis*) that are also relatively small, but well-cared for. The variety of trees would make this parcel an ideal location for a park or open space area.

Photo 4. Seven trees suitable for long-term preservation at tax lot 31E07 00601; note that the large ponderosa pine near the house has very poor crown structure and is potentially hazardous - Map ID No. 4.

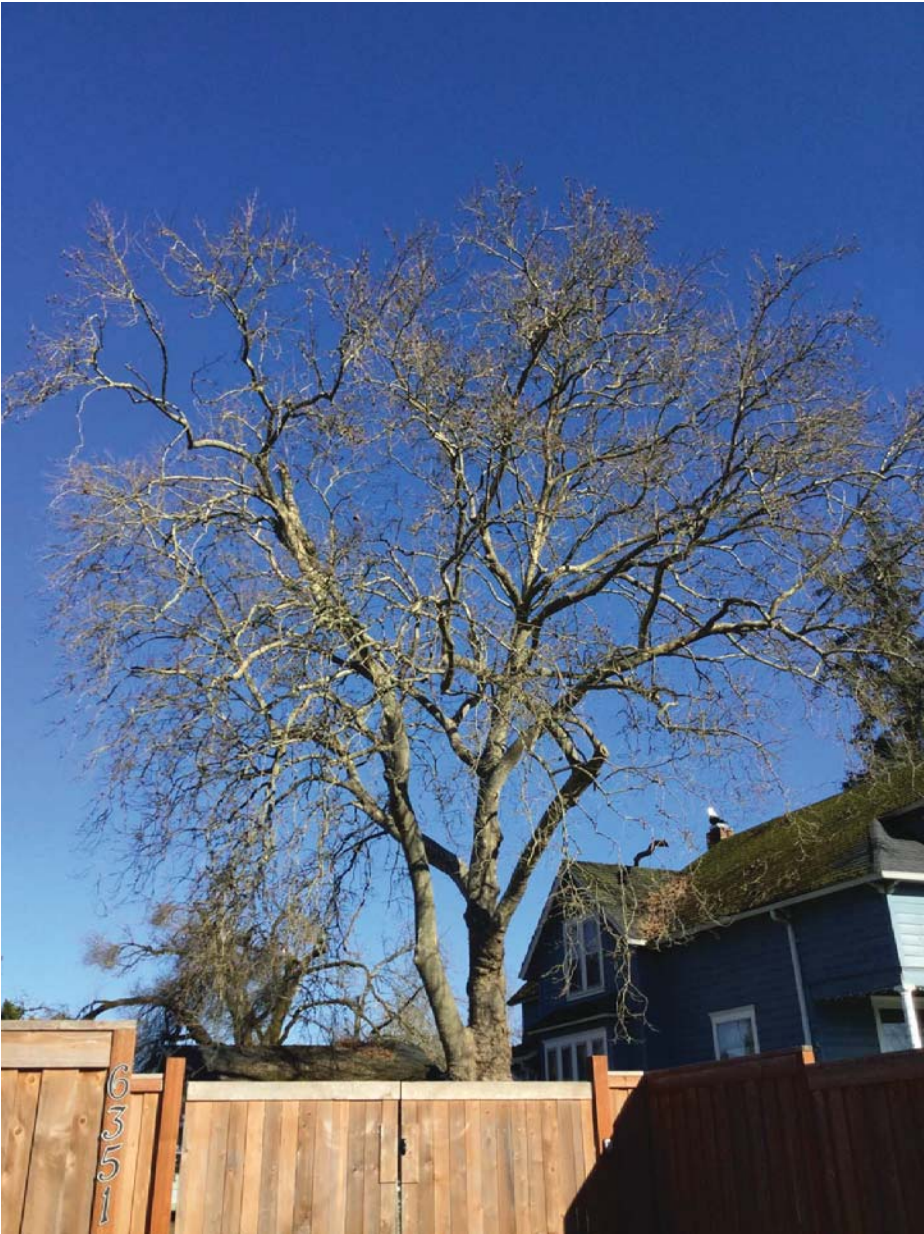
- **31E07 01200 (Map ID No. 5; Photo 5):** No site access was authorized and observations were limited by an existing fence. One open grown sycamore (*Platanus* spp.) near the existing house suffered minor storm damage, but still appears in good condition from a distance. An elm (*Ulmus* spp.) noted in the 2014 assessment suffered extensive storm damage and is no longer suitable for long-term preservation.

Photo 5. A mature sycamore in good condition from a distance at tax lot 31E07 01200 - Map ID No. 5.

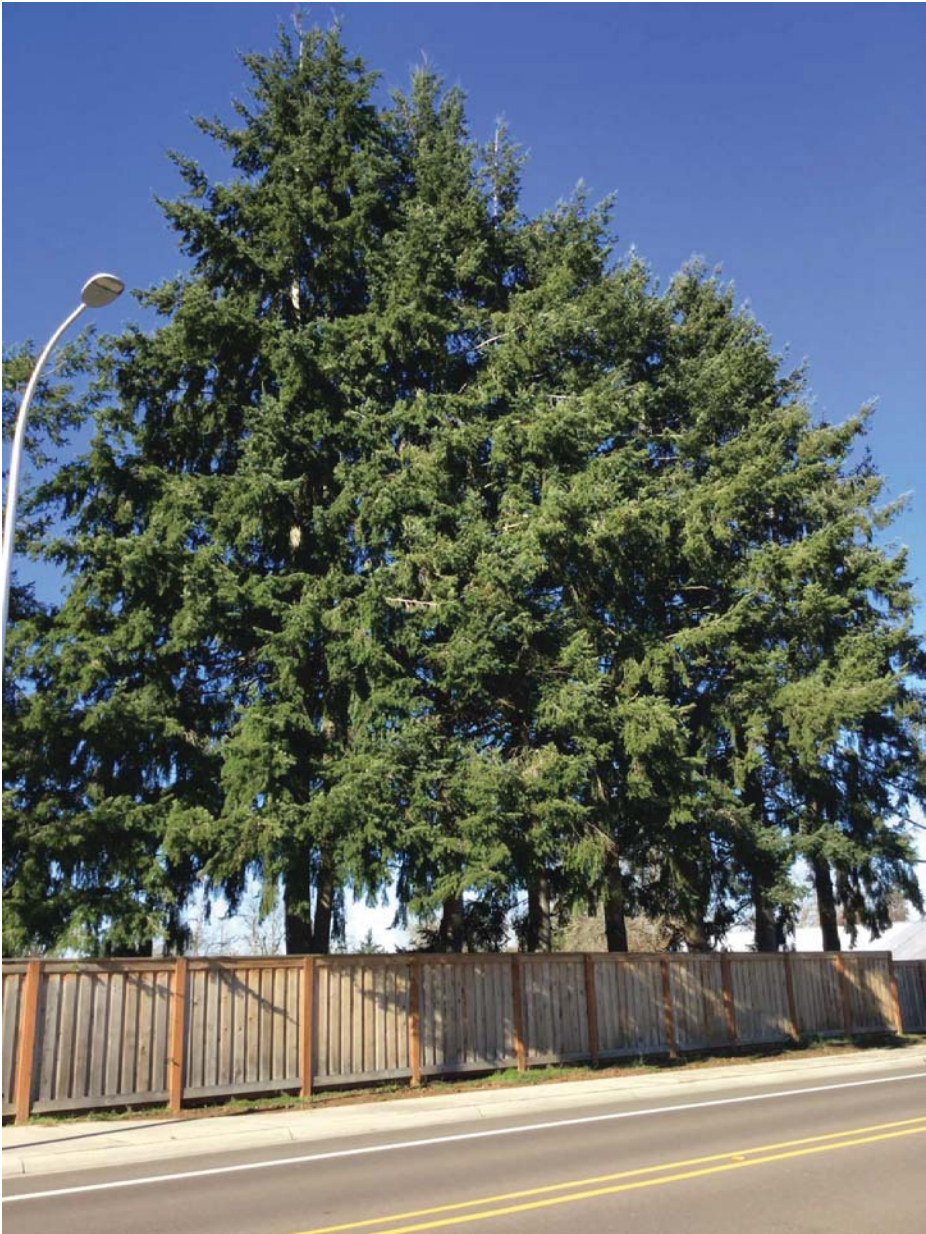
- **31E18 02100 (Map ID No. 6; Photo 6):** The southern boundary is lined with Douglas-firs (*Pseudotsuga menziesii*) in variable condition. The east-west row includes some dead and dying trees and the trees in the north-south row are in generally good condition. Select trees may be suitable for preservation as intact groups with removal of dead and dying trees. A row of relatively young conifers along the northern boundary identified as being in good condition in the 2014 assessment no longer exist.

Photo 6. North-South row of Douglas-firs along sidewalk in generally good condition as intact group Tax lot 31E18 02100 - Map ID No. 6. East-West row of Douglas-firs along south property boundary (not pictured) in variable condition with some dead and some declining trees.

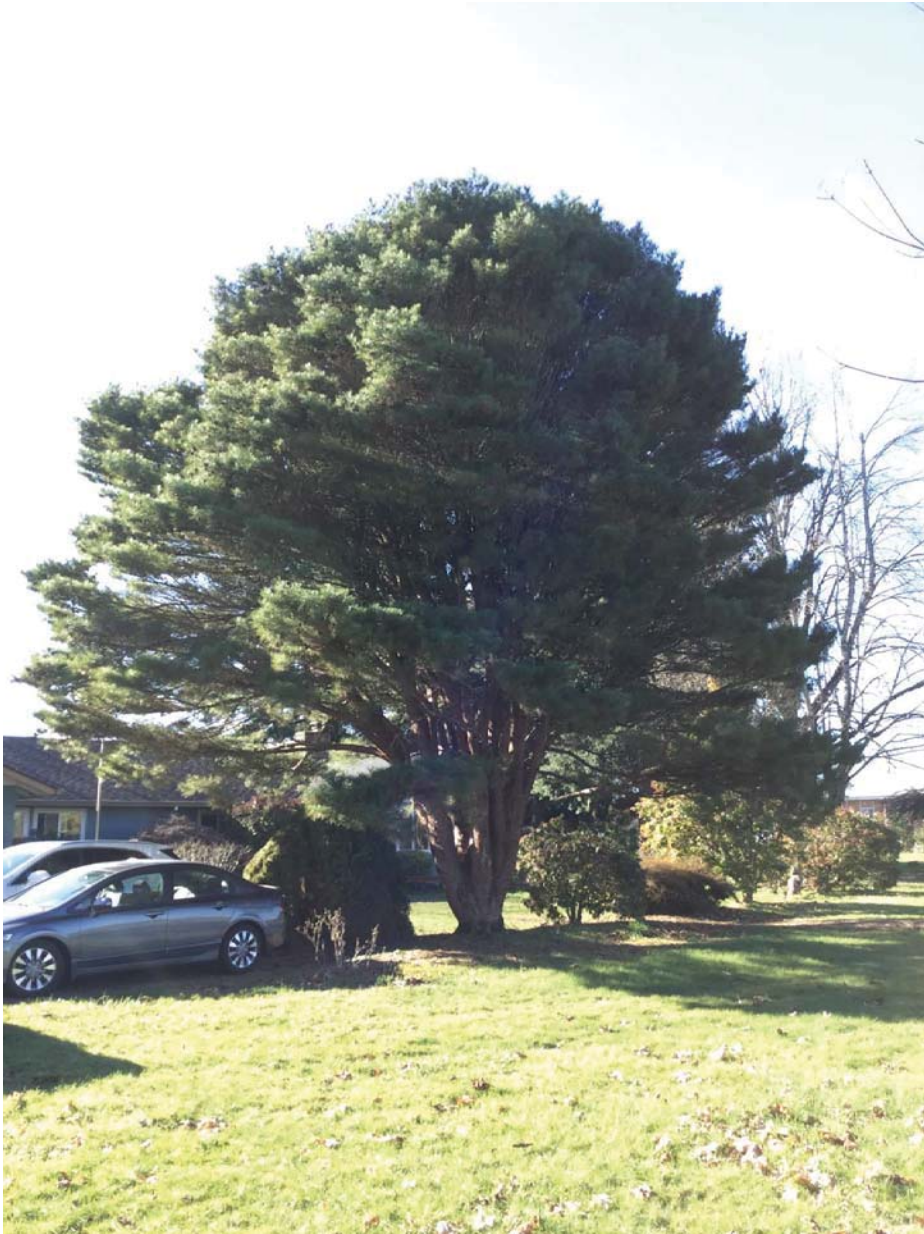
Photo 7. Scotch pine at tax lot 31E18B 02001 well maintained as an ornamental landscape tree - Map ID No. 7.

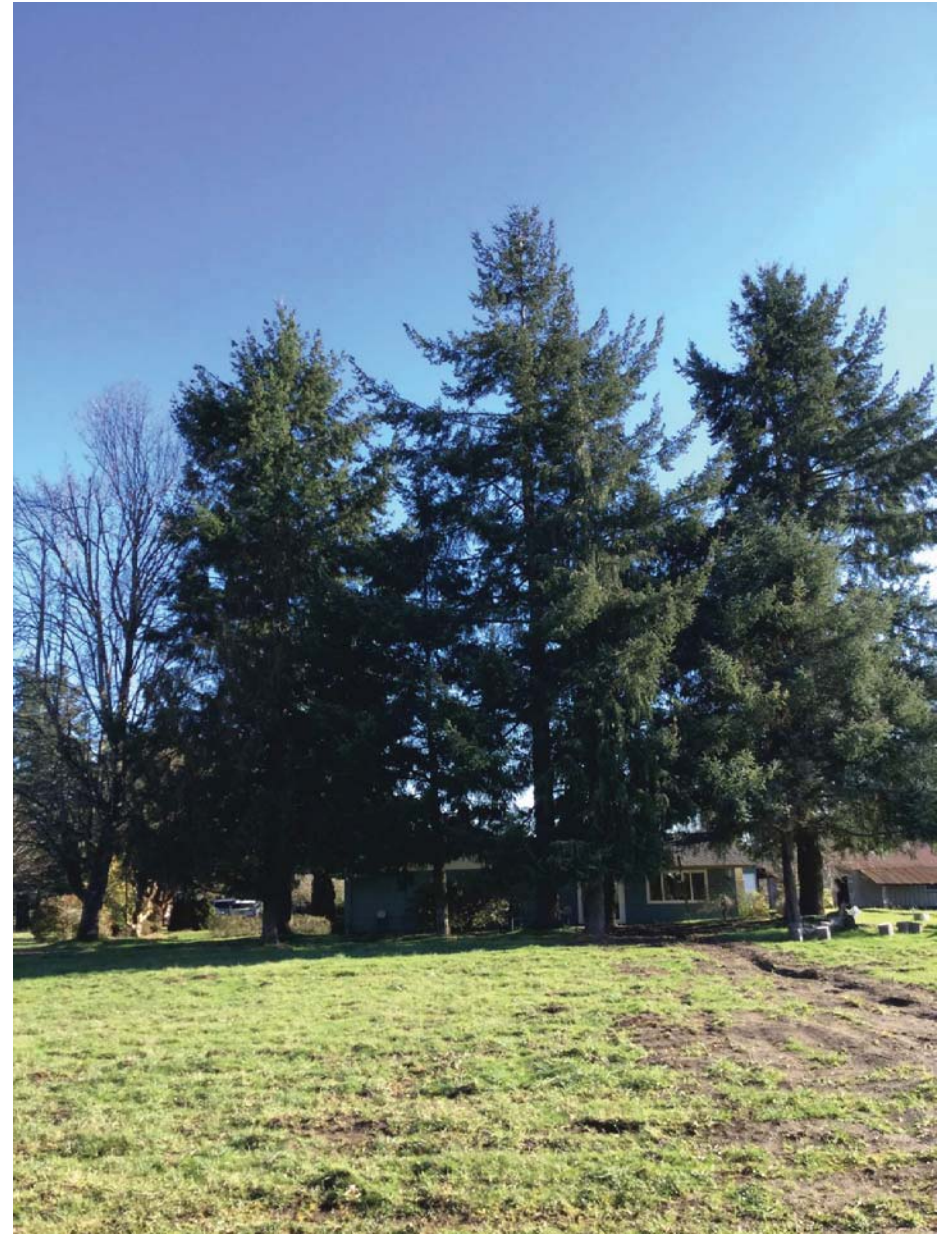
Photo 8. Dense group of mostly Douglas-firs with two western redcedars, one spruce, and a tuliptree on the north edge (to left) at tax lot 31E18B 02001 - Map ID No. 8.

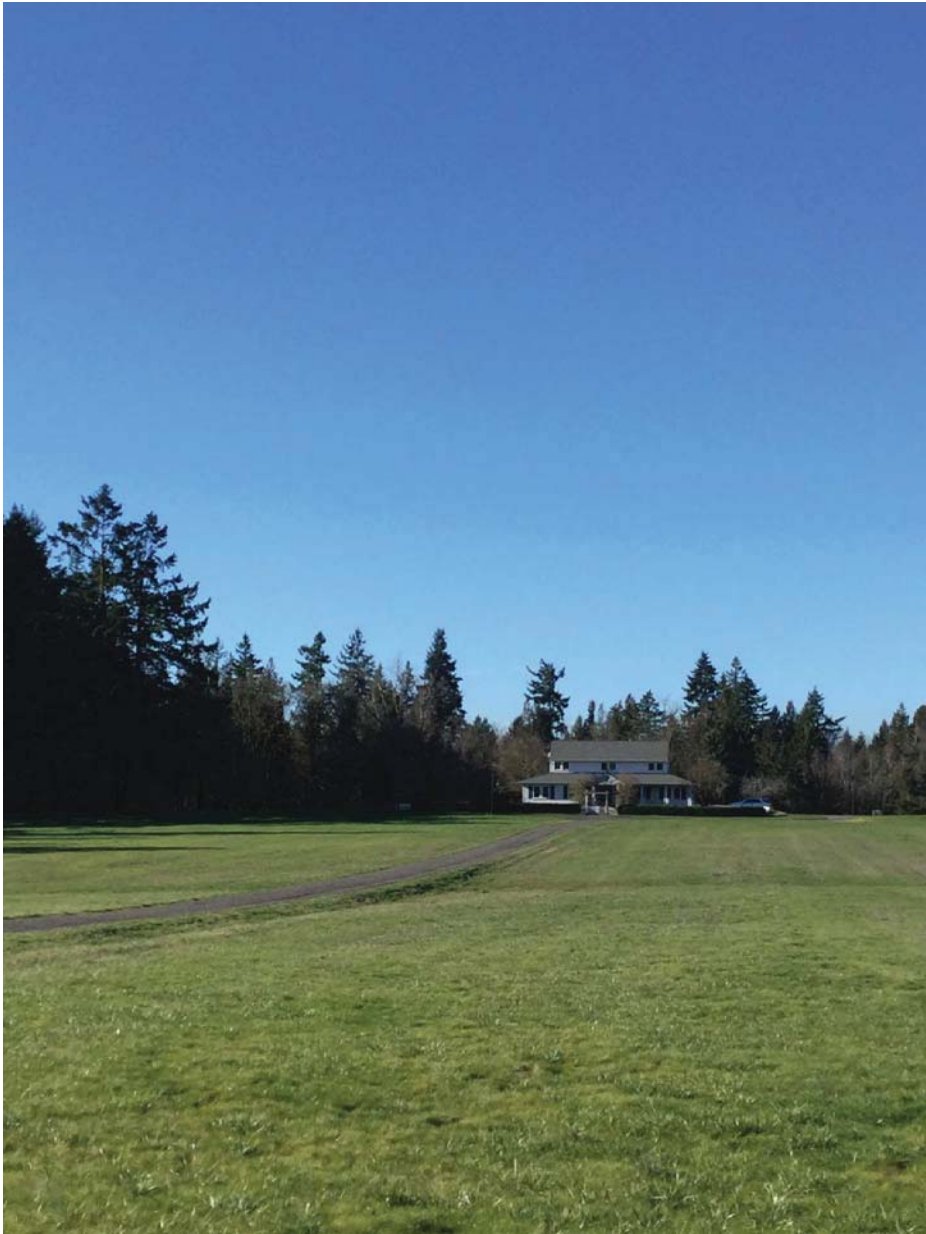
- **31E18 02700 (Map ID No. 9; Photo 9):** No site access was authorized and observations were limited to what could be seen from SW 60th Avenue. Trees identified in the 2014 assessment appear to remain standing. Notes from 2014 describe: 1) a pair of Douglas-firs in good condition, suitable for retention together as a small group; 2) one mature bigleaf maple with three codominant stems, some dead and broken branches and branches with decay; 3) one mature silver maple with multiple attachments; and, 4) one other mature bigleaf maple in moderate condition with codominant stems and some branch and stem decay. Closer examination is warranted to determine whether these trees continue to be suitable for long-term preservation.

Photo 9. No access authorized at tax lot 31E18B 02700; trees identified in 2014 appear to remain standing, condition unknown - Map ID No. 9.

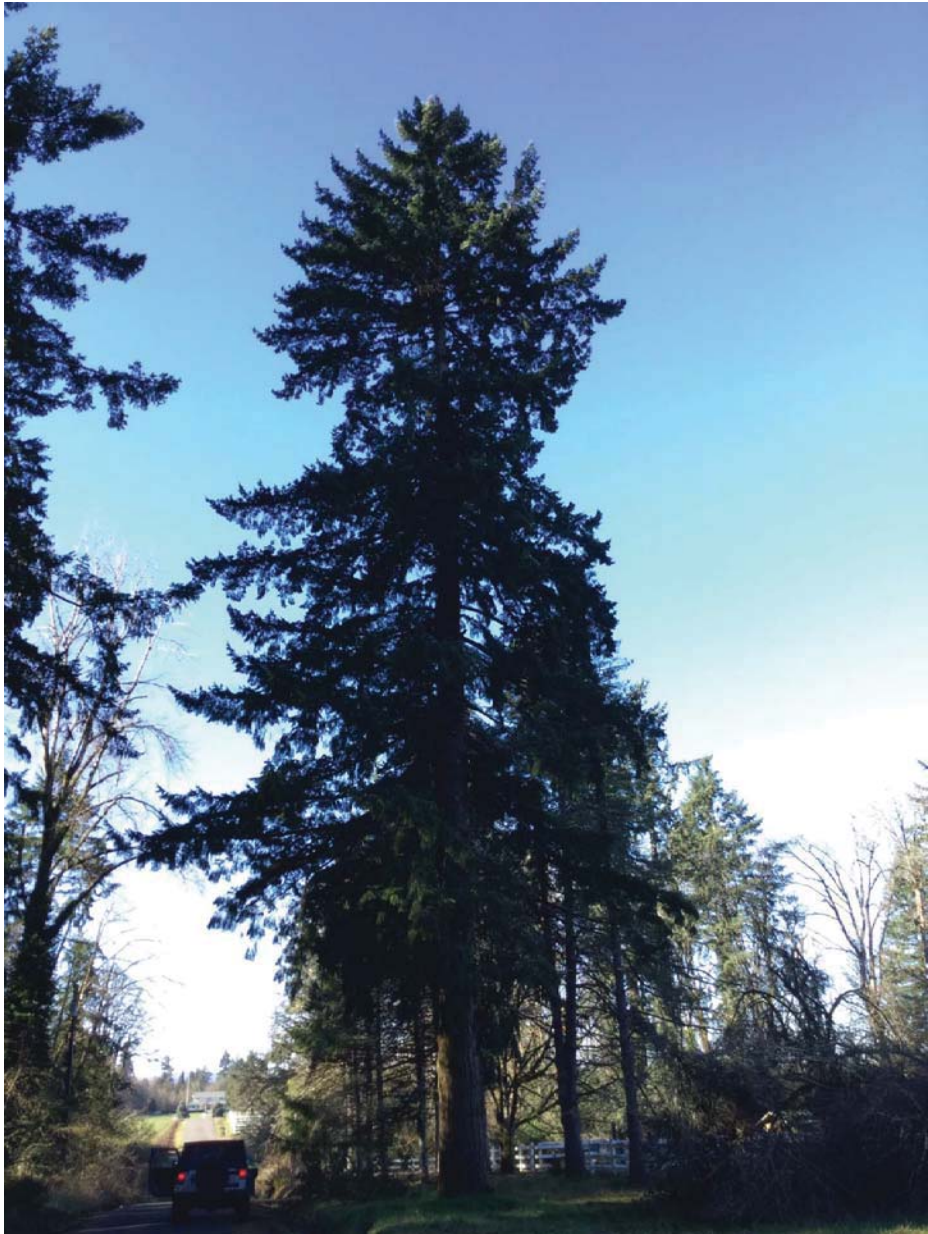
Photo 10. 40" DBH Douglas-fir located in the SW Kruse Road right of way adjacent to tax lot 31E18 02600 - Map ID No. 10.

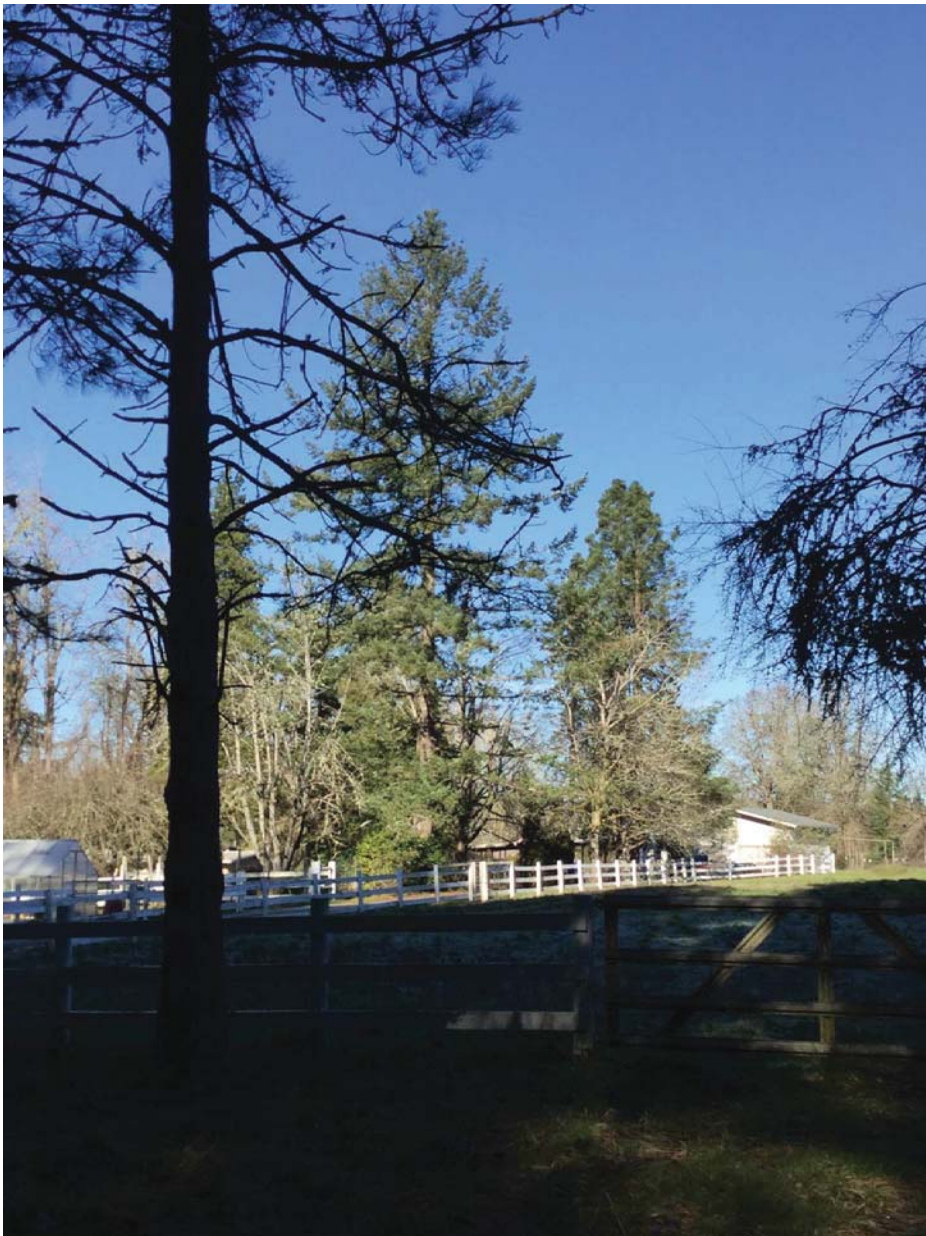
Photo 11. Mixed species in variable condition from a distance; no site access authorized for closer assessment at tax lot 31E18B 02000 - Map ID No. 11.

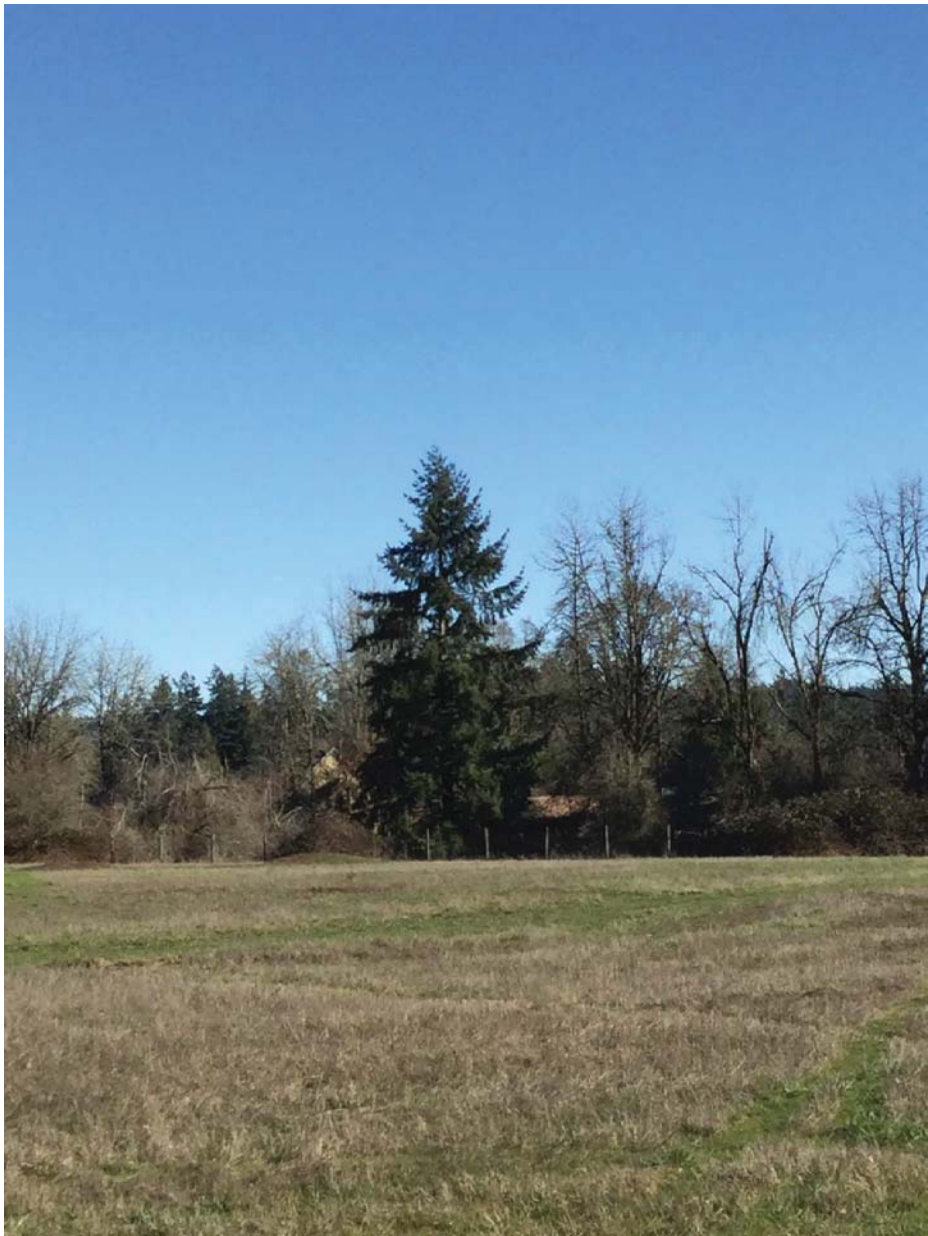
- **31E18B 01900 (Map ID No. 13; Photo 12):** One Douglas-fir in generally good condition observed from a distance along the edge of a mapped Habitat Conservation Area. The 2014 assessment noted a long-live crown and good branch distribution. The tree now has a few broken branches, but still has a long-live crown and good vigor.

Photo 12. Open grown Douglas-fir in generally good condition with a long live crown and some broken branches at tax lot 31E18B 01900 - Map ID No. 13.

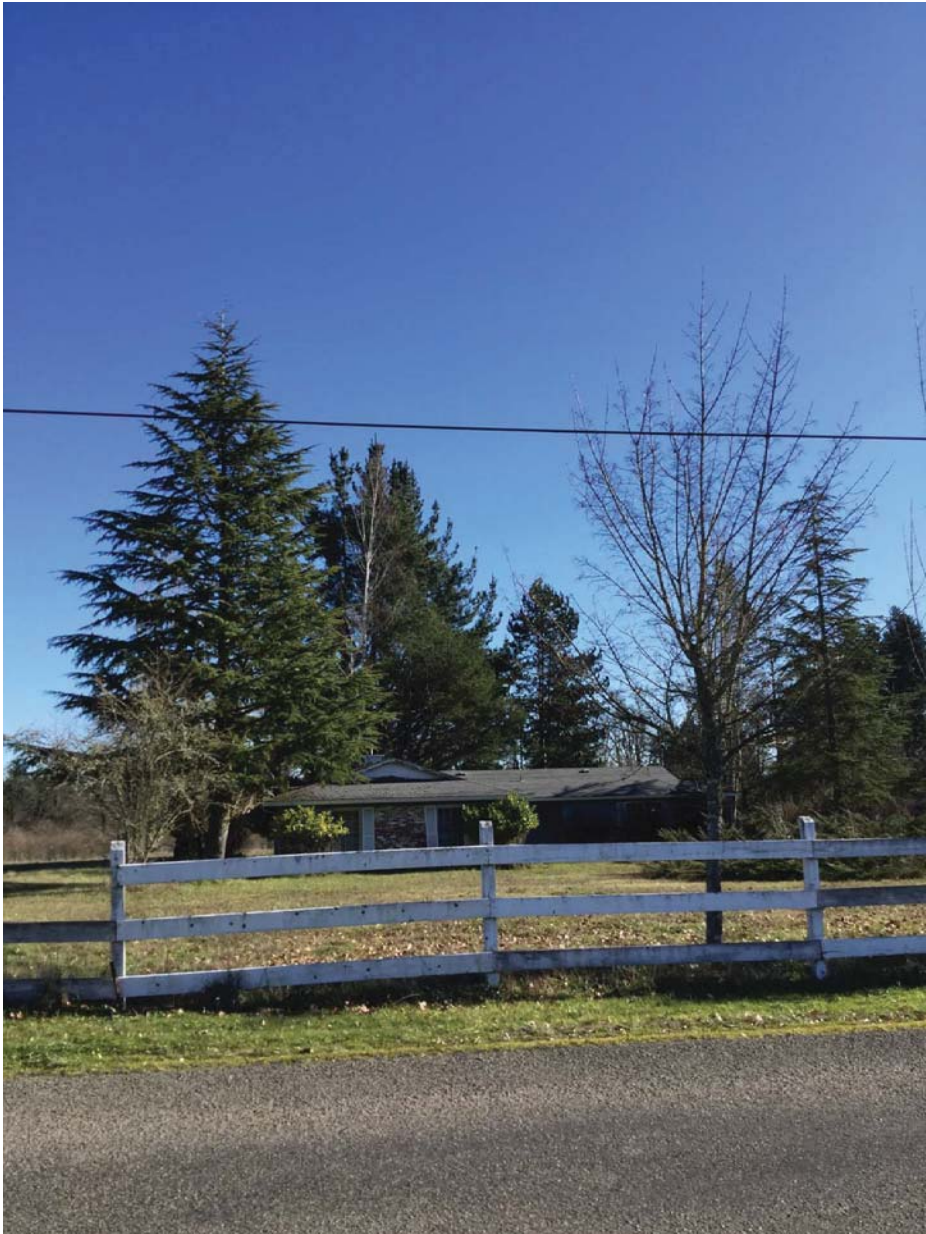
- **31E18B 01800 (Map ID No. 14; Photo 13):** Site access was not authorized, but mixed conifers noted in the 2014 assessment remain standing, including open-grown deodar cedars (*Cedrus deodara*) and a group of pines (*Pinus* spp.) trees in good. Several birches (*Betula* spp.) scattered among the conifers are in poor condition and not long-term amenities.

Photo 13. Mixed conifers appear in good condition from a distance at tax lot 31E18B 01800 - Map ID No. 14.

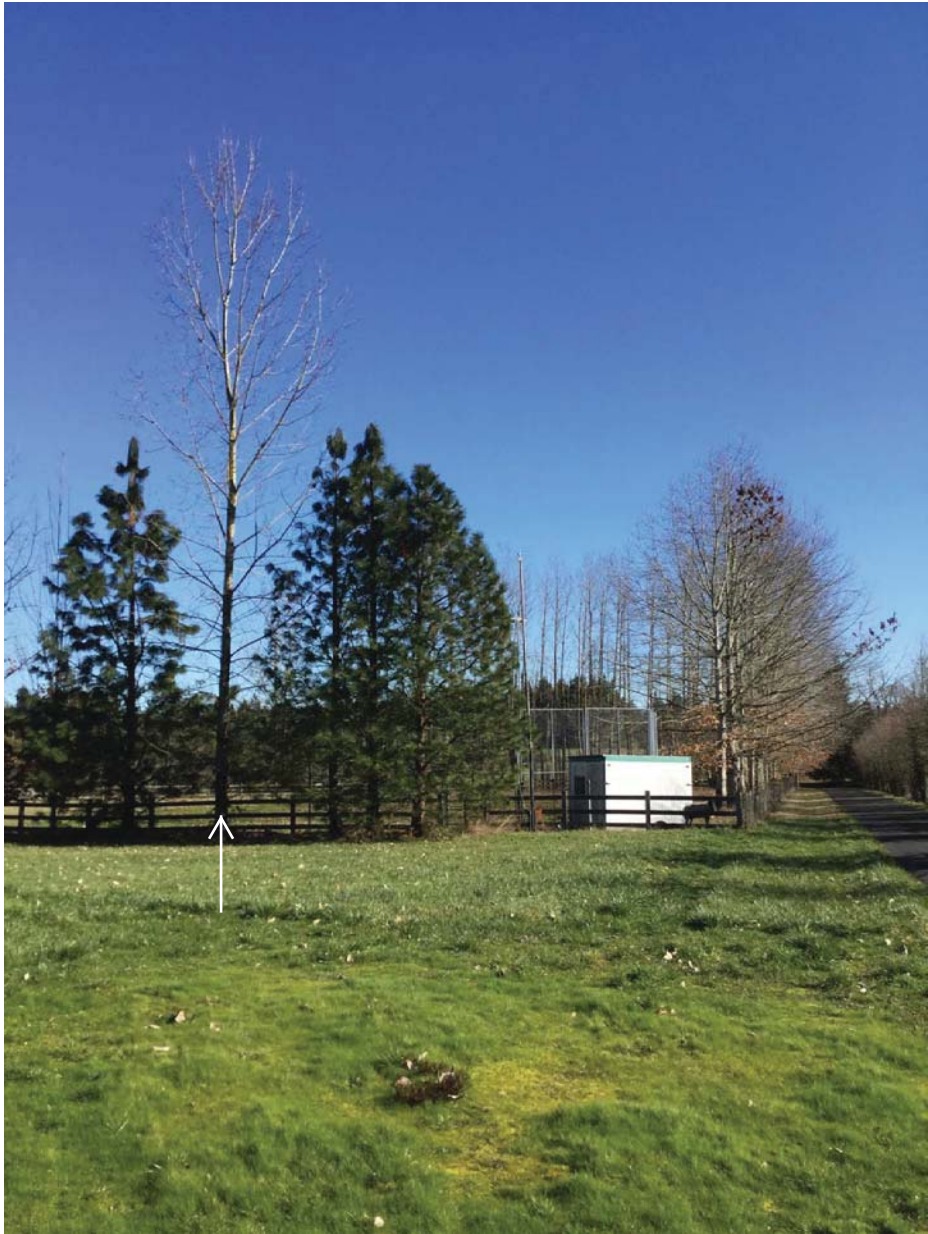
- **31E18B 01500 (Map ID No. 15; Photo 14):** Planted rows of red oaks (*Quercus rubra*) along the east-west fence and a mix of oaks, maples and ponderosa pines along the north-south fence are in generally good condition as intact group. These trees are relatively young, but well-established. A single black cottonwood (*Populus trichocarpa*) mixed in with the north-south row is not recommended for long-term preservation due to inherent species limitations.

Photo 14. Rows of red oaks along east-west fence line (right) and mix of oak, maple and four ponderosa pines along north-south fence line (left) in generally good condition at tax lot 31E18B 01800; black cottonwood (identified with arrow) not recommended for retention. Map ID No. 15.

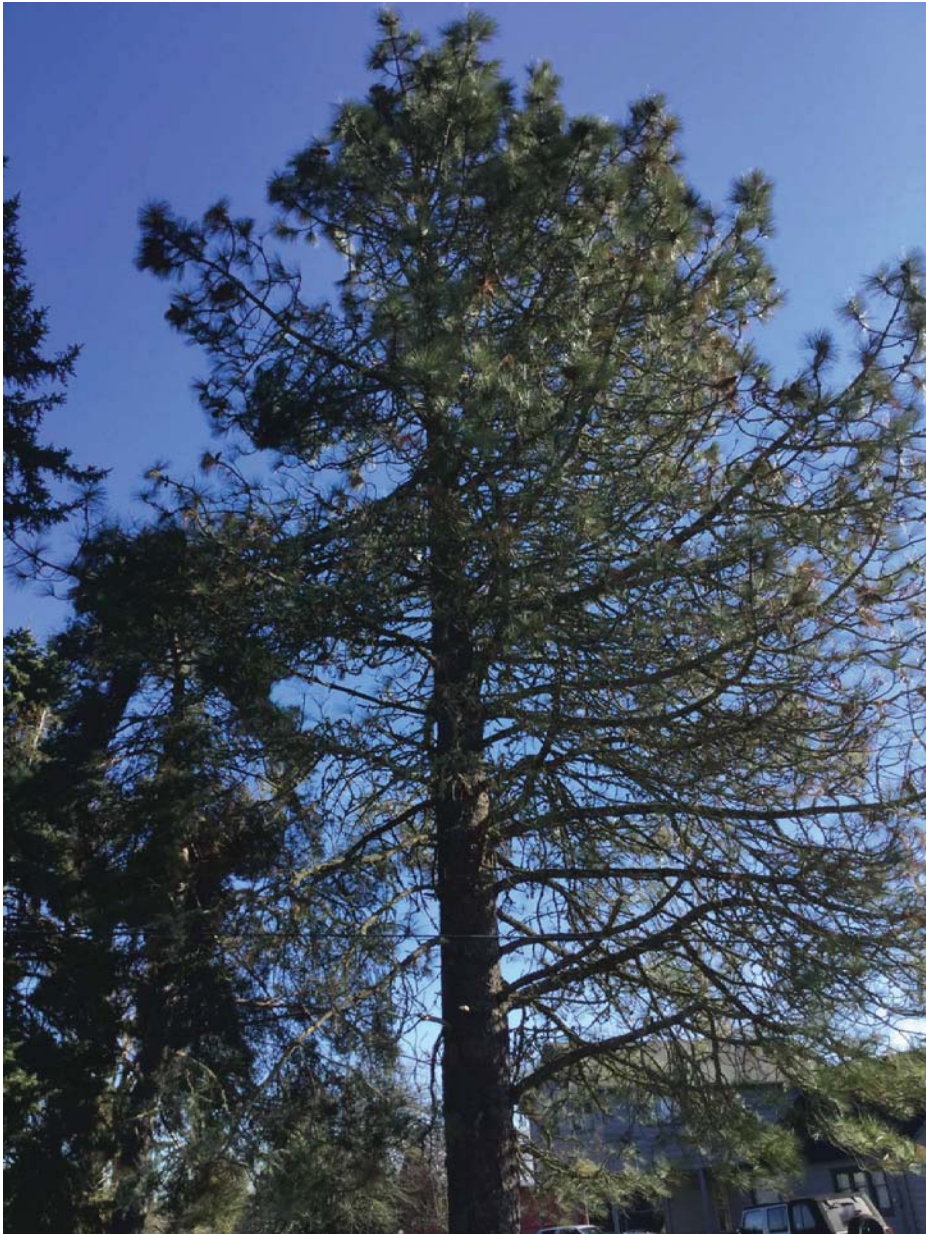
Photo 15. 34" DBH ponderosa pine in good condition at tax lot 31E18B 01400 - Map ID No. 16.

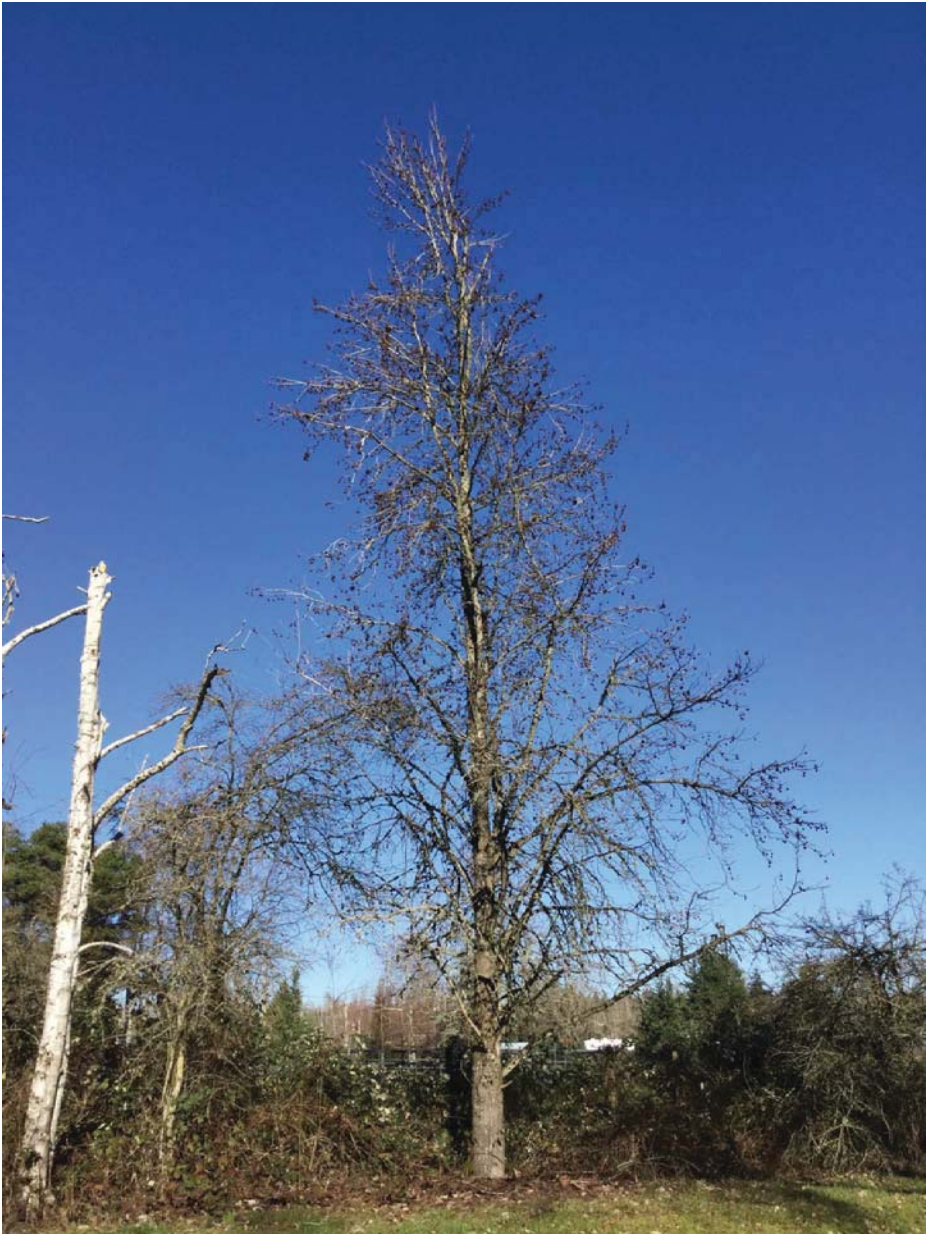
Photo 16. 18" DBH sweetgum in generally good condition at tax lot 31E18B 01400 - Map ID No. 17.

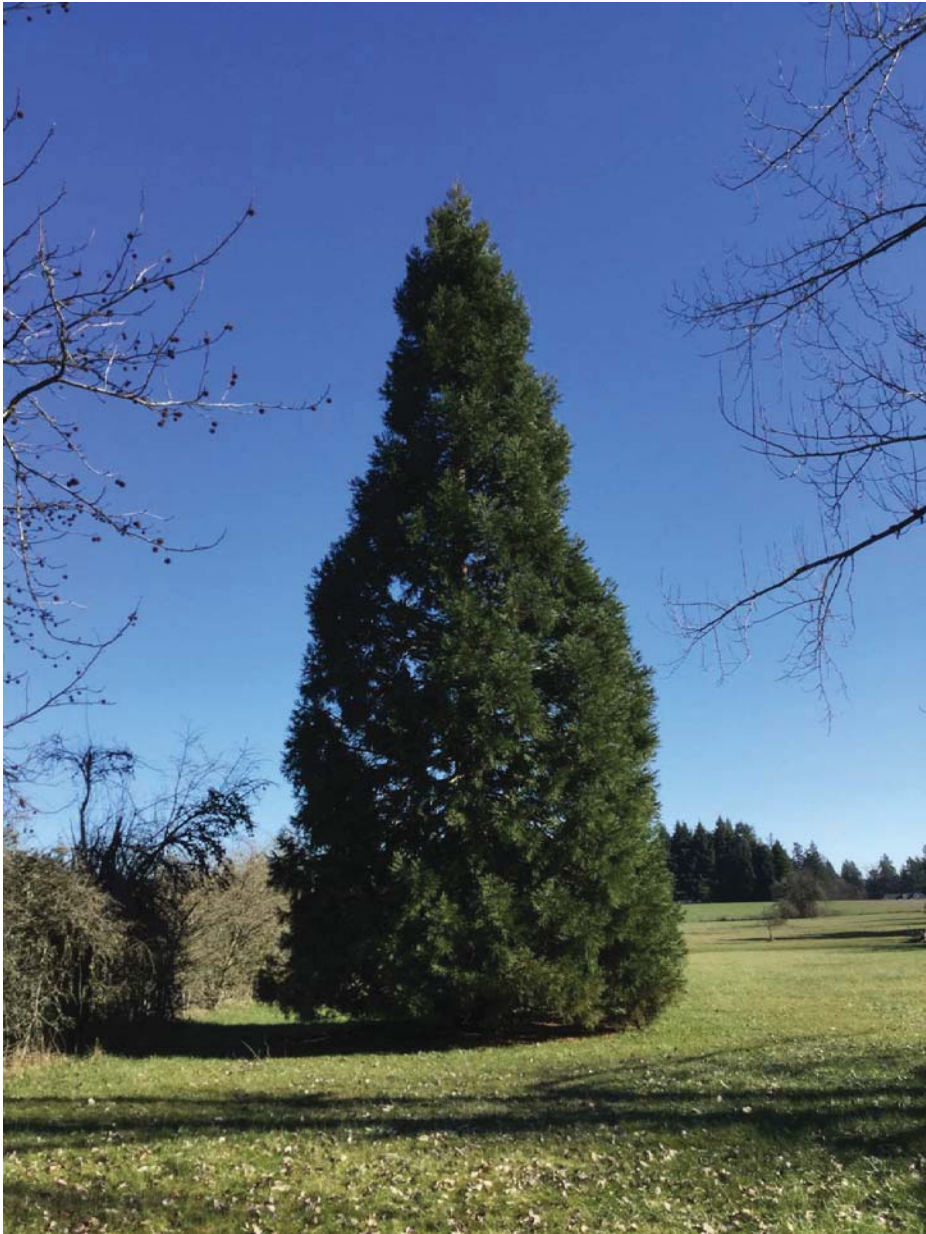
Photo 17. Open-grown giant sequoia in generally good condition at tax lot 31E18B 01400 - Map ID No. 18.

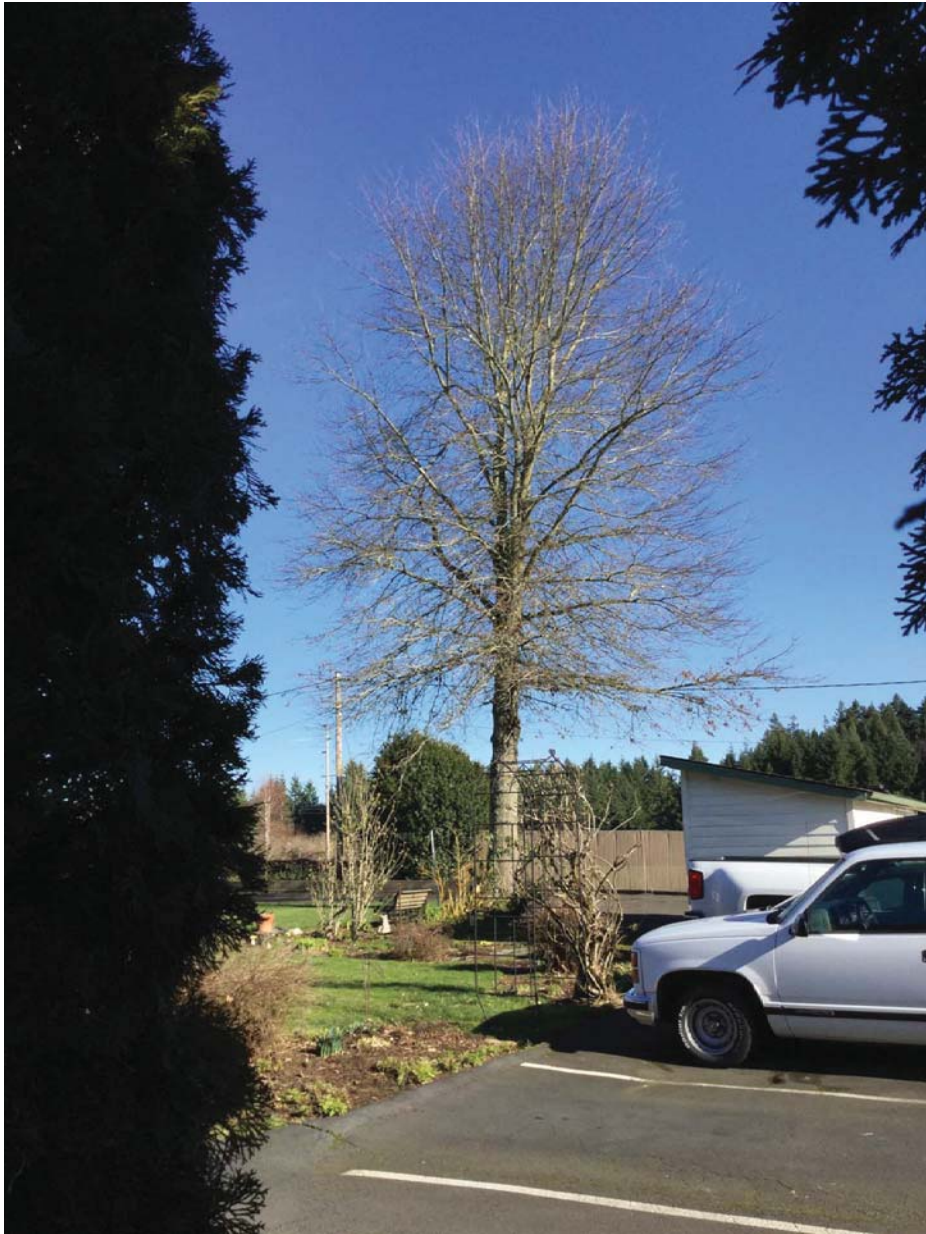
Photo 18. Pin oak in generally good condition based on observations made from a distance at tax lot 31E18B 00100 - Map ID No. 19.
