APPENDIX E: ARBORIST REPORT

Frog Pond East and South Master Plan – Wilsonville, Oregon Tree Reconnaissance February 6, 2022

MHA21056

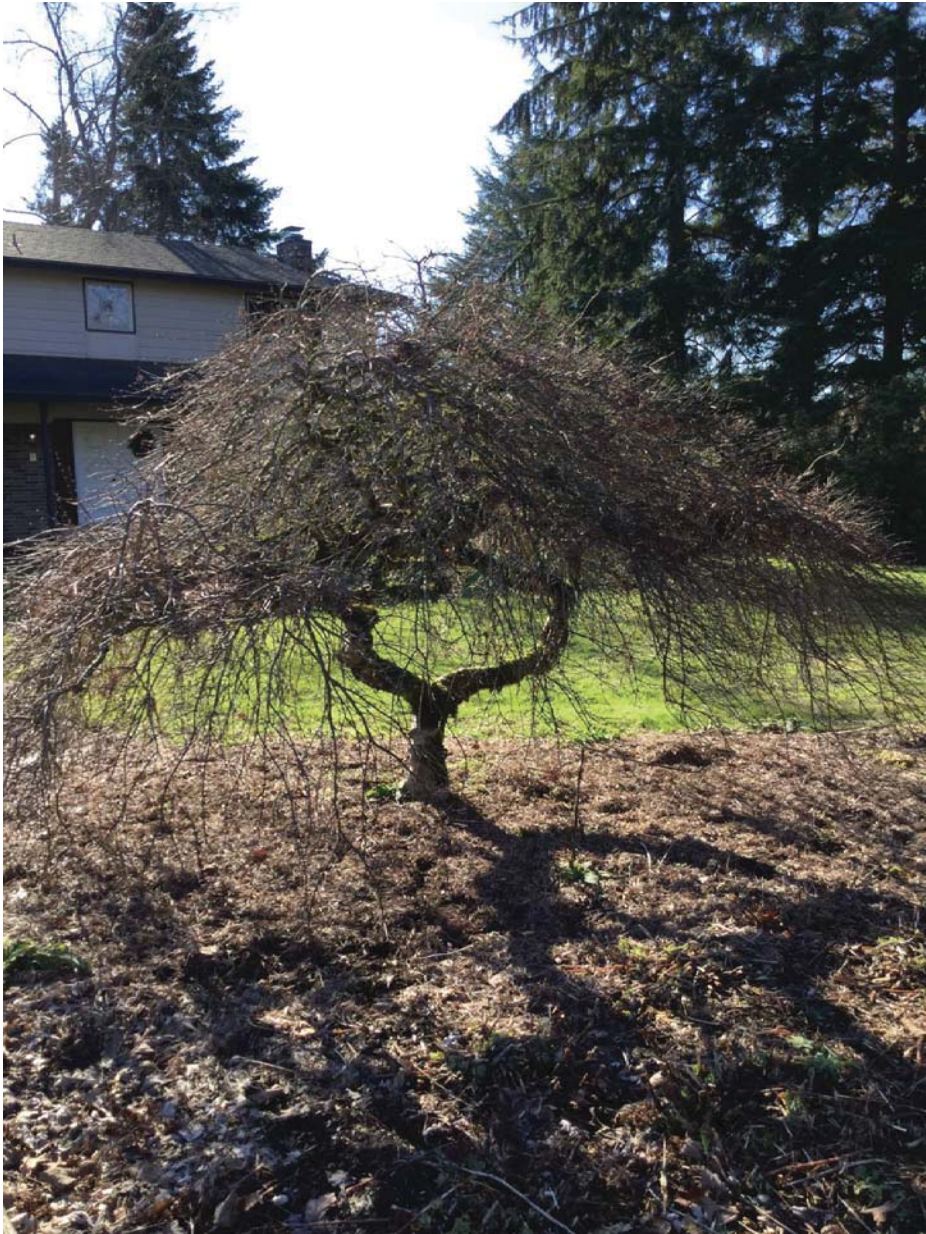
- **31E18B 00300 (Map ID No. 20; Photo 19):** Maples, deodar cedars and Port-Orford-cedars (*Chamaecyparis lawsoniana*) observed during the 2014 assessment have either been removed or suffered storm damage and are no longer priorities for preservation. In the front of this lot, I observed a small, but mature and well-maintained Japanese maple (*Acer palmatum*) in good condition with an 8' crown radius. Although this tree is relatively small, it is an attractive amenity and might be worthwhile to transplant or incorporate into site design. A row of red oaks identified in the 2014 assessment suffered severe ice storm damage and are no longer priorities for preservation.

Photo 19. Small but mature and well-maintained Japanese maple at tax lot 31E18B 00300 - Map ID No. 20.

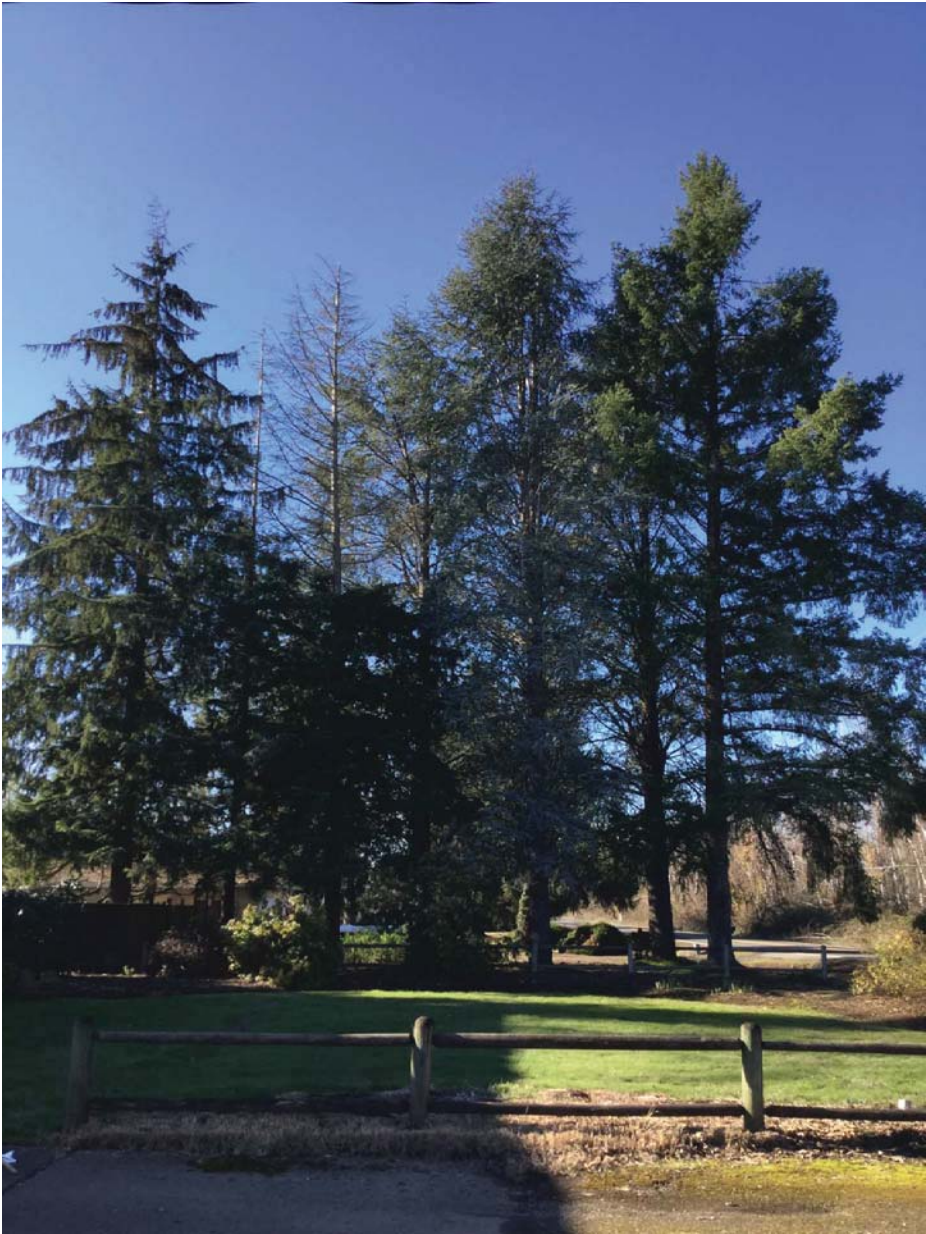
- **31E18B 00500 (Map ID No. 21 and No. 22; Photos 20 and 21):** Site access was not authorized, but from the neighboring property and right-of-way, I observed a row of mixed conifers in generally good condition; while several western hemlocks (*Tsuga heterophylla*) were dead or dying, three Atlas cedars and a Douglas-fir appeared suitable for preservation as an intact group. South of the existing home, a small group of deodar cedars including in the 2014 assessment remain standing and appear in generally good condition from a distance.

Photo 20. Row of mixed conifers along eastern boundary of tax lot 31E18B 00500 include dead and dying hemlocks and Atlas cedars and a Douglas-fir in generally good condition as an intact group - Map ID No. 21.

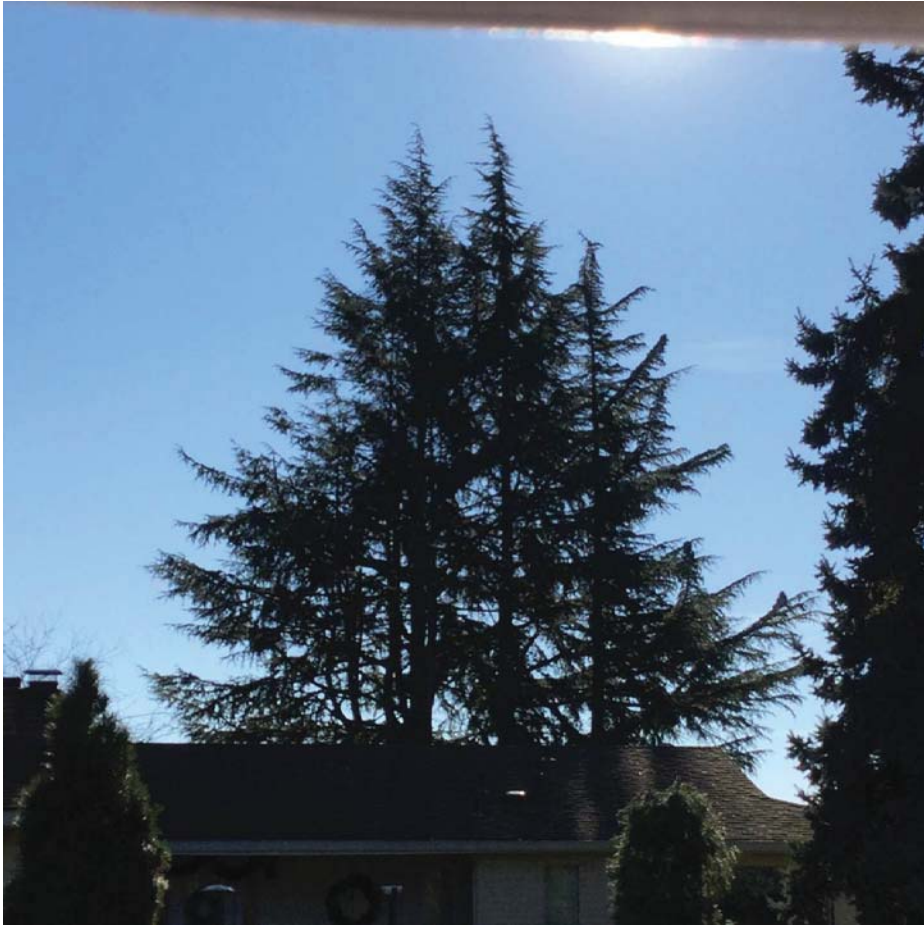
Photo 21. Row of deodar cedars at tax lot 31E18B 00500 appear in generally good condition from a distance- Map ID No. 22.

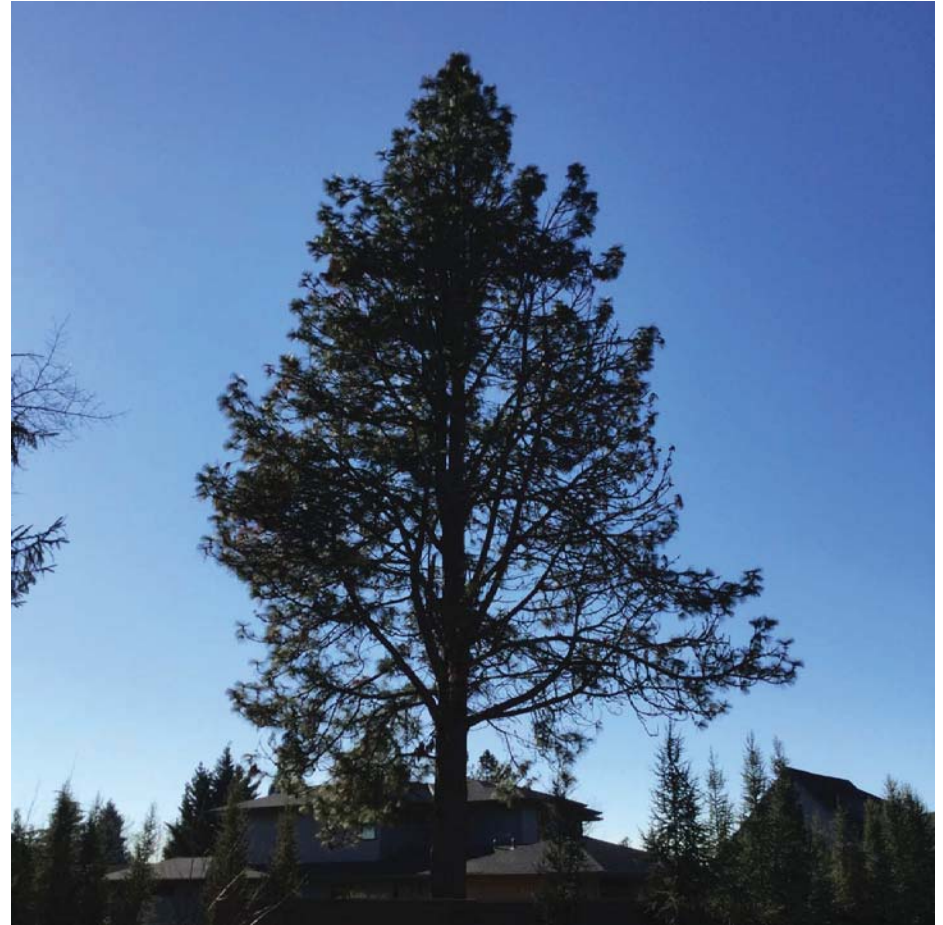
- **31E18B 00800 (Map ID No. 23; Photo 22):** One open grown ponderosa pine with a 24' crown radius was noted as being in good condition during the 2014 assessment. Now, the tree is in fair condition with minor crown asymmetry, dead branches on the north side of the tree, and some western gall rust infection. This tree is still identified as suitable for preservation, but is no longer a high priority due to diminished condition and disease. A small but well-maintained magnolia identified in the 2014 assessment appears to have been removed.

Photo 22. Open grown ponderosa pine in fair condition and with moderate structure at tax lot 31E18B 00800 - Map ID No. 23.

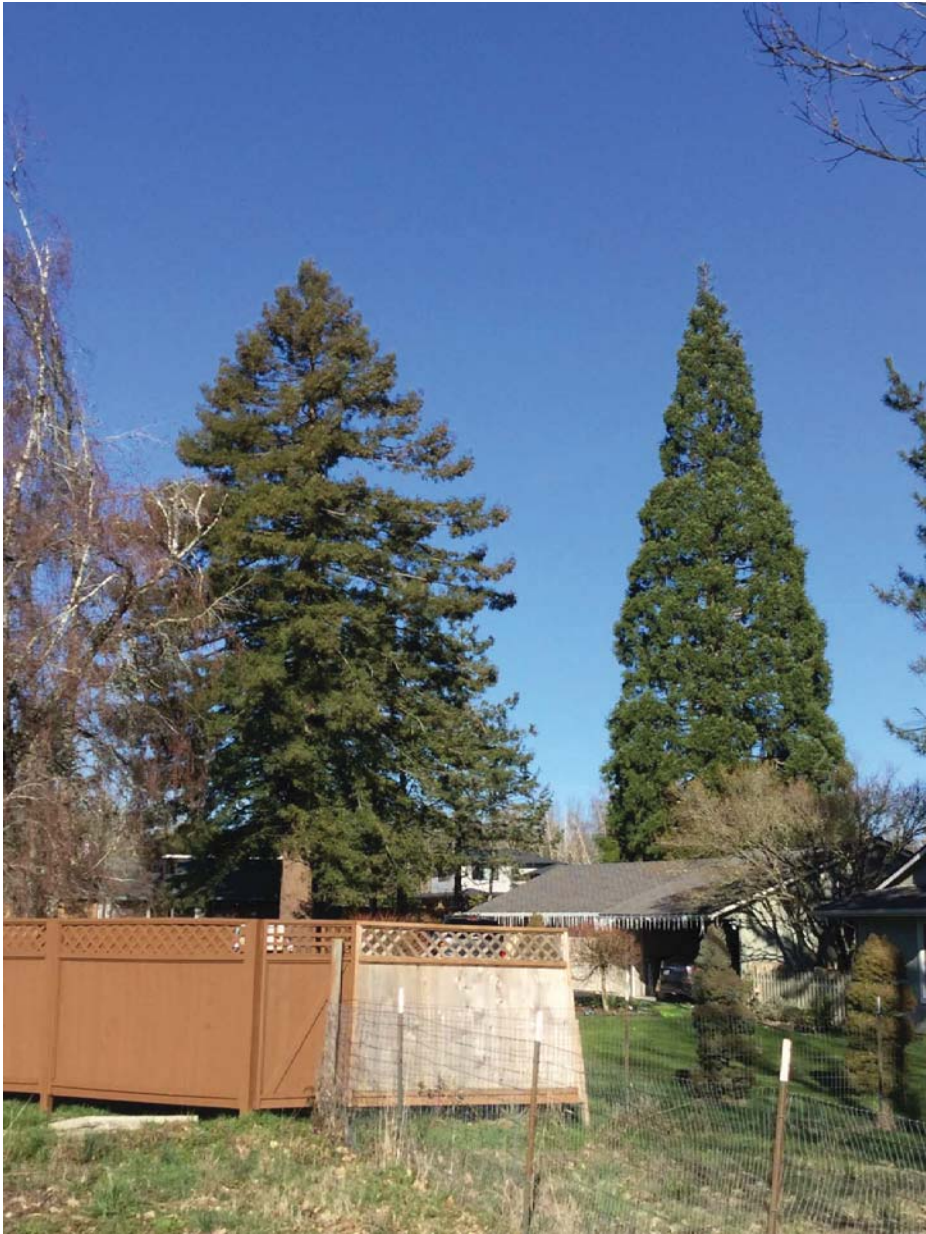
Photo 23. Large redwood (left) and giant sequoia (right) appear in generally good condition from a distance at tax lot 31E18B 01100 - Map ID No. 24.

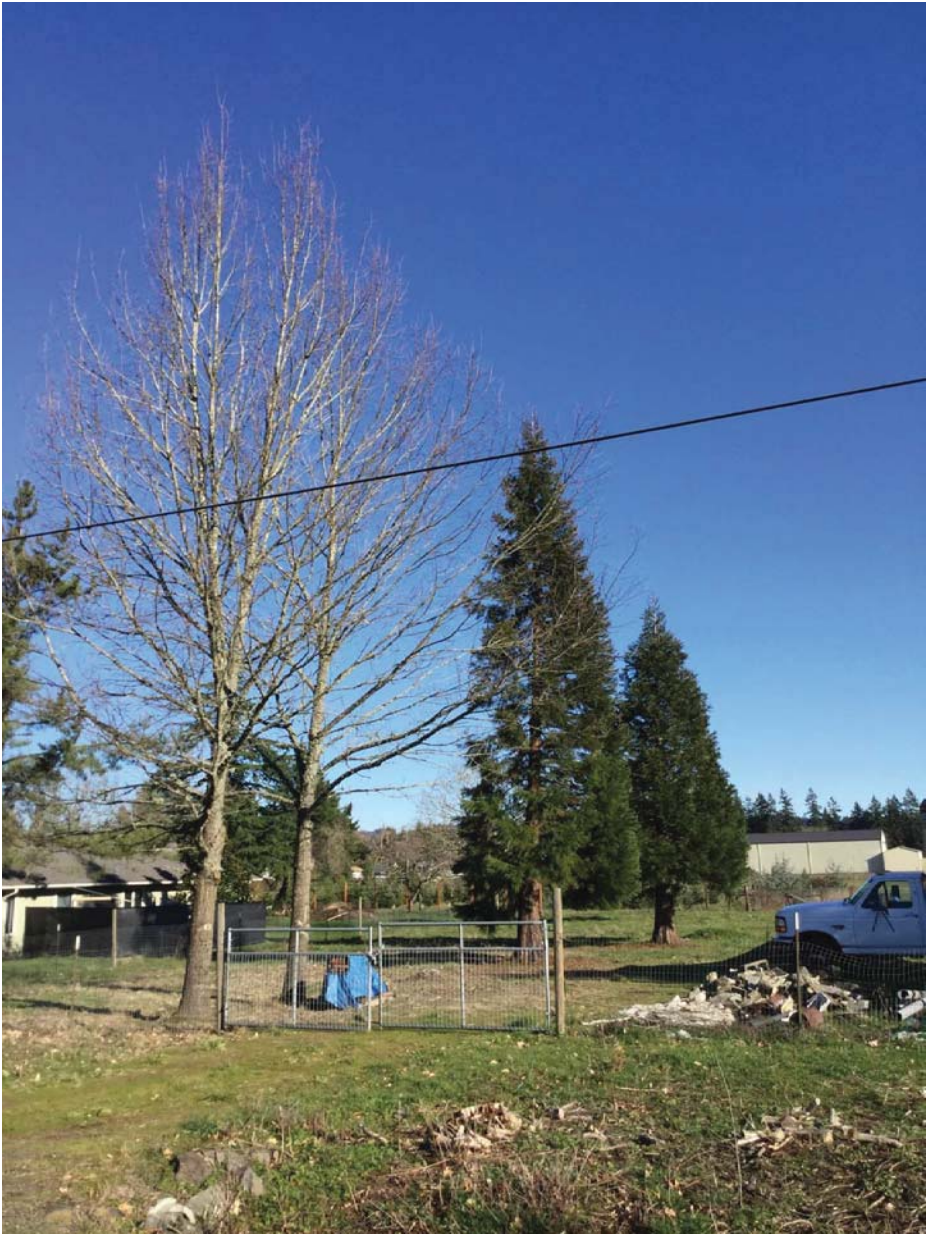
Photo 24. Two semi-mature redwoods and two oak species trees appear in generally good condition from a distance at tax lot 31E18B 01200 - Map ID No. 25.

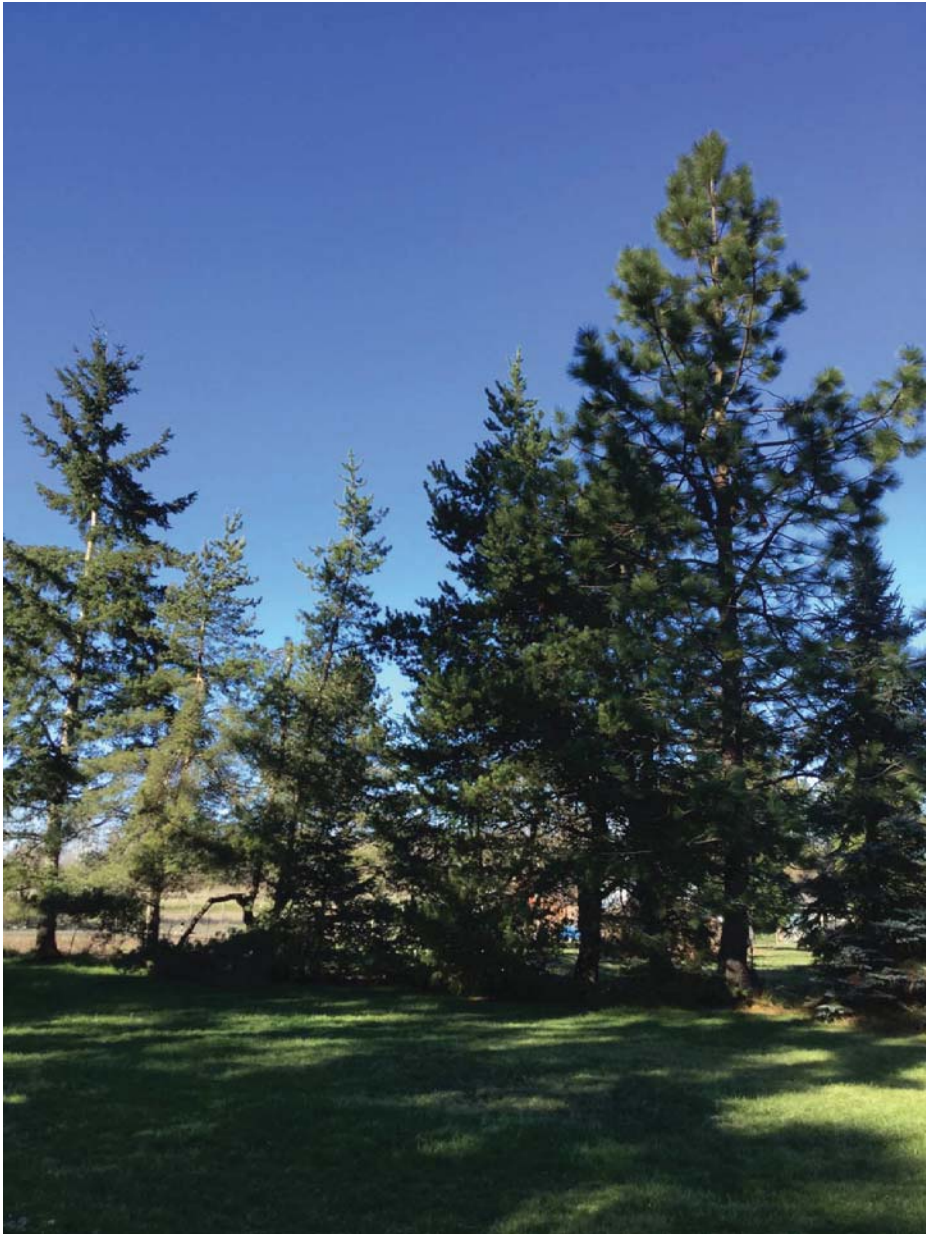
Photo 25. Dense row of semi-mature conifers in variable condition at tax lot 31E18B 01300 - Map ID No. 26.

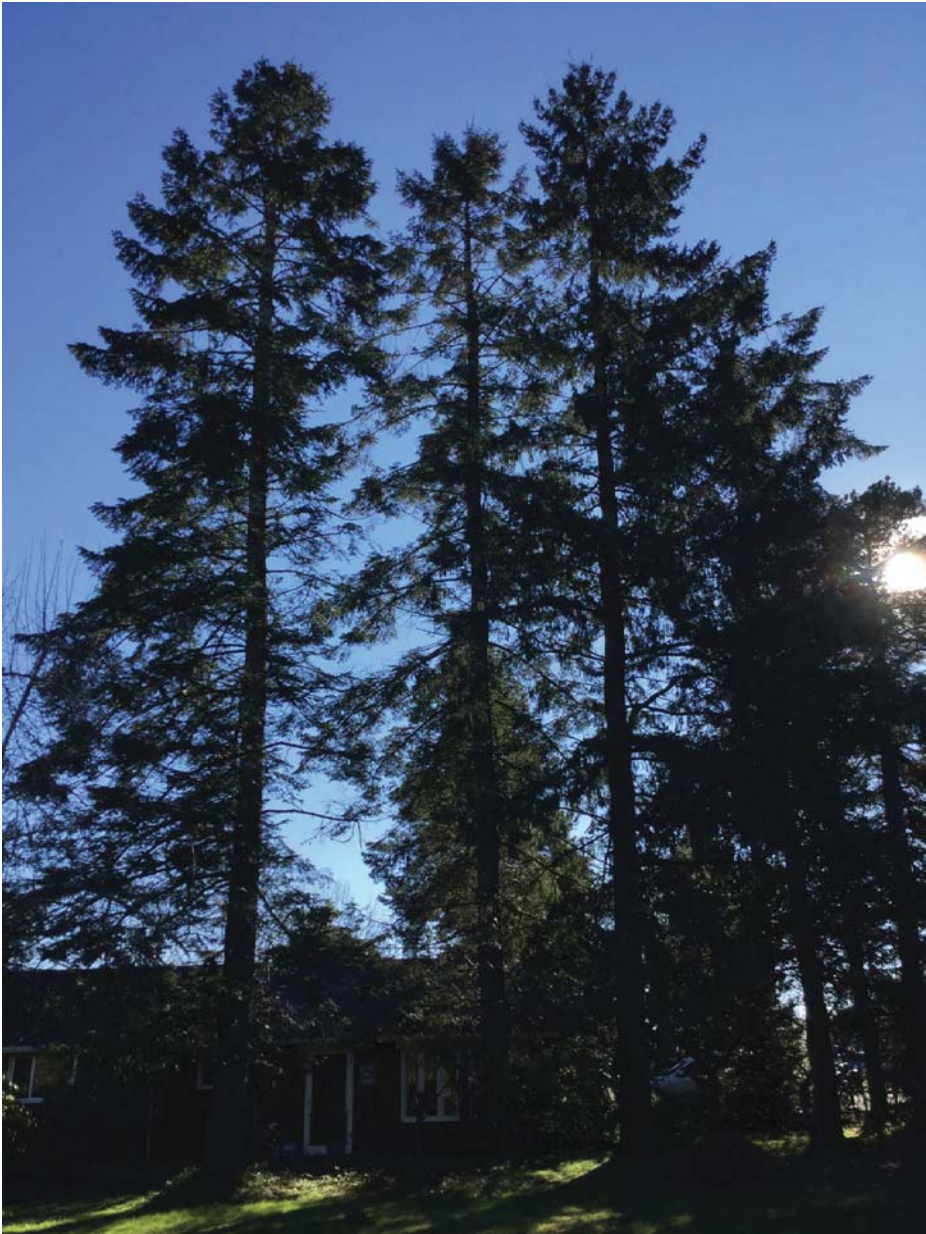
- **31E18B 01300 (Map ID No. 26 and No. 27; Photos 25 and 26):** A dense row of semi-mature conifers along the northern boundary of this parcel are in fair to good condition and most suitable for preservation as an intact row. Closer to the existing house, a dense group of one mature Douglas-fir and two mature grand firs (*Abies grandis*) are in generally good condition and suitable for preservation as an intact group. Other mature conifers around the house and along the street are in fair to poor condition and with structural defects and sequoia pitch moth (*Synanthedon sequoia*) infestation.

Photo 27. Two grand firs and one Douglas-fir in a group close to the existing house are relatively the best trees at tax lot 31E18B 01300 - Map ID No. 26.
