From The Director's Office:

Aeration Basin Reboot

Utilities—Wastewater Collections

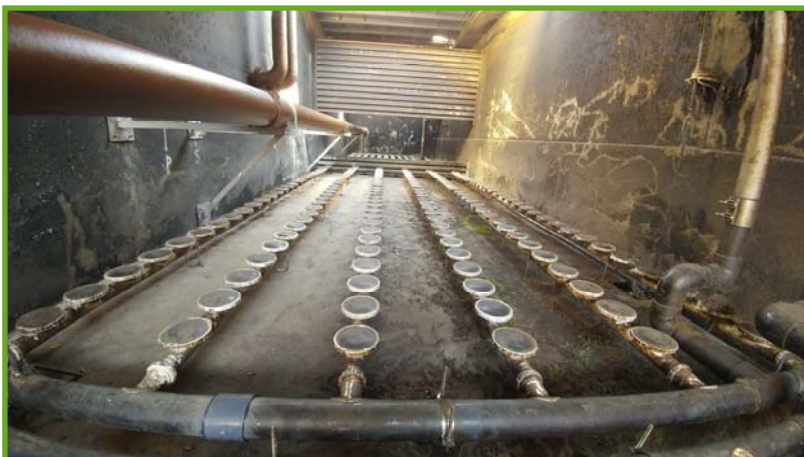
View inside of aeration basin looking from south to north—baffle wall at the far end separates the anaerobic zone (far) from the aerobic zone (near). Brown pipe on left side of basin recirculates activated sludge back to the anoxic area

Improvements include increasing the aerobic area by relocating the baffle wall. Adding a pipe to transfer liquid sludge from the aerobic zone back to the anoxic zone. Installation of large bubble piping to blend the liquid in the anoxic areas.

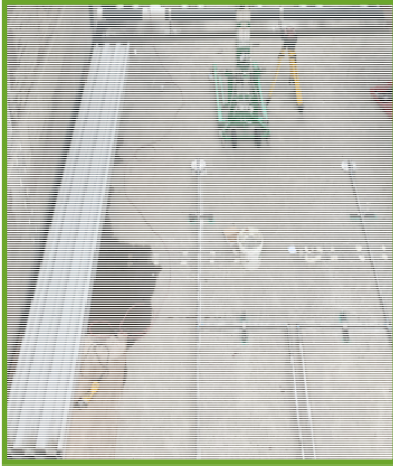
*Large bubble mixer pipes to
blend the liquid in the
anoxic zone*

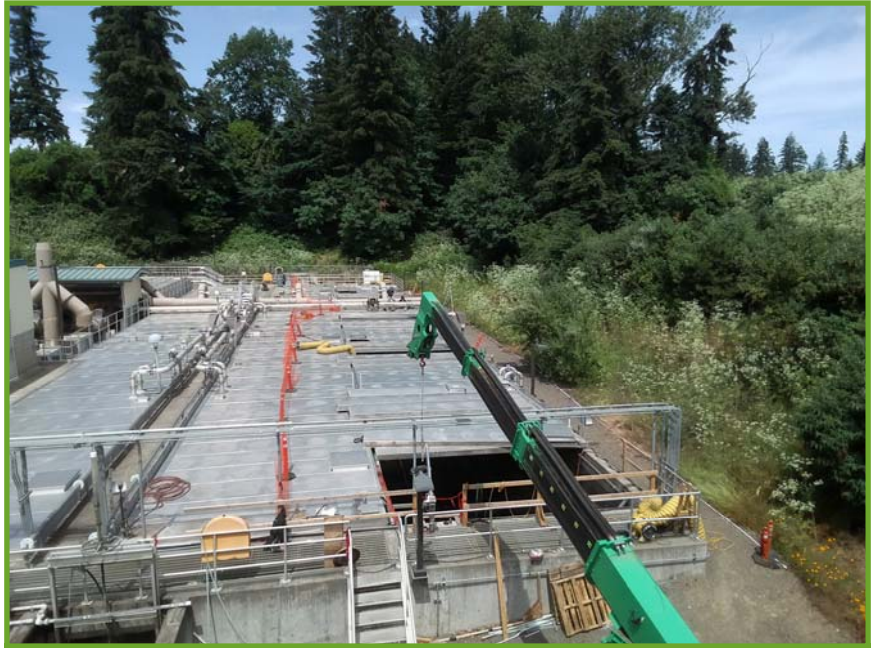
Crane removing cover panels over aeration basins

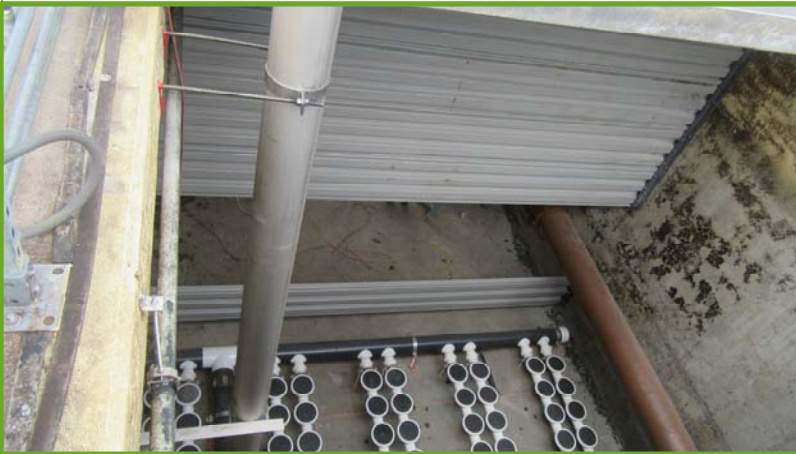
Relocated baffle wall to expand basin aerobic zone

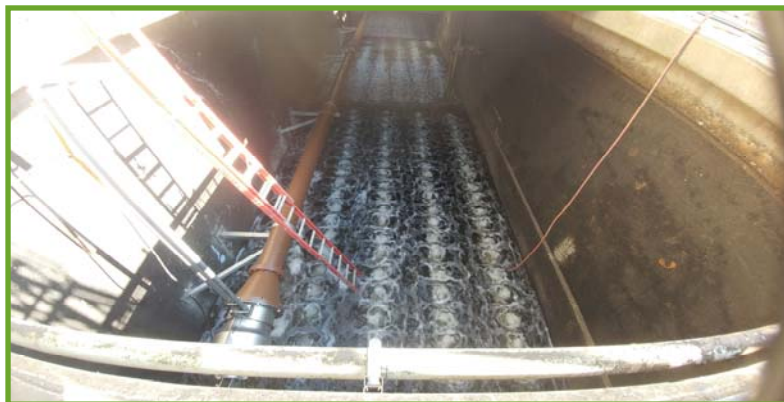
*Testing new air diffusers which add oxygen
to the activated sludge*

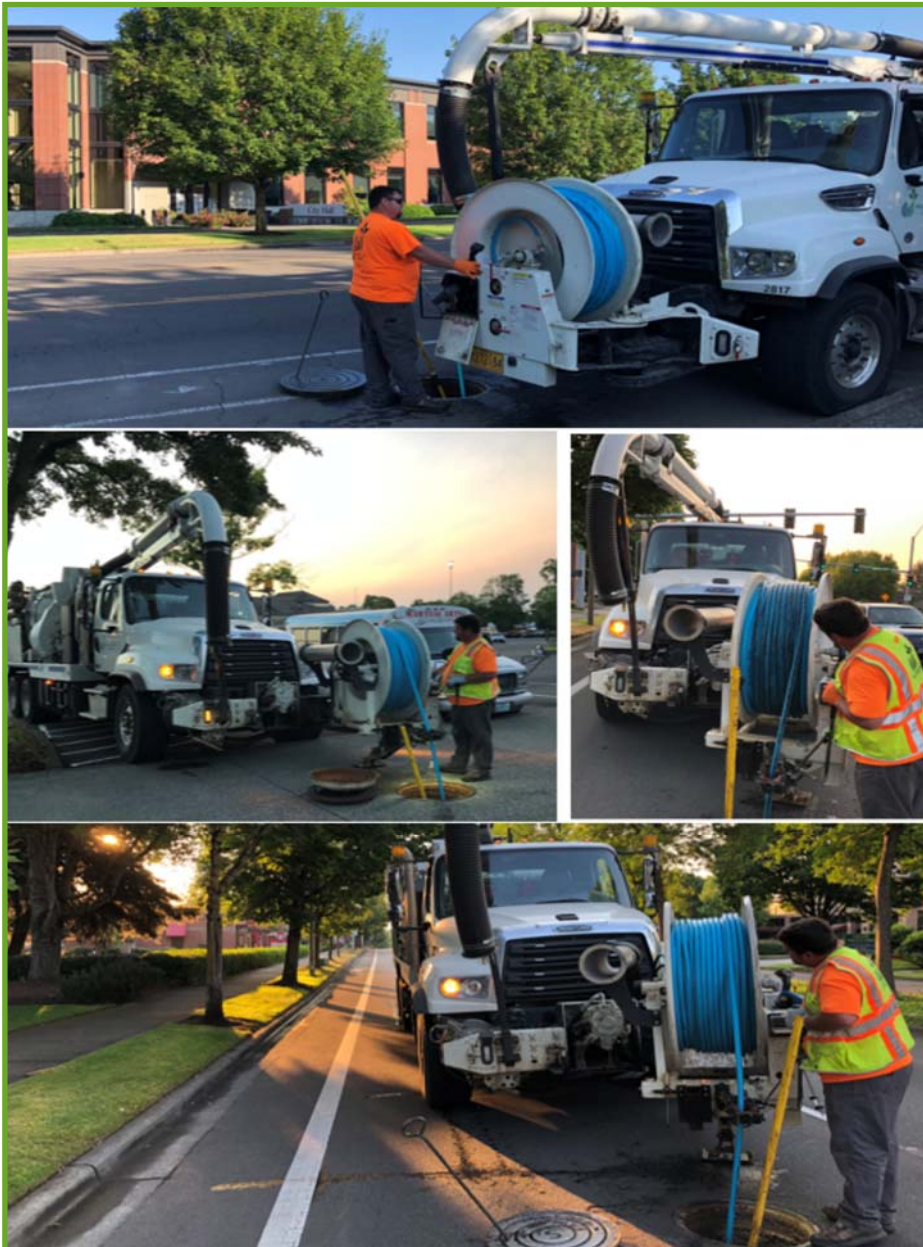
Early Morning Cleaning—Town Center Loop

This month, the wastewater crew focused cleaning efforts on the Town Center Loop area, including nearby City Hall, Public Works and the Wilsonville Town Center shops. Many of the access points for these sewer mains are in parking lots with a high volume of vehicle and pedestrian traffic. In order to minimize disruption, the crew started a few hours earlier than their normal shift. An early start gave them the opportunity to complete necessary cleaning before normal business hours.

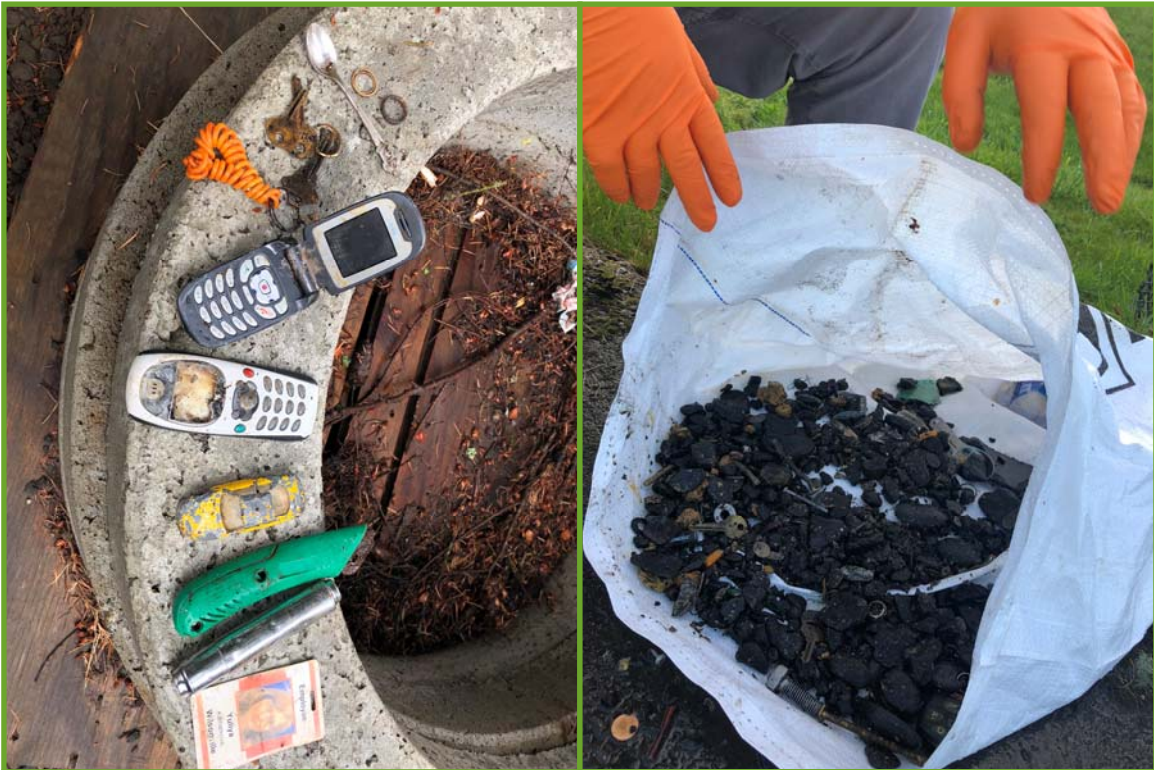
Objects found during sewer maintenance

The crew recovered several treasures that traveled unknown distances through the system. Found items included keys, toys, phones, loose change, jewelry and even live ammunition. The most exceptional item—an engagement ring and wedding band. After a thorough cleaning, a stamp was found on the inside of the band identifying the jeweler. With the help of a reporter from the Oregonian newspaper and some online research, we learned the engagement ring originally retailed for over \$10,000. The owner has yet to be located and we can only speculate how it ended up in the sewer.

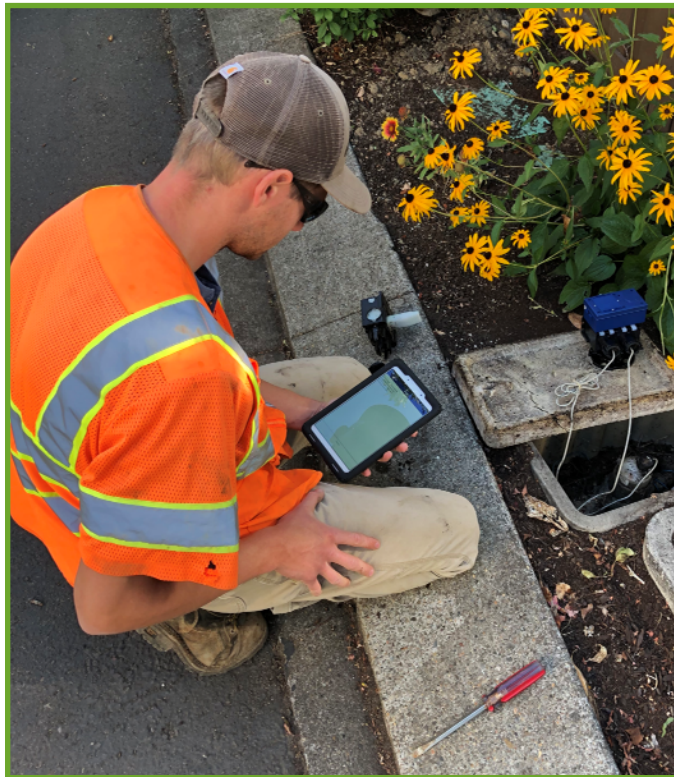
AMI radio installation

The water crew installed 23 Advanced Metering Infrastructure (AMI) radios and 3 Ally water meters as part of the PGE/Sensus AMI water meter and Streetlight Pilot Project. The AMI radios enable the City to obtain water meter data instantly through an online portal. Installation is a relatively simple process— attach the existing touch read cord from the water meter into the new AMI radio unit, and then program the unit through a mobile device.

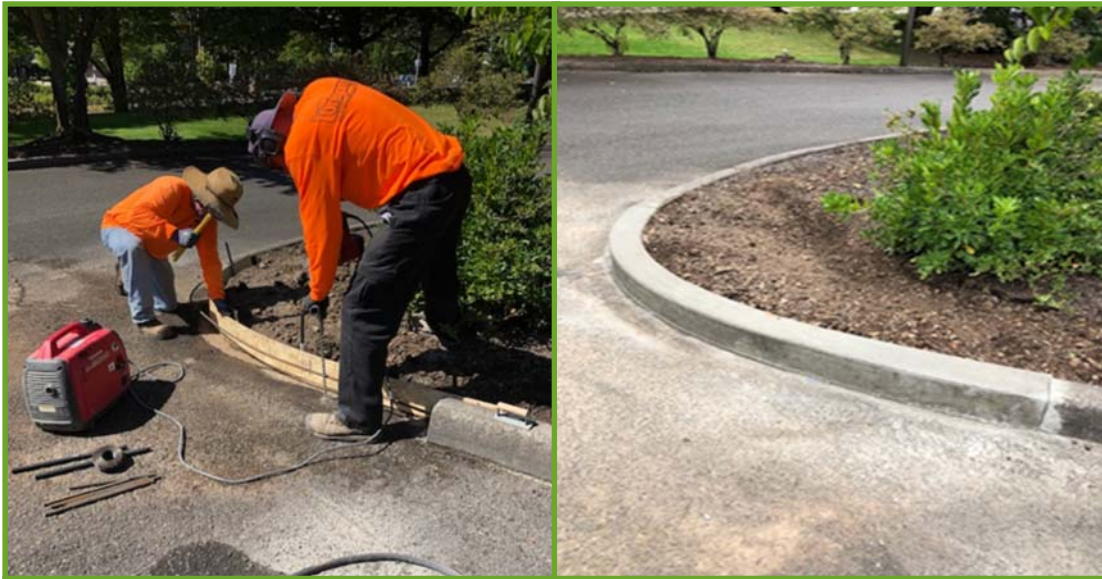
Taking advantage of the dry season, the Facilities crew made much needed curb repairs to the Community Center parking lot. They were installed in the late eighties and showing significant signs of wear. A few sections were broken into chunks, presenting a driving and pedestrian trip hazards. Crews removed all of the broken pieces, set up form board, installed rebar reinforcement, hand mixed and poured the new curbing.

Daniel Morena and Mike Pierce tackle curb repair

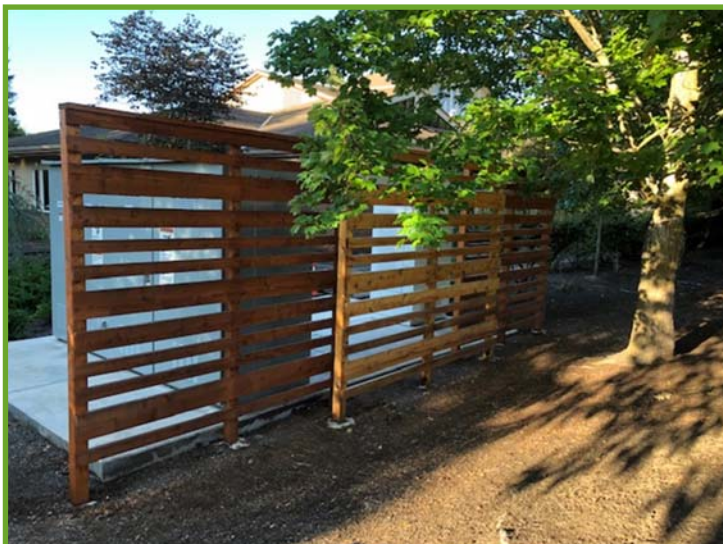
Two-toned privacy screen

The dry weather allowed the crew to apply additional coats of stain to the new Library privacy screens. The screen shields the transformer and electrical cabinets that power the electric car charging stations.

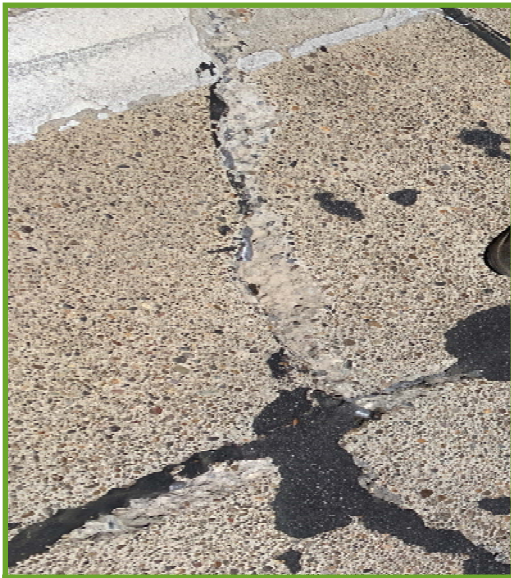
The Roads crew performed crack repairs on 95th Avenue this month. Cracks in the roadway are caused by the fluctuation of the concrete panels. Large cracks in the road can be hazardous, causing vehicle damage and increasing the risk of motorcycle and bicycle accidents.

Crack in need of repair on 95th Ave

The crew used high-grade silicone filler that bonds with the edges of the concrete and stretches with the panels as they expand and contract. The silicone has greater friction than the previous sealant, making it a safer option for drivers and cyclists when traveling in wet conditions. Sealing the gaps in the concrete reduces the risk of traffic accidents and creates a smoother, safer driving surface.

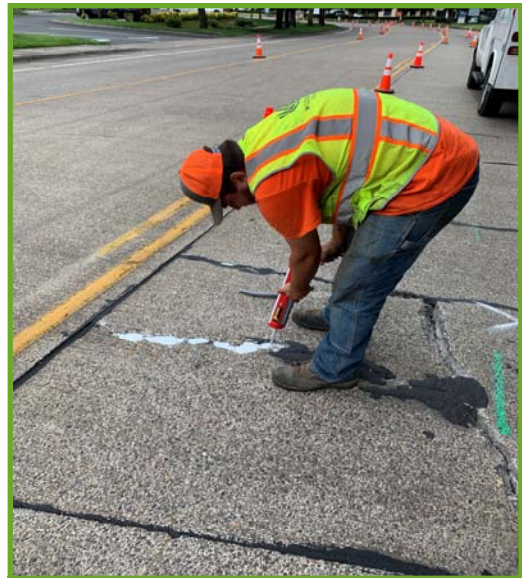
Filling with silicone

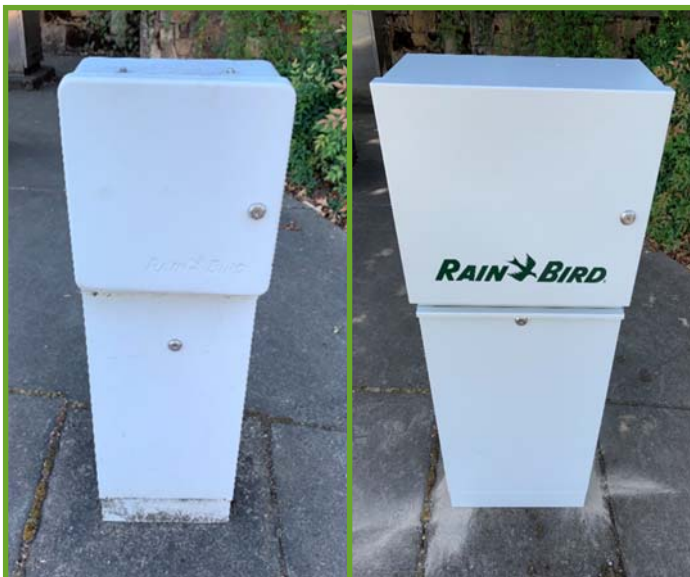
Irrigation Controller Upgrade

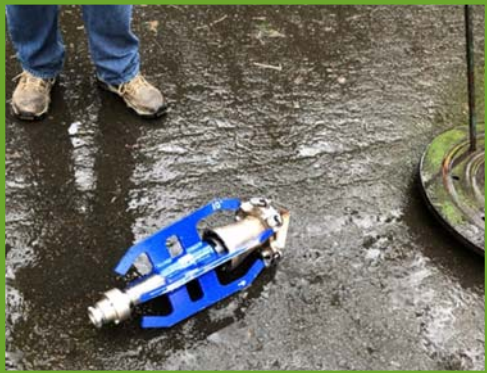
Root cutting flail

A root cutting flail connects directly to the high pressure water line. The water jet from the truck propels a chain inside, spinning it very rapidly, making quick work of roots. Clearing roots restores proper flow, keeping water from backing up in to catch basins and potentially into the streets.

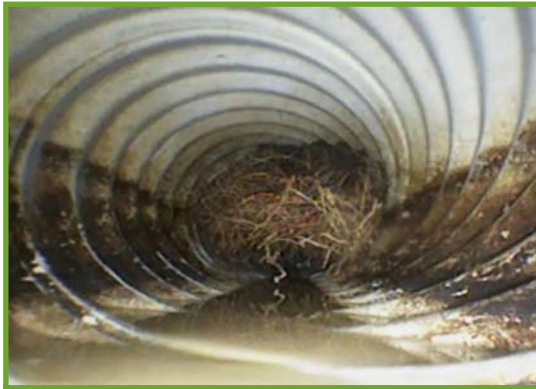
The Stormwater crew regularly cleans the storm lines using a high pressure water jet from the Vac Con truck. This dislodges and flushes debris away to restore proper flow. Occasionally, roots make their way into the line and cause significant obstruction. The solution— a root cutting flail attachment.

Before— roots obstructing flow

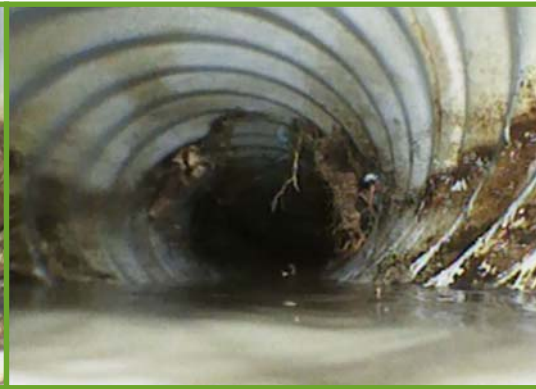
After— line cleared

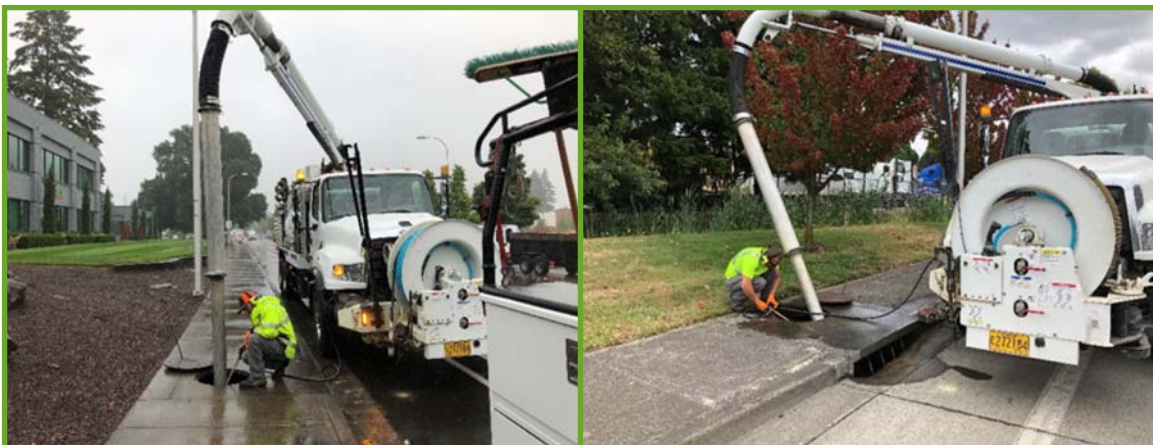
Performing scheduled catch basin cleaning

The crew cleaned over 200 catch basins in August. These catch basins are scheduled to be cleaned each year because of their location in high traffic areas that have a large amount of debris or trees. Annual cleanings reduce the potential for flooding on city streets and capture pollutants entering our streams and
