From The Director's Office:

RAW WATER FACILITIES

Raw Water Facility Project

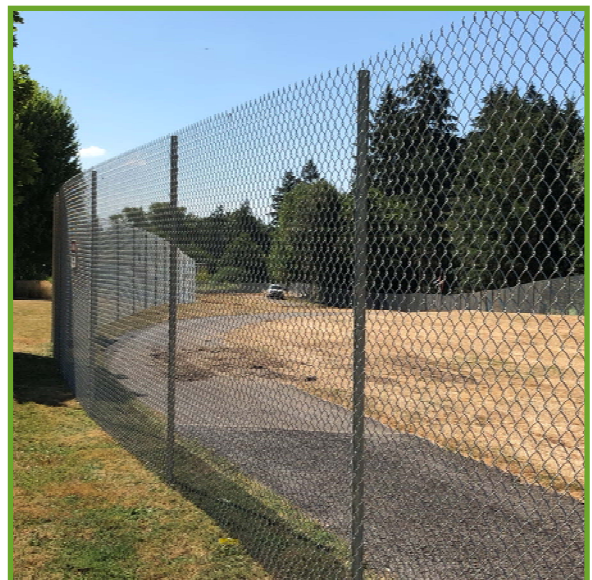
Construction fencing around the work area

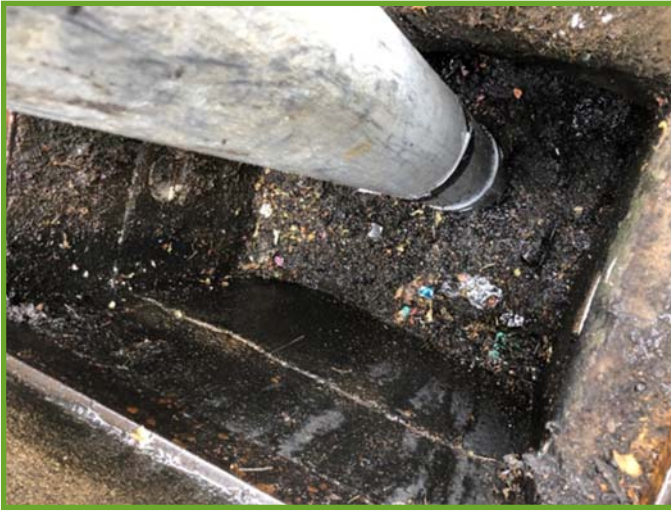
Before—no pipe in sight

The water runoff from roads that enter our stormwater collections system carries a large amount of debris and pollutants. Stormwater catch basins require regular maintenance or cleanouts due to the amount of debris that can build up in the basin. Each basin has a sump that is a designed volume of space to hold the debris and still allow the stormwater water component to discharge downstream. Once that sump volume is consumed the debris can obstruct the discharge pipe and cause road flooding or even residential flooding issues. The images below depict the typical stormwater catch basin clean-out process.

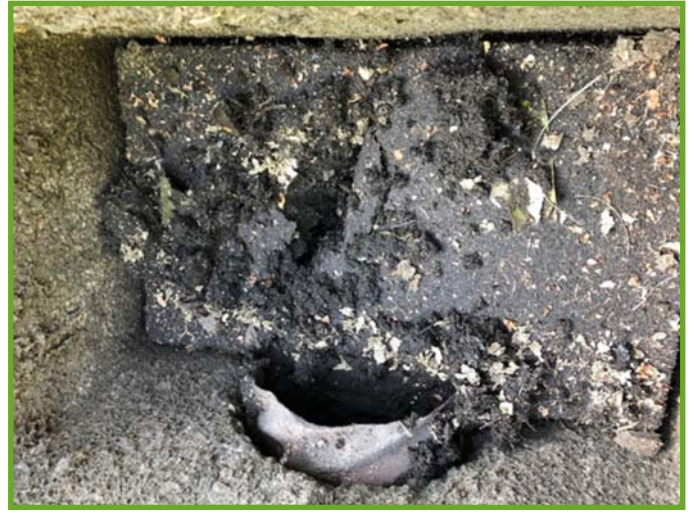
During—can start to see pipe

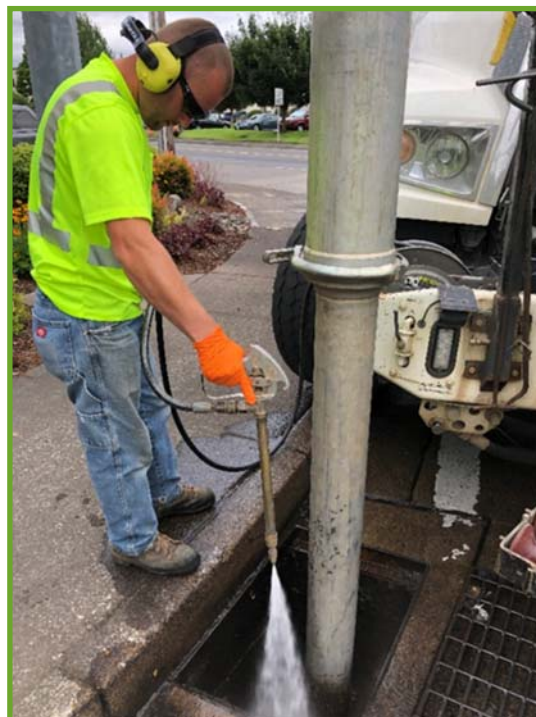
Cleaning catch basin

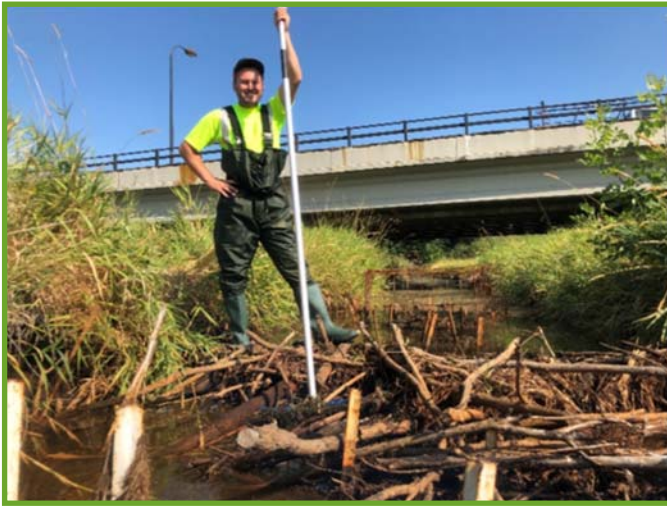
BEFORE— built up debris pile

Last year the Department installed a flood control and habitat device referred to as the “Beaver Deceiver”. Its intent is to allow for habitat creation for beavers while minimizing the risk for road or residential flooding associated with beaver dams. The Beaver Deceiver does require routine maintenance to strike the careful balance between habitat and flood control. The images below depict staff clearing the bypass pipe required to allow the device to properly function.

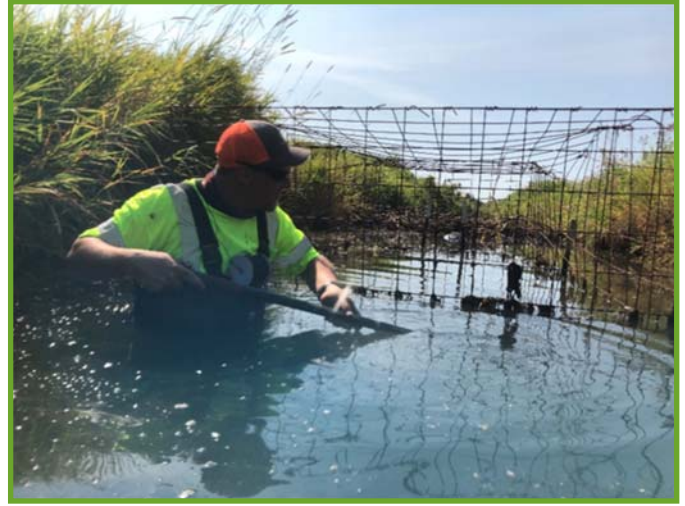
AFTER—water flowing again

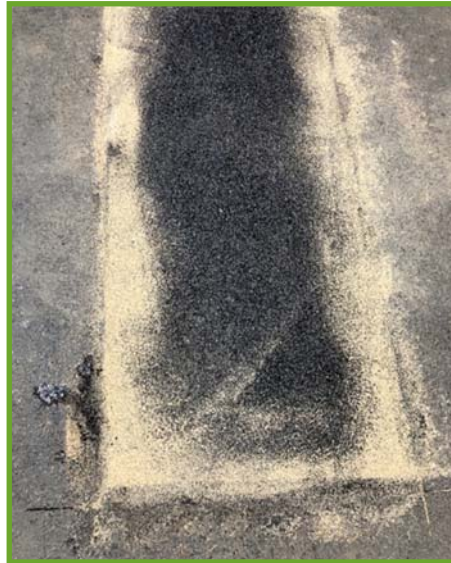
Patched

Pothole repair on Day Road are an ongoing issue due to the high daily truck traffic. The repair helps ensure a safe and smooth driving surface and minimize the risk of accidents and damage to vehicles. Minor potholes can simply be filled with either cold or hot asphalt. This isn't ideal but is typically done when a larger road treatment is planned in the future. Larger potholes require a patch which is a larger cut out with defined edges to prevent the pothole from spreading further.

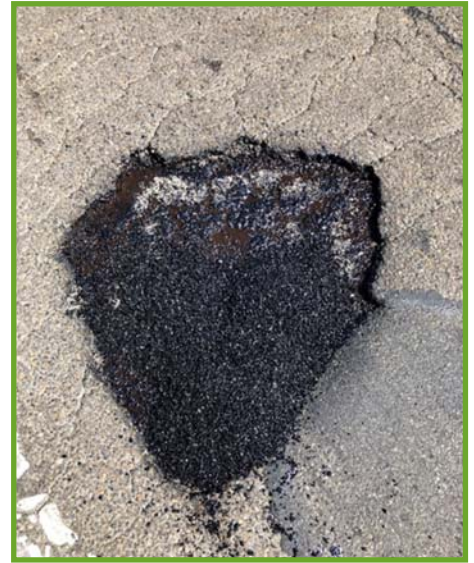
Newly filled pothole

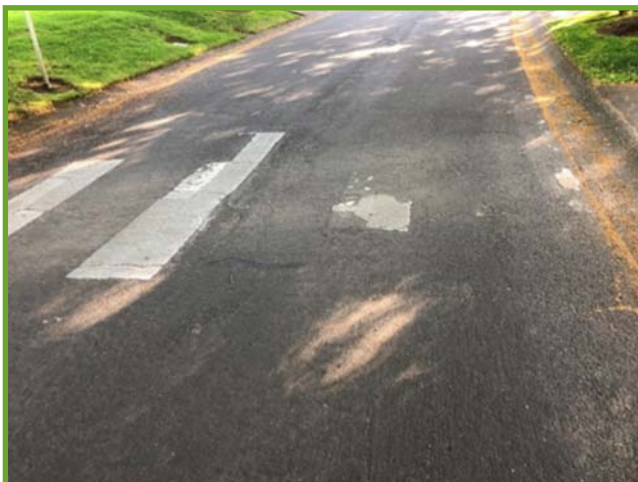
Crosswalk—Before

The typical crosswalk markers seen within the City are composed of a material referred to as thermoplastic. Thermoplastic provides for better surface traction, longer life span and increased visibility over the traditional paint alternative. Recently several sections of “thermo” crosswalks were replaced along Boones Bend Road in Charbonneau. The process is fairly simple for a trained road specialist with the right equipment.

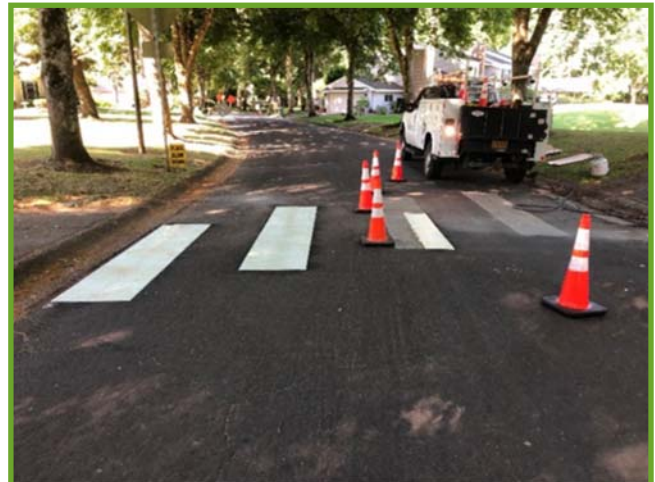
Crosswalk—After

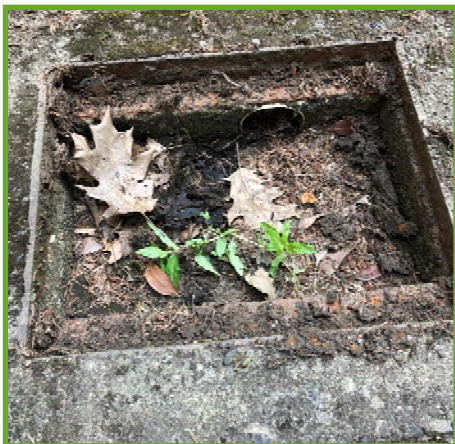
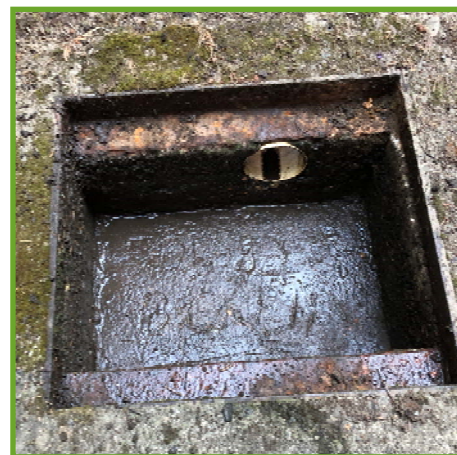
Stormwater Facility at Charbonneau Well Site Before & After

Summer time is here and the dry weather provides the opportune time to implement the Facility department's annual storm asset maintenance program. Earlier in the year, Facilities Maintenance Specialist Robert Todd, used a combination of as-built drawings and good old-fashioned brush beating to locate and enter all of the Facility storm assets into Cartegraph. In the end, there was found to be 108 storm assets that were split into a rotating biennial maintenance schedule leaving crews with slightly more than 50 storm assets to clean each year.

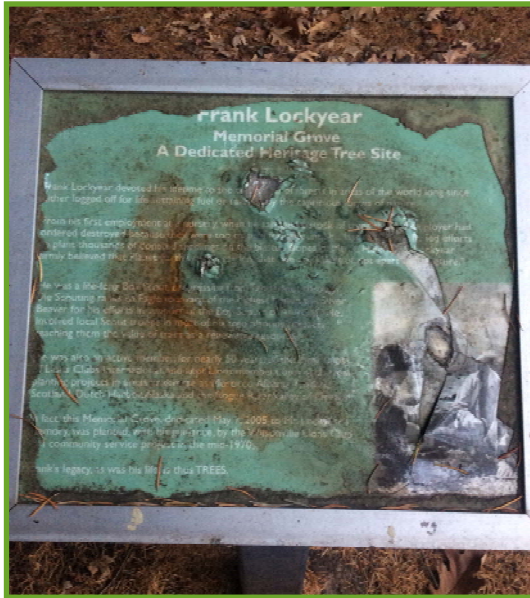
Old Lockyear sign damaged by vandals

Facility Maintenance Specialist Daniel Morena and Technician Ivan Crumrine, Installed a new Frank Lockyear interruptive sign at the Library outdoor sitting area. The crews poured a new footing and anchor bolts before assembling and installing the sign. Additionally, staff modified the sign by placing a plexi-glass cover over the sign for added protection from vandals.

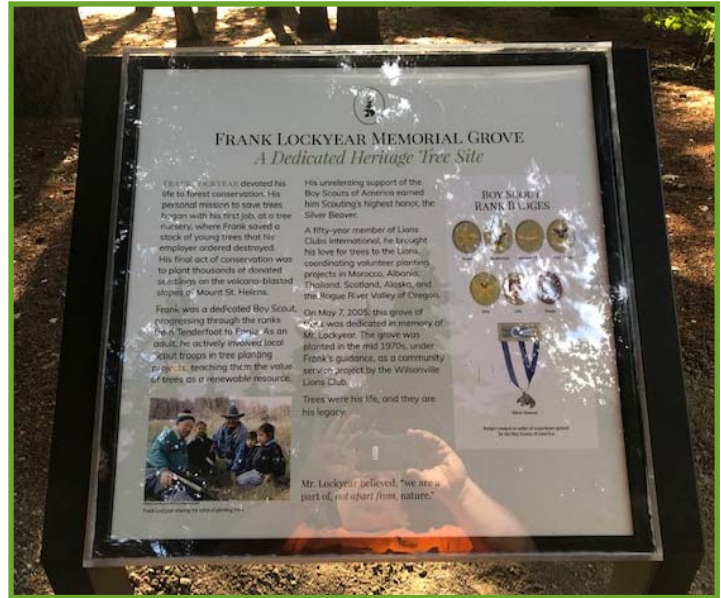
New Lockyear sign with plexi-glass cover

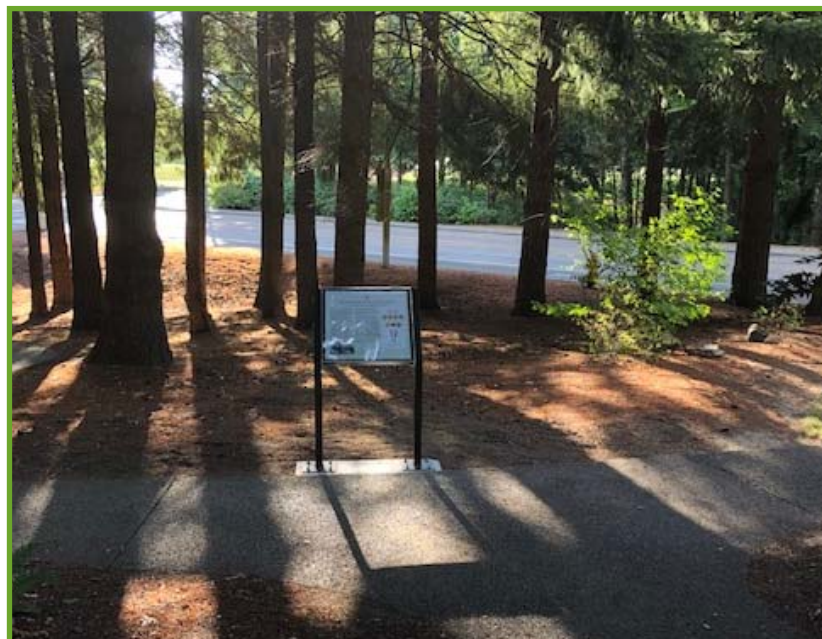
New sign sits upon a the new footing

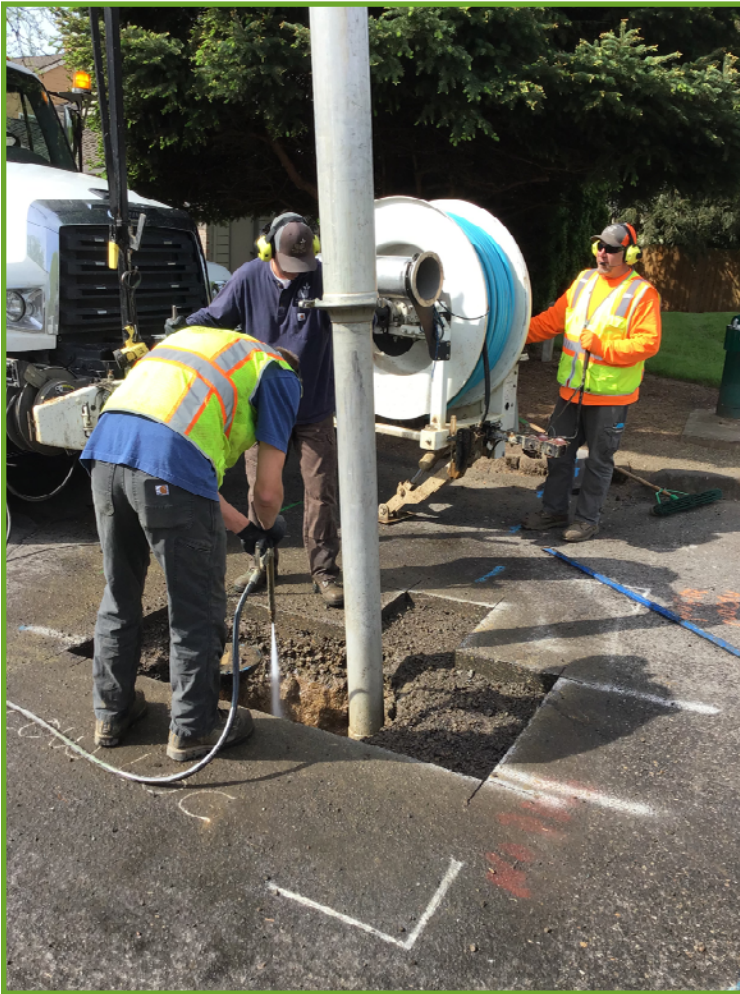
Using the vacuum truck to excavate trench

The water crew has been hard at work replacing old blow off valves that are at the end of their life span. The valves that are being targeted are a “wheel valve” style, which over time corrode and become prone to failure when they are operated. The valves are being replaced with a standard gate valve, which is a far more robust style of valve. In addition to replacing blow off valves, the crew has been performing some full fire hydrant replacements. The crew is targeting the old Dresser brand fire hydrants in the system, which no longer have readily available repair parts.

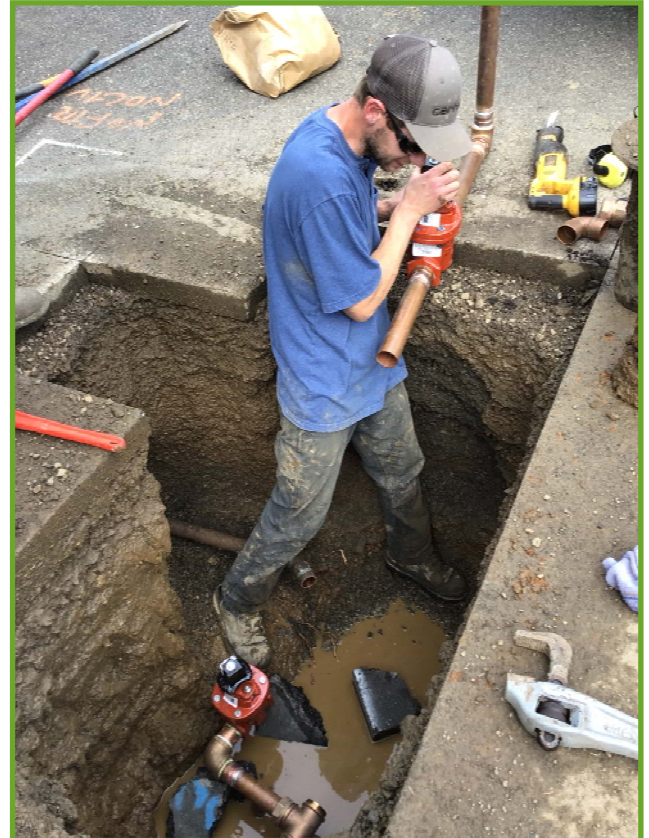
Installation of blow off valve

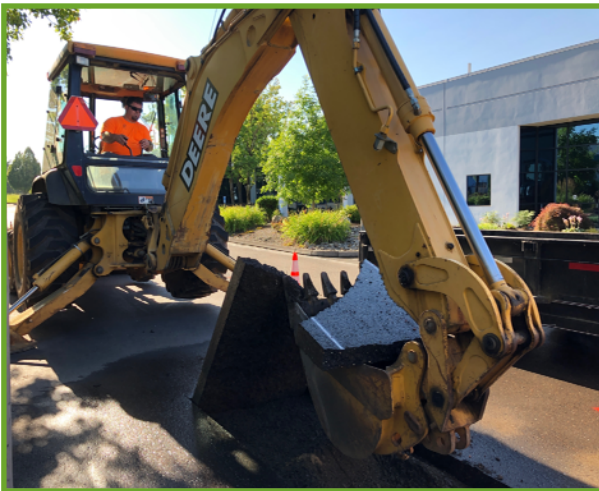
The first repair the crew tackled was a 12 foot deep section of pipe that was nearly half blocked with concrete. The concrete had settled and become attached to the inside of the sewer main. If left unchecked this obstruction could possibly collect debris until the pipe was completely blocked, causing a sewer overflow at the nearest upstream manhole.

Removing Asphalt

In order to prevent this from occurring, the wastewater crew excavated a trench 3 feet wide by 9 feet long and 12 feet deep. The trench was shored with hydraulic rams, allowing a crew member to safely enter the excavation. The section of concrete pipe that contained the blockage was removed and replaced with 4 feet of new PVC pipe. Once repaired, the trench was back filled, compacted and the asphalt was patched.

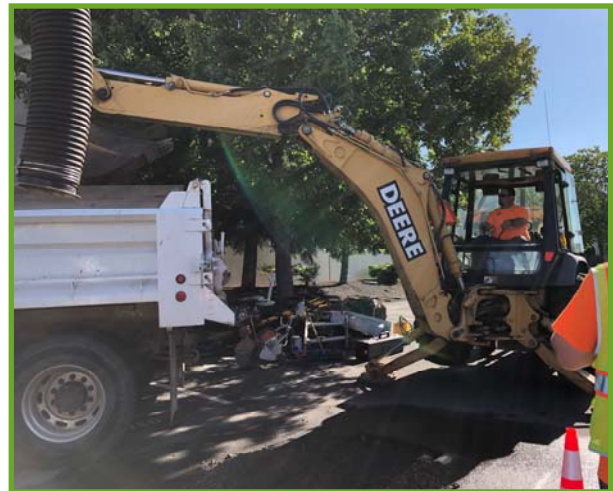
Loading up

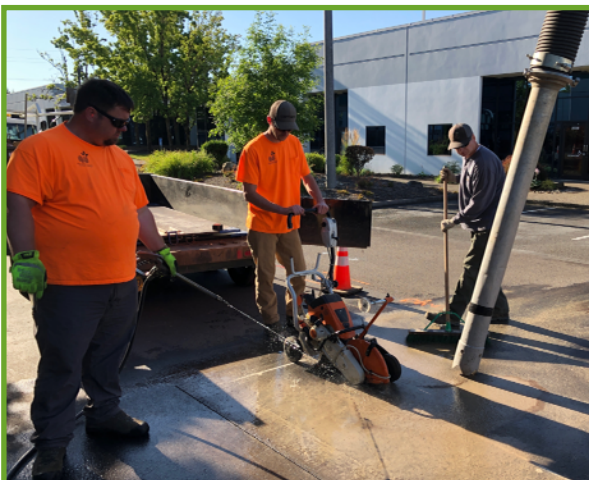
Cutting Concrete

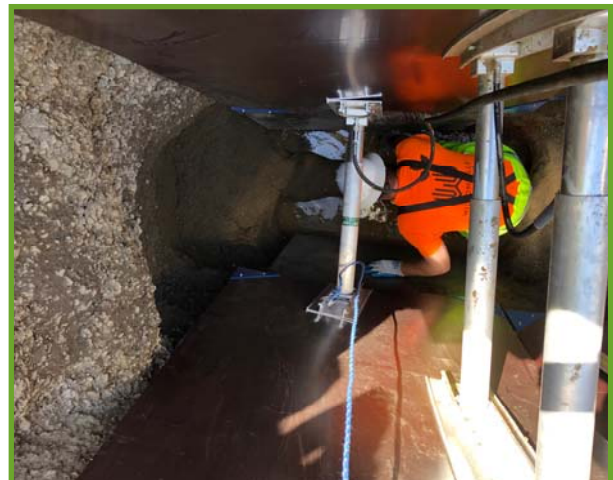
Working in the trench
