REPORT OF GEOTECHNICAL ENGINEERING SERVICES

Delta Logistics Day Road Annex
SW Day Road
Wilsonville, Oregon

For
Delta Logistics, Inc.
June 30, 2021

Project: DeltaLog-1-01

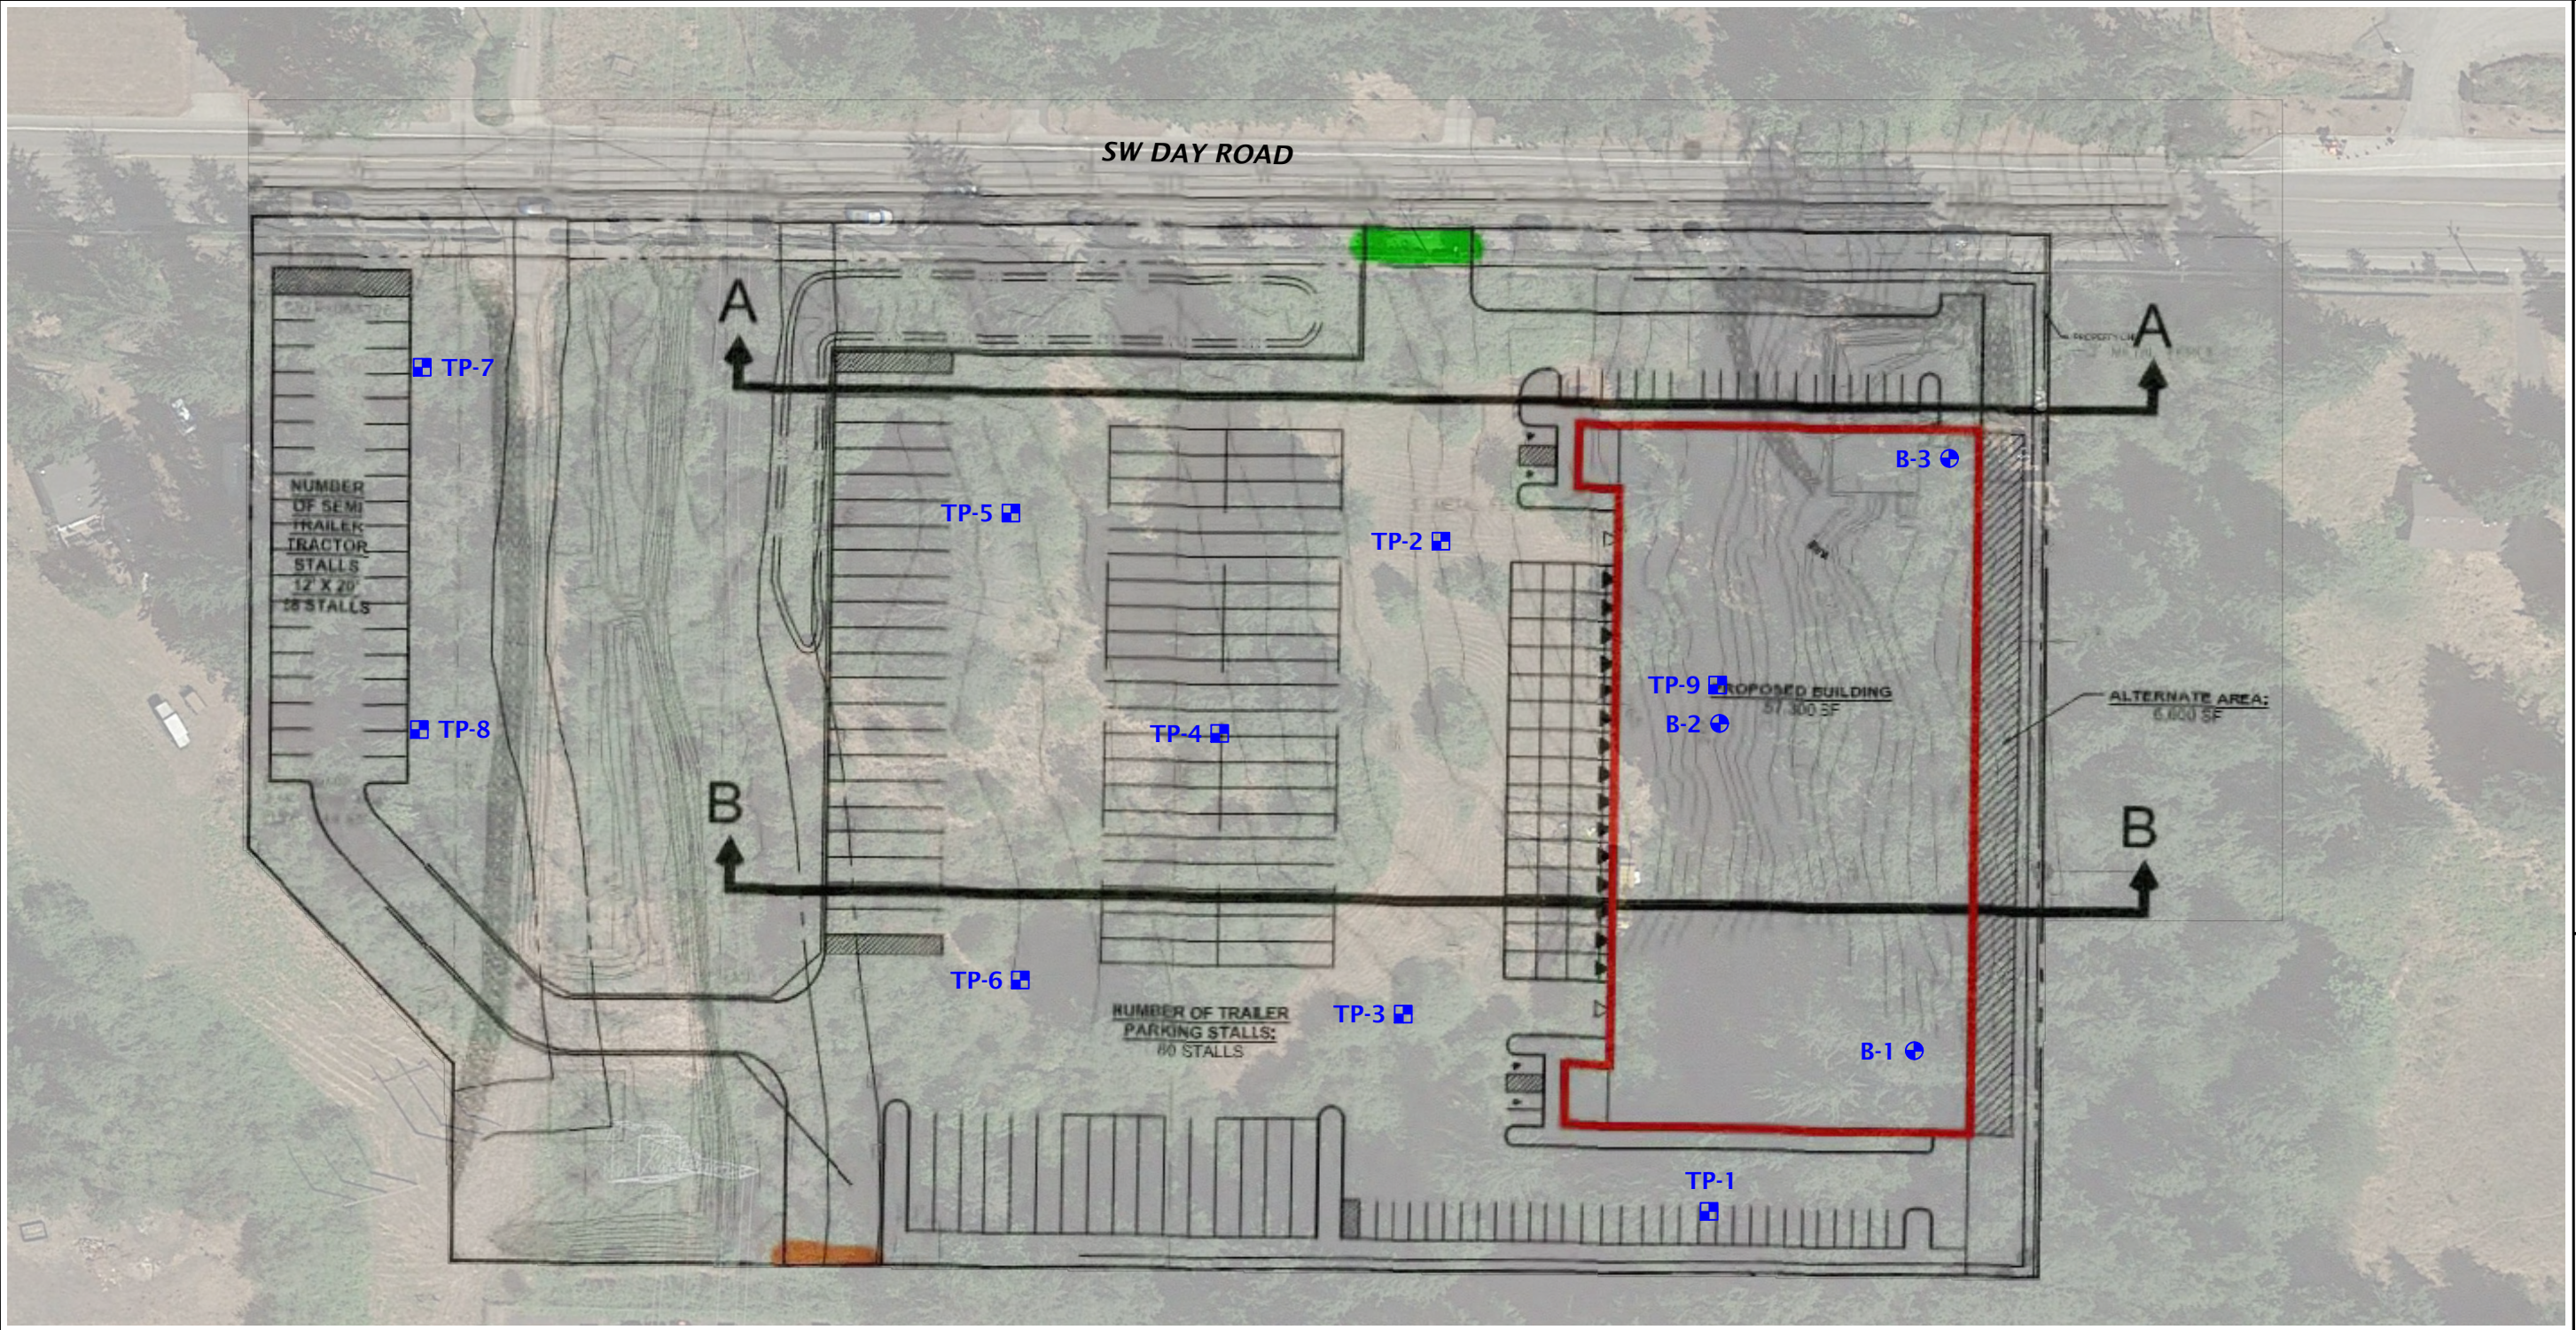
Printed By: mmliller | Print Date: 6/29/2021 9:47:30 AM
 File Name: J:\A-D\DeltaLog\DeltaLog-1-01-SP01.dwg | Layout: FIGURE 2

The site location is shown relative to surrounding features on Figure 1. Existing conditions and the proposed site layout (overlay) are shown on Figure 2. Acronyms and abbreviations used herein are defined above, immediately following the Table of Contents.

Subsurface conditions were explored by drilling three borings (B-1 through B-3) to depths between 15 and 22.5 feet BGS and excavating nine test pits (TP-1 through TP-9) to depths between 3 and 12 feet BGS. The locations of the explorations are shown on Figure 2. The exploration logs and laboratory test results are presented in the Appendix.

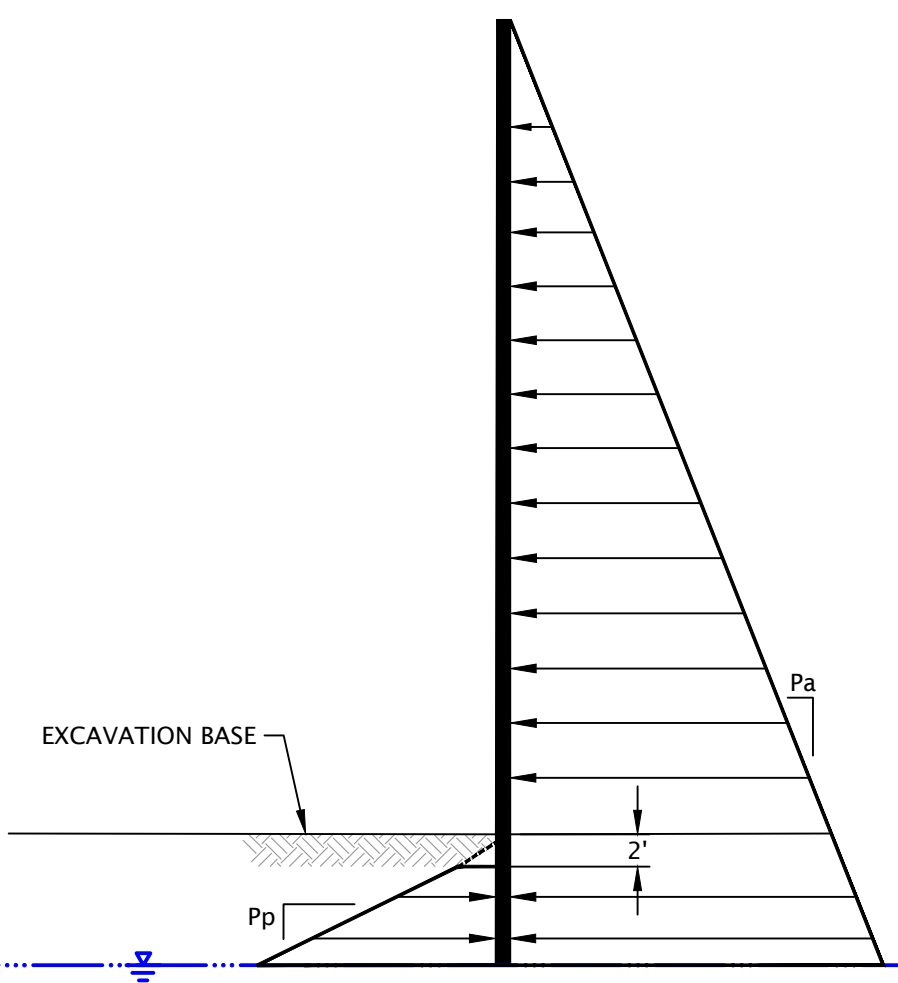
RECOMMENDED DESIGN PARAMETERS FOR CANTILEVERED WALL

- Pa = 35 PCF FOR SOIL OR STRUCTURAL FILL ABOVE WATER TABLE
- Pa = 15 PCF FOR BASALT ABOVE WATER TABLE
- Pp = 350 PCF FOR SOIL ABOVE WATER TABLE
- Pp = 850 PCF FOR BASALT ABOVE WATER TABLE

Lateral earth pressures can be computed using Figure 3. Seismic earth pressures can be calculated assuming a uniformly distributed load equal to force equal to 7H pounds per linear foot of wall where the wall retains soil, where H is the wall height. The seismic force should be applied as a distributed load with the centroid located at 0.6H from the wall base. Footings for retaining walls should be designed as recommended for shallow foundations.

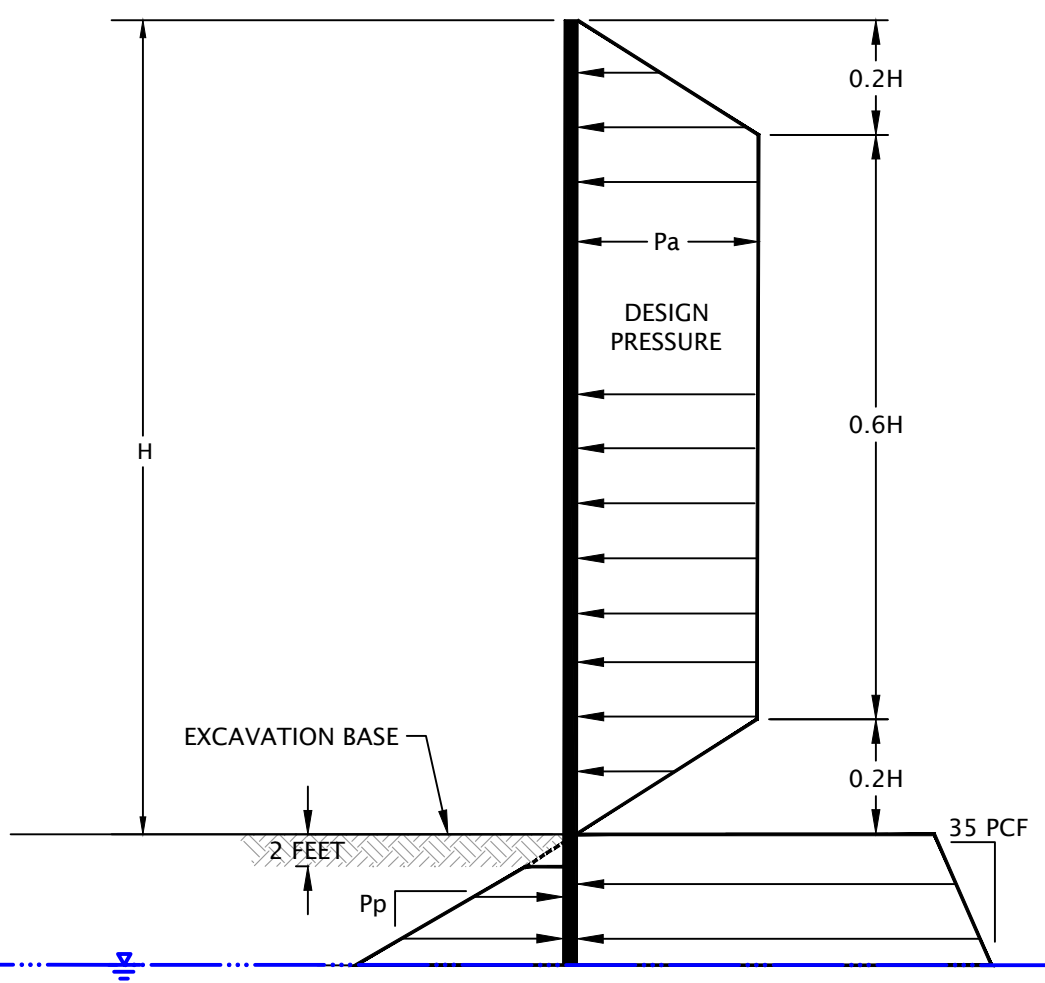
RECOMMENDED DESIGN PARAMETERS FOR BRACED WALL

- Pa = 25 PCF FOR SOIL OR STRUCTURAL FILL ABOVE WATER TABLE
- Pa = 12 PCF FOR BASALT ABOVE WATER TABLE
- Pp = 350 PCF FOR SOIL ABOVE WATER TABLE
- Pp = 850 PCF FOR BASALT ABOVE WATER TABLE

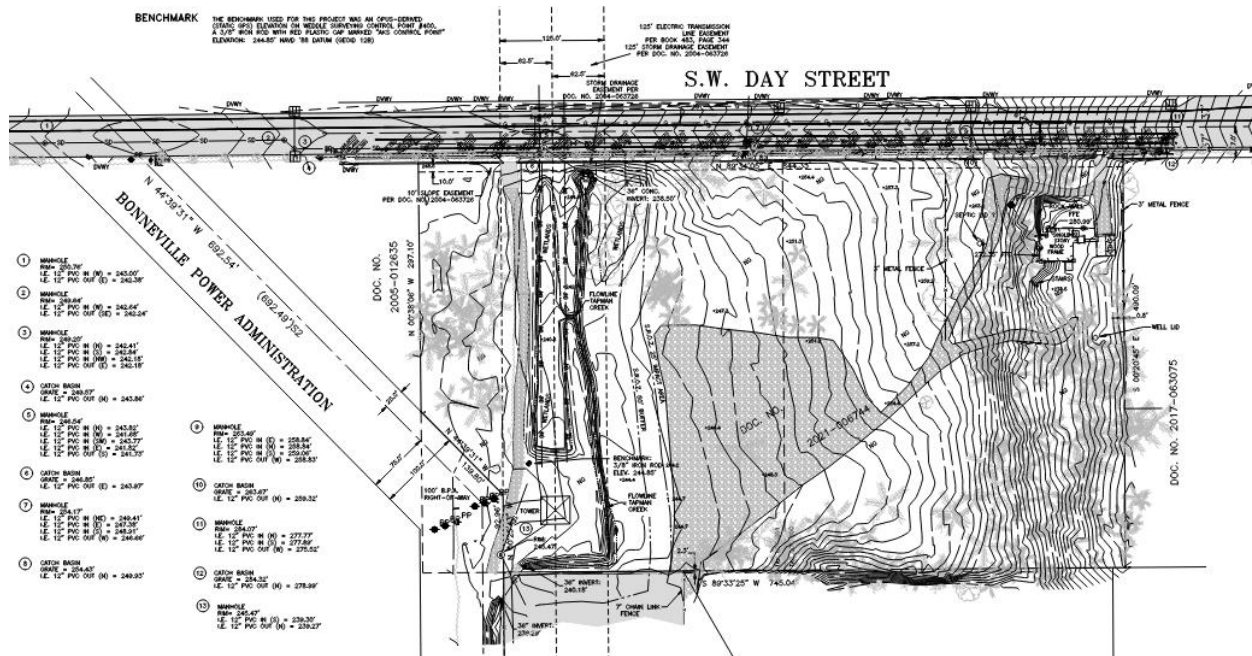
Figure 2: Existing Conditions Survey

“Tapman Creek, a tributary to Seely Ditch and the Willamette River, flowed from double 36-inch diameter culverts under SW Day Road, south through the western portion of the site and into a culvert at the southwestern site corner. A compensatory wetland mitigation (CWM) site was located just west of and parallel to the creek. The CWM site was constructed to mitigate for the widening of SW Day Road and replacement of a single culvert with the existing 88-foot-long double culverts at Tapman Creek (DSL #25201-FP; Corps #2002-00173). Both of these features are within the 125-foot powerline/storm drainage easement.”

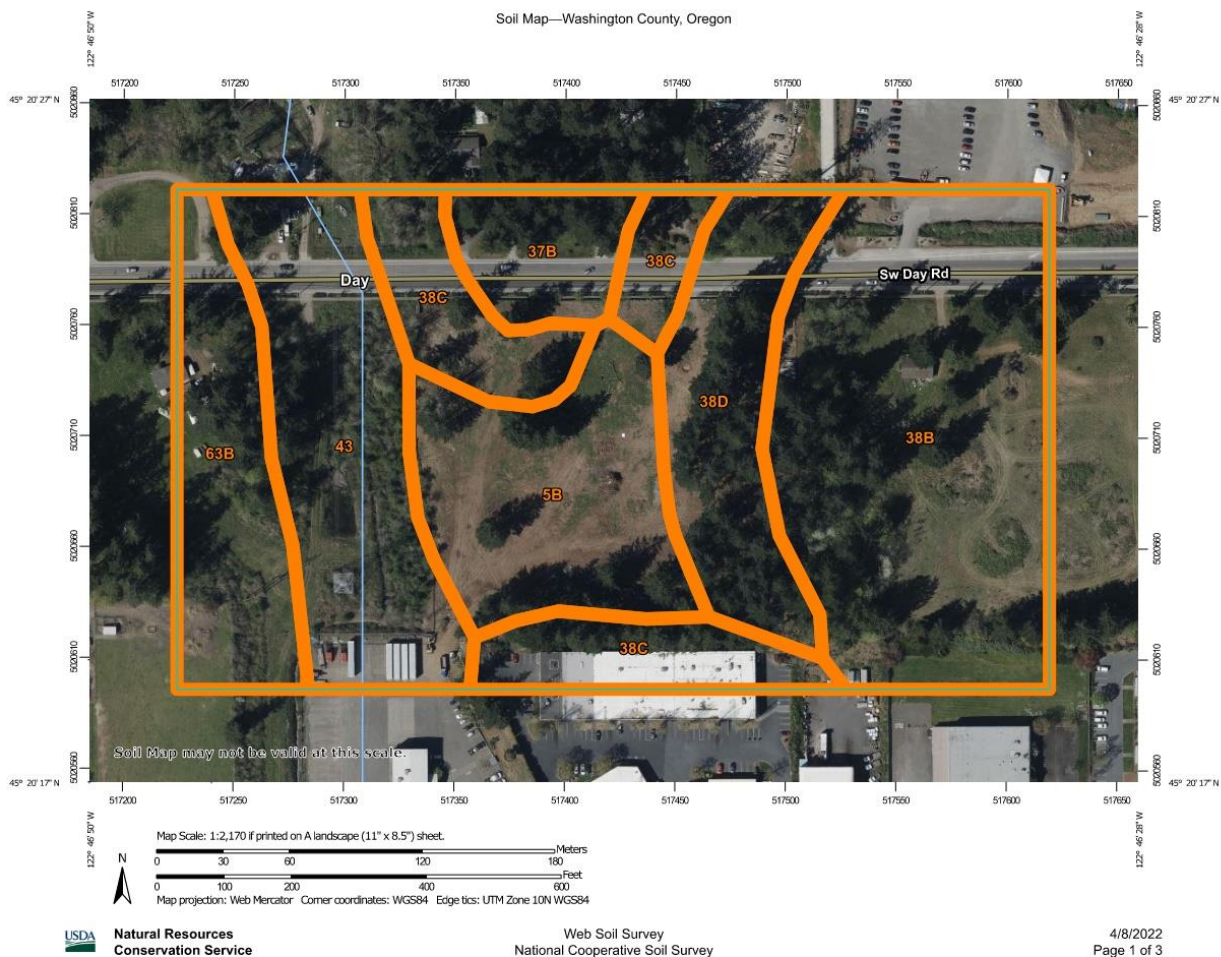
Figure 3: Web Soil Survey Map

Per the USDA Web Soil Survey, the existing soil is primarily a variety of silty and loamy soils. See Figure 3 for their locations across the site. The site has soils identified as Hydrologic Soil Groups B, C, and D for the purposes of relating to the Discharge Management Area (DMA) Soil Group in the BMP Sizing Tool.

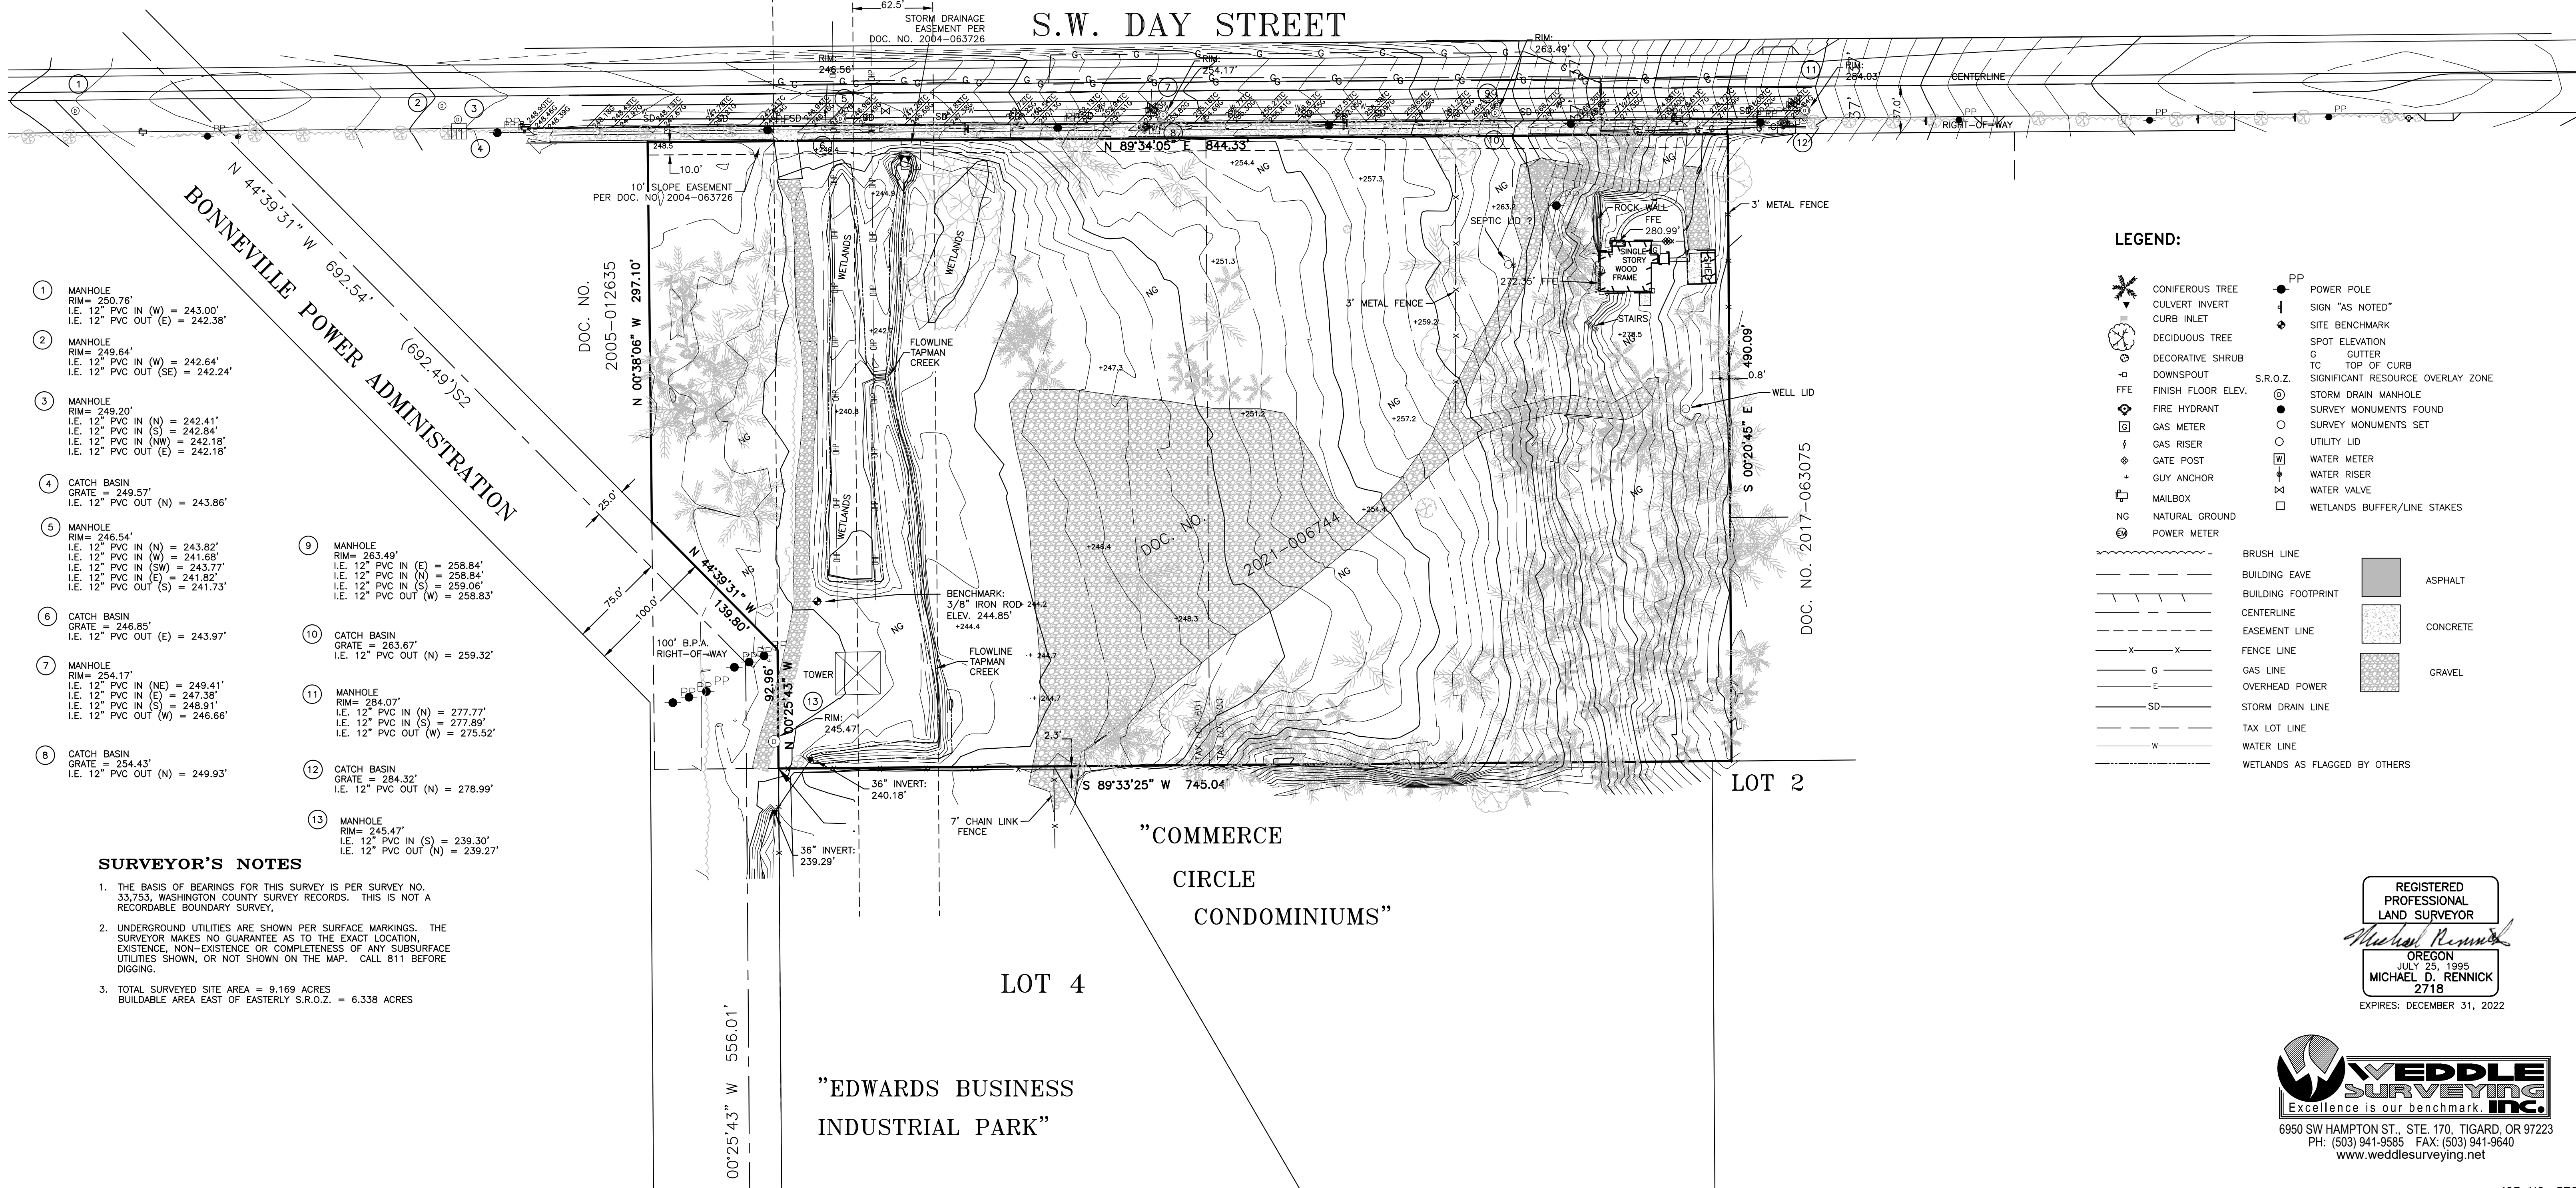
TOPOGRAPHIC SURVEY

125' ELECTRIC TRANSMISSION LINE EASEMENT PER BOOK 4B3, PAGE 344
 125' STORM DRAINAGE EASEMENT PER DOC. NO. 2004-063726

- 1 MANHOLE
RIM = 250.76'
I.E. 12" PVC IN (W) = 243.00'
I.E. 12" PVC OUT (E) = 242.38'
- 2 MANHOLE
RIM = 249.64'
I.E. 12" PVC IN (W) = 242.64'
I.E. 12" PVC OUT (SE) = 242.24'
