Appendix A: Project Planning Matrices

Table A-1 . Wilsonville Problem Area Matrix

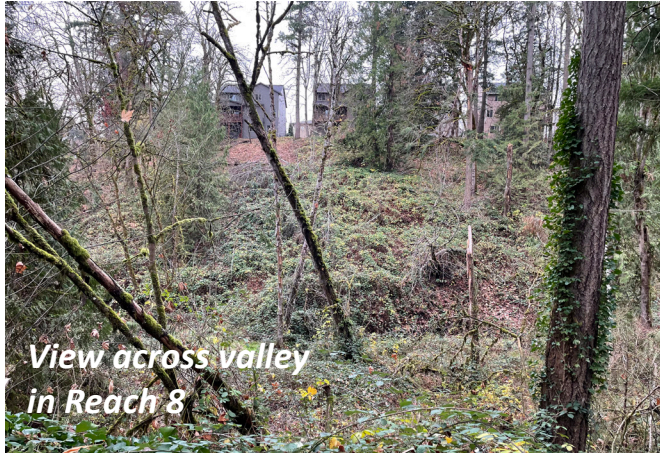
*View across valley
in Reach 8*

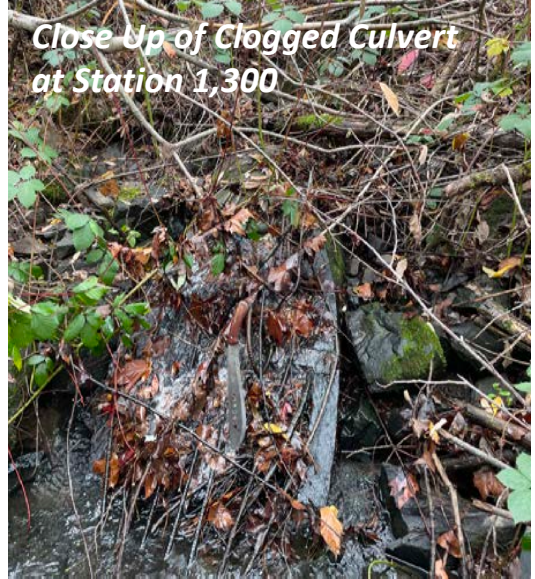
*Close Up of Clogged Culvert
at Station 1,300*

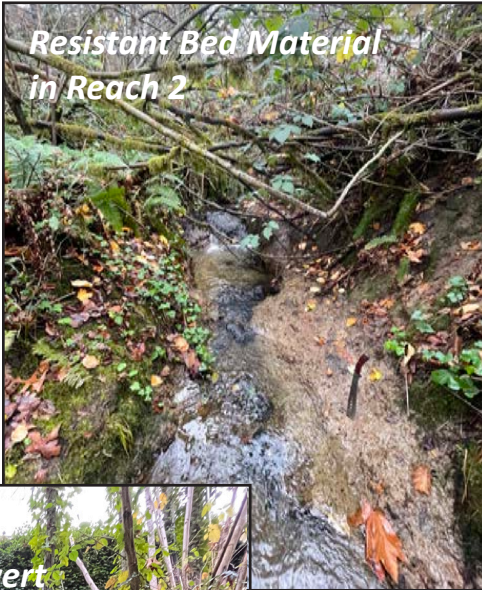
*Resistant Bed Material
in Reach 2*

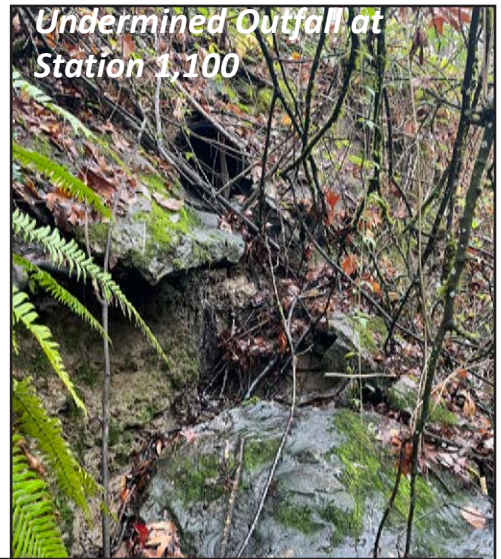
*Undermined Outfall at
Station 1,100*

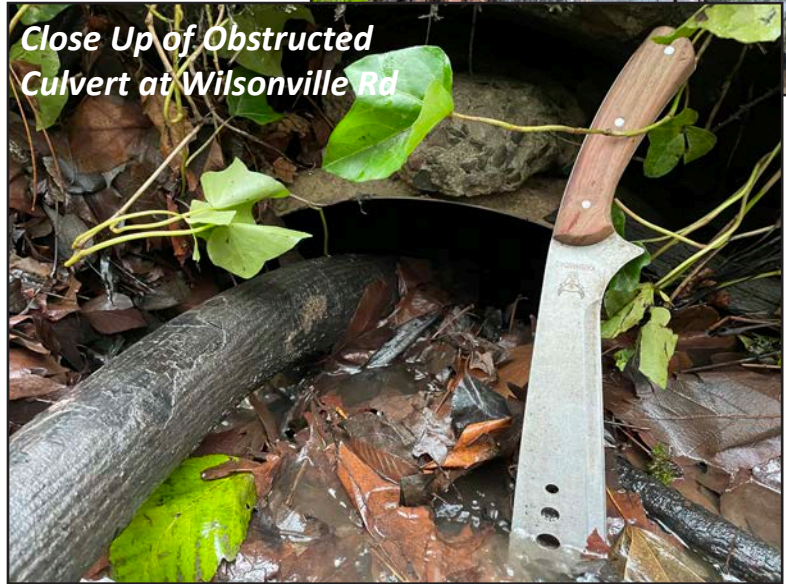
*Close Up of Obstructed
Culvert at Wilsonville Rd*

The primary infrastructure issue in this reach is the crossing of Meridian Creek under Wilsonville Road (**Figure 11; Photos on Figure 13**). The culvert appears to be undersized and is nearly clogged with fine sediment. This obstruction caused a wedge of sediment to accumulate in the channel upstream. The lack of drainage appears to cause some ponding under current conditions, and complete plugging of the culvert seems like a reasonable possibility. It is unlikely that ponded water would overtop Wilsonville Road, but repeated ponding behind the road could cause geotechnical instability through other

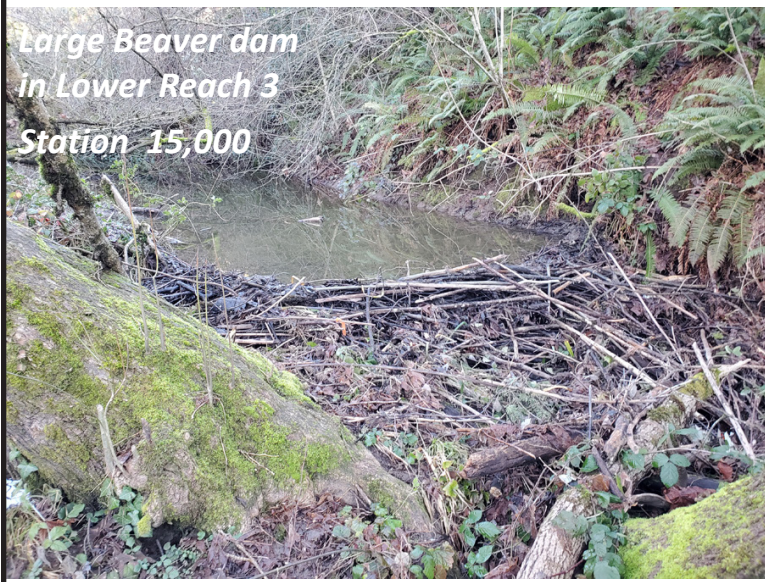
*Large Beaver dam
in Lower Reach 3
Station 15,000*

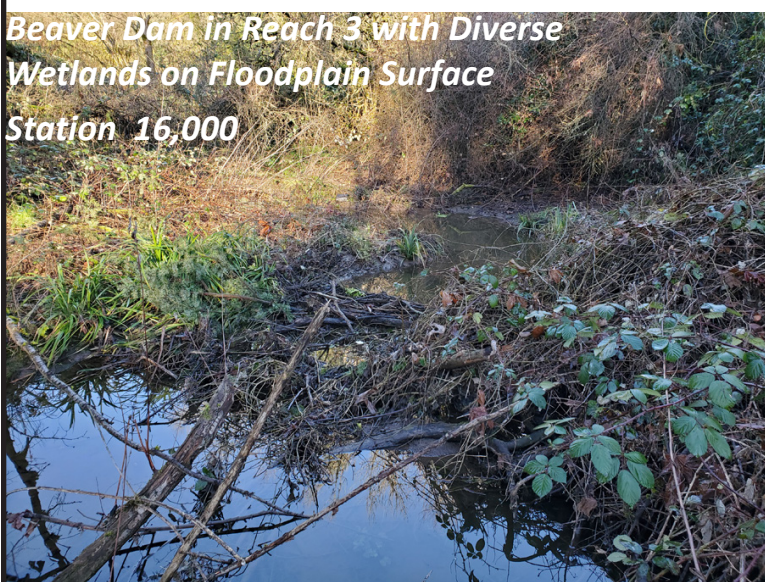
*Beaver Dam in Reach 3 with Diverse
Wetlands on Floodplain Surface
Station 16,000*

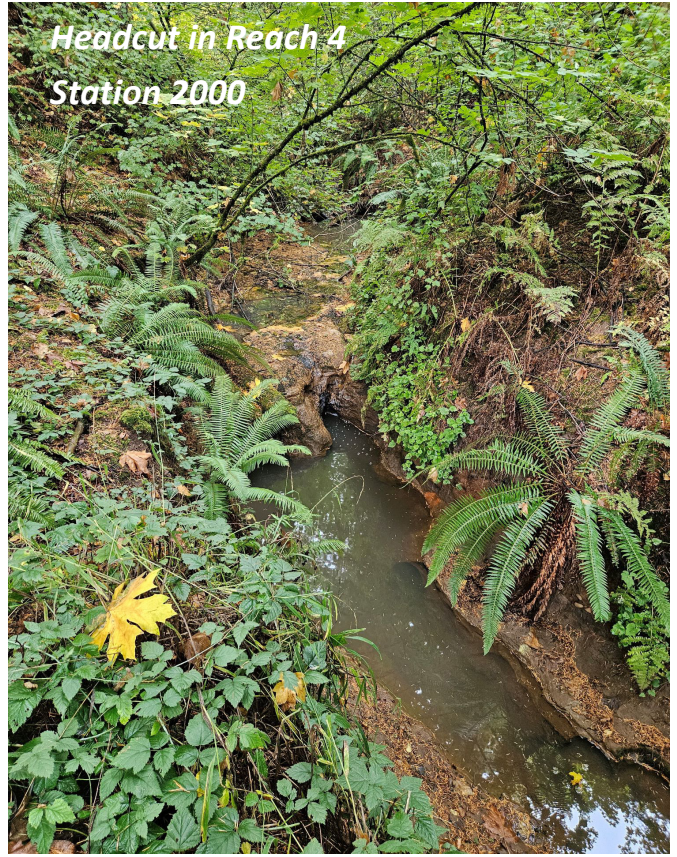
- Only one large headcut was observed in Reach 4. This reach may be in a widening phase in response to past incision as more bank instability was observed.

*Headcut in Reach 4
Station 2000*

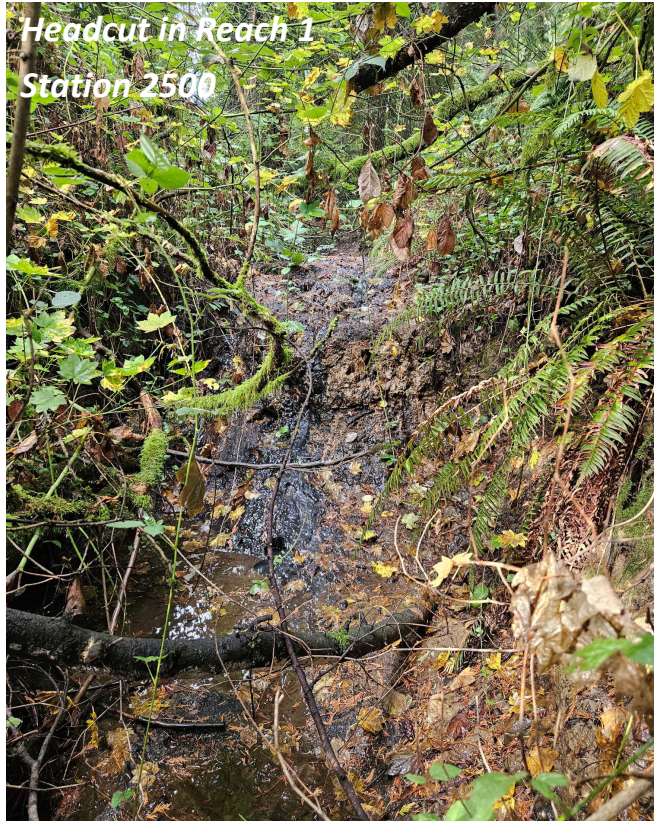
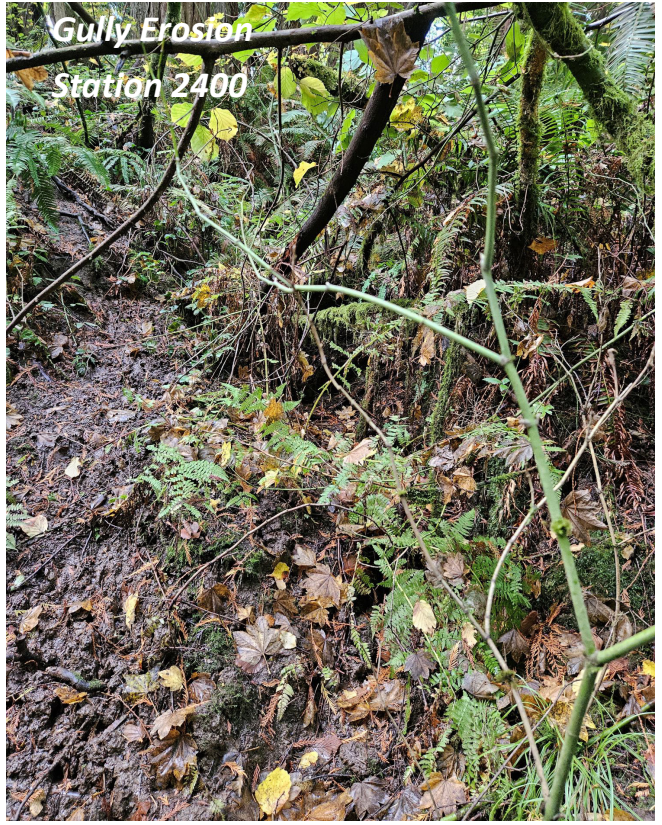
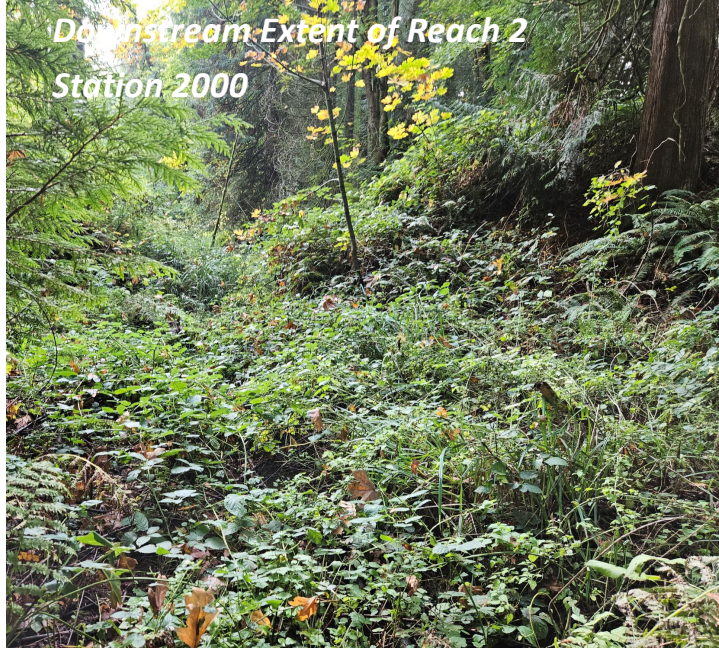
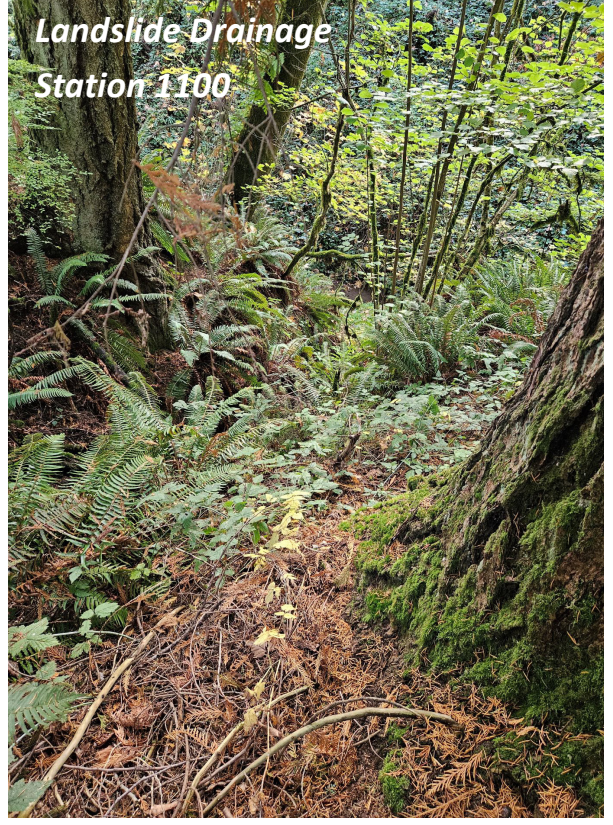
**Selected Photos From
Kruse Creek,
October 2023**

- Although the channel is moderately incised in both Reaches 1 and 2, only one headcut was observed with the rest of the channel being relatively stable. This is likely due to the downstream landslides, which begin at the Reach 2 to 3 transition, and act as a downstream base level for these upstream reaches.

- Reach 3 and 4 were very inaccessible due to deep channel incision and unstable banks associated with the adjacent large landslides.
- Active landslides and bank failures followed by subsequent channel incision through unconsolidated landslide debris is indicative of channel conditions through all of Reach 3 and potentially Reach 4. High ground water tables and seeps and springs through much of Reach 3 adds to the instability.

- Protection of the existing mature forest should be a priority in this area including management of ivy and removal of holly.
- Profile stabilization will need to be considered if the crossing at SW Kruse Road is upgraded.
